MILE POST 7 WEST RIDGE RAILROAD RELOCATION, DAM EXTENSIONS, AND STREAM  
MITIGATION PROJECT ENVIRONMENTAL ASSESSMENT WORKSHEET (EAW)

RECORD OF DECISION – FINDING OF FACT 28.i  
1975 WAHLER REPORT

Evaluation of  
**MILE POST 7 ON-LAND  
TAILINGS DISPOSAL PLAN**  
Proposed by Reserve Mining Company  
Performed by W.A. Wahler and Associates  
For the State of Minnesota

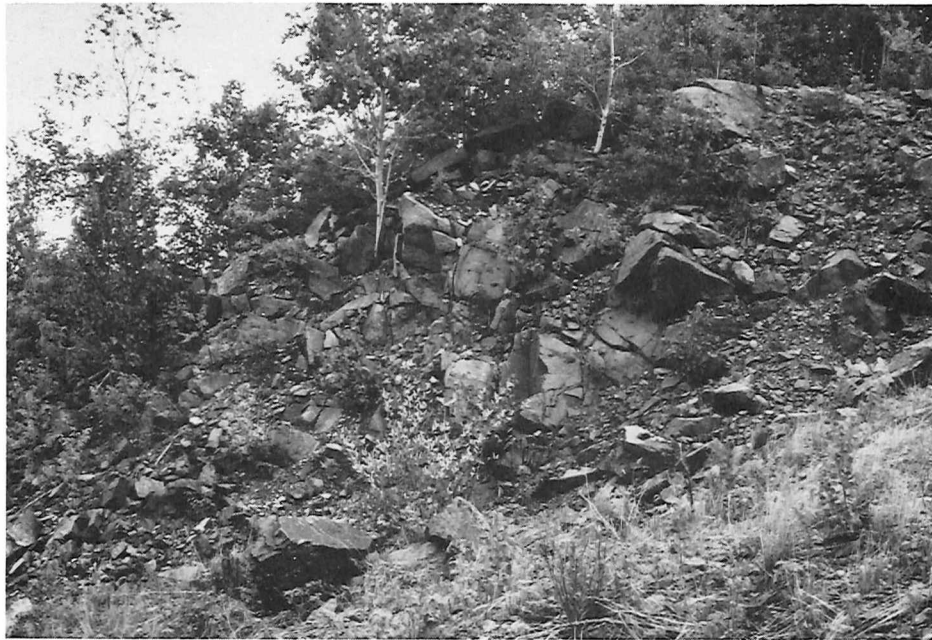
Bedrock exposed at the surface at the site is a dark, dense, fine-grained intrusive rock, herein collectively called gabbro. The bedrock is exposed over large areas on the east ridge and in scattered areas on the west side. Photo A, Photoplate III-1, shows a typical exposure of the gabbro in artificial cut.

PHOTO A. GABBRO OUTCROP AT CUT FOR GAS EASEMENT, SOUTH OF EAST ABUTMENT OF DAM NO. 1.

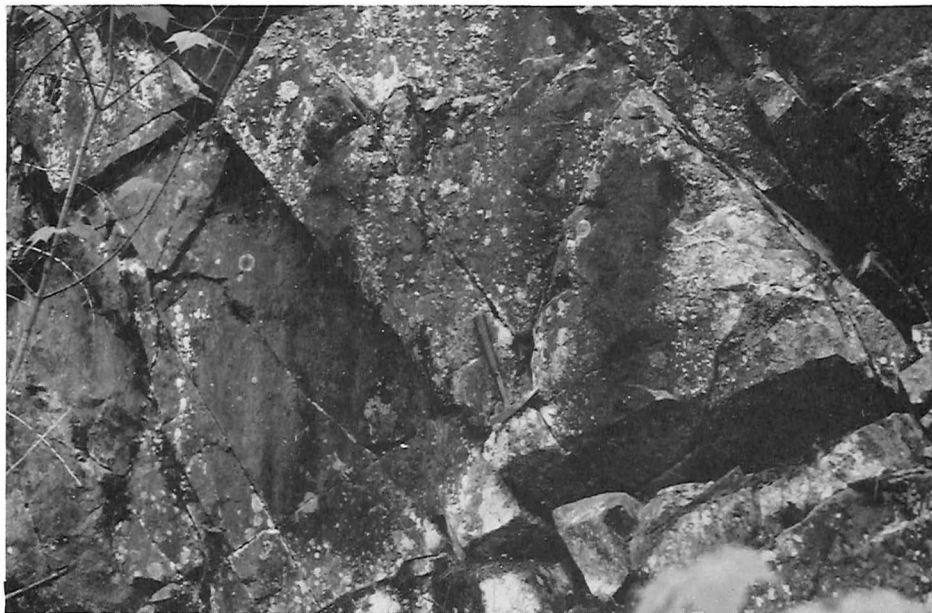
PHOTO B. GABBRO OUTCROP EXPOSED ON 10 TO 12 FOOT VERTICAL FACE (TYPICAL OF WEST SIDE OF EAST RIM). NOTE JOINTING (STRIKE N.70°E.; DIP 45° S).

The near vertical "wall", described previously along the east rim, is formed by hard gabbro outcrops (see Photo B, Photoplate III-1). The talus along the base of the "wall" consists entirely of rock blocks derived from gabbro. Another vertical face 60 to 80 feet high occurs along the east side of the knob forming the east abutment of Dam Site No. 2-3. This dike, which does not cross a definable stream course, is designated as Dam 2-3 in the Klohn Leonoff report. This structure is a substitute for two previously considered structures, Dams No. 2 and No. 3. Rock talus also occurs at the base of this prominent outcrop. These rock faces are probably the result of deep glacial scouring which preferentially plucked the rock along zones of weakness, such as faults or alignments of closely fractured rock. Subsequently, blocks of rock gradually broke away from along and above the rock faces, forming the talus slopes.

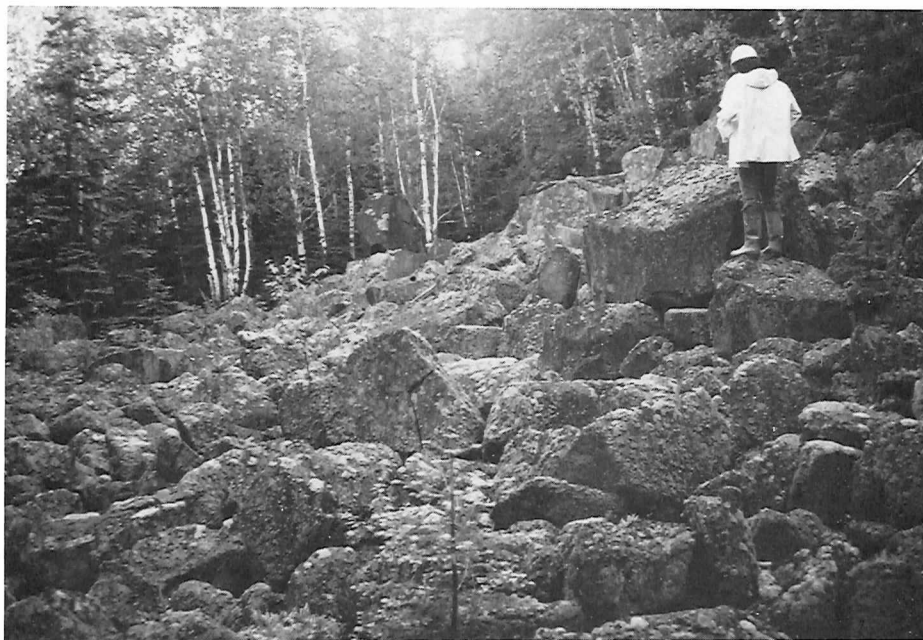
A rock talus deposit is exposed in a linear band along nearly all of the west slope of the east ridge (Photo A, Photoplate III-2). The rock talus occurs at approximate elevations ranging from 1225 to 1275 feet (Drawing III-1, in pocket, and Drawing III-2). The talus area

PHOTO A. ROCK TALUS ALONG WEST SLOPE OF EAST RIM, NORTH OF  
EAST ABUTMENT OF DAM NO. 1.

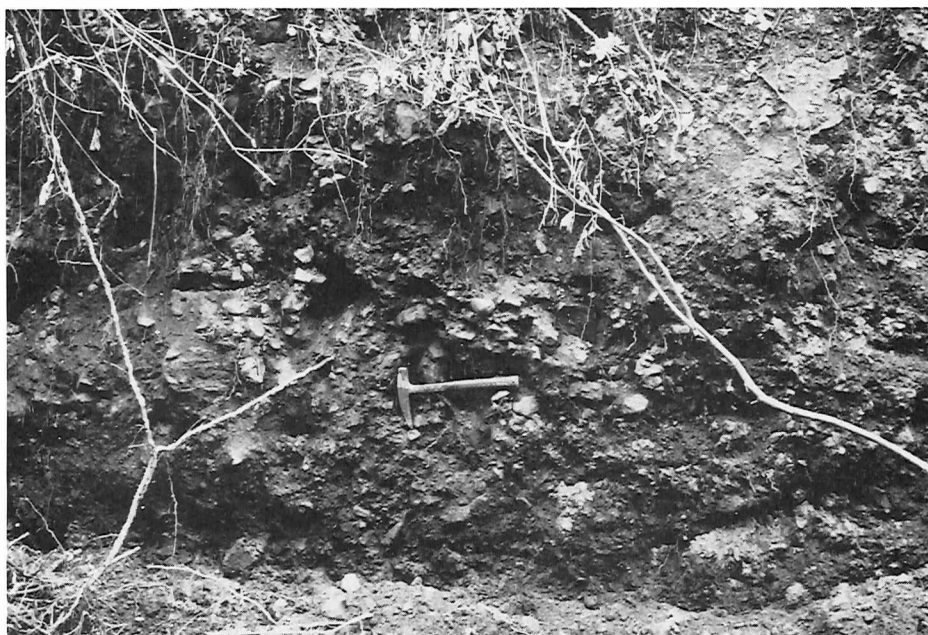
PHOTO B. EXPOSURE OF GRAVELLY SAND IN 5-FOOT HIGH ROAD CUT, ON  
WEST SLOPE OF EAST RIDGE ABOUT 1000 FEET SOUTH OF EAST ABUT-  
MENT CONTACT OF DAM NO. 1. GEOLOGIST'S PICK GIVES SCALE.

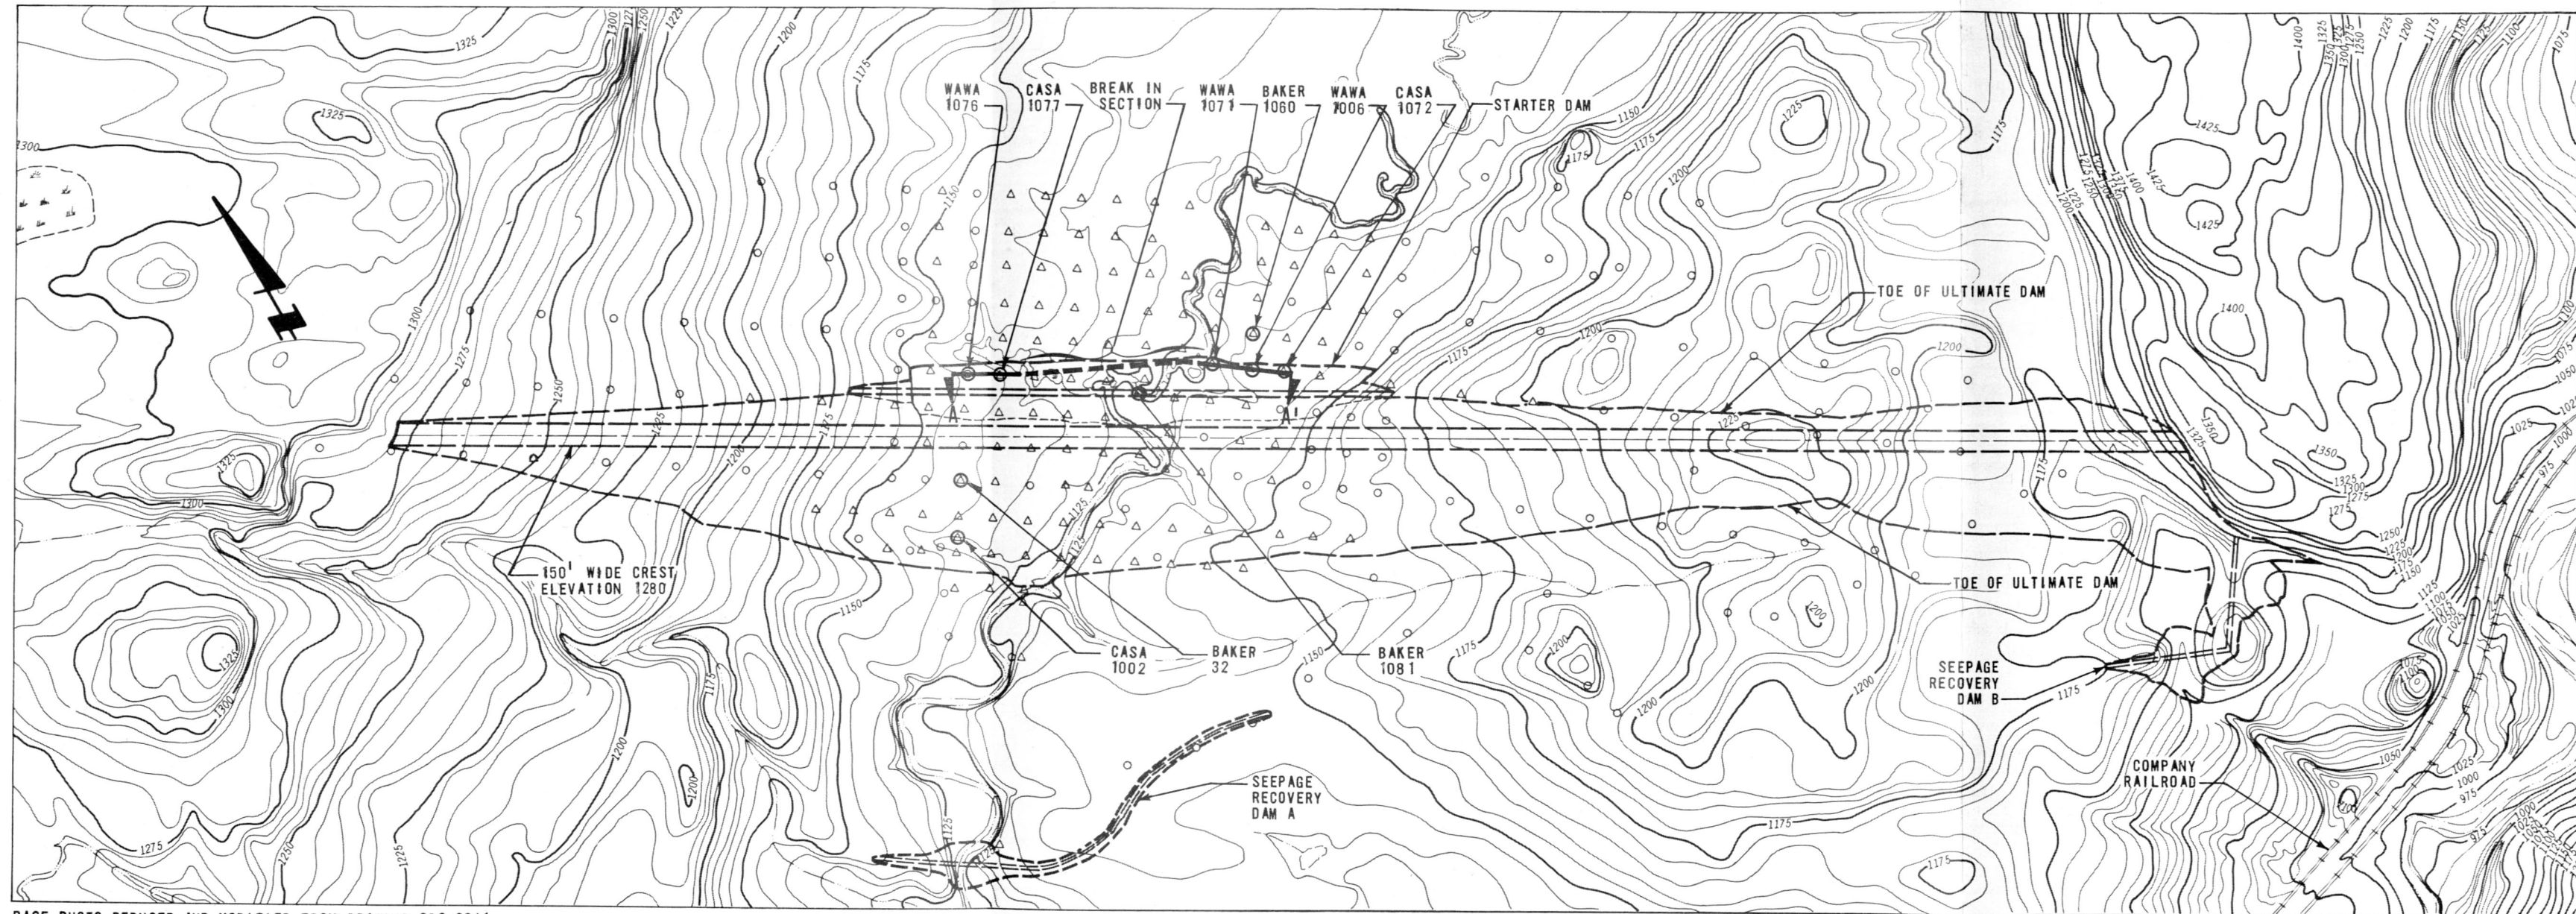
EXPLORATION MAP  
DAM SITE NO. 1

Subsurface exploration carried out at Dam Sites No. 1 and No. 2-3 by the Reserve Mining Company consultants has been very extensive. Drilling for the State's three consultants was accomplished adjacent to previous exploration by Reserve (Drawings III-3 and III-5) for verification and supplemental data purposes.

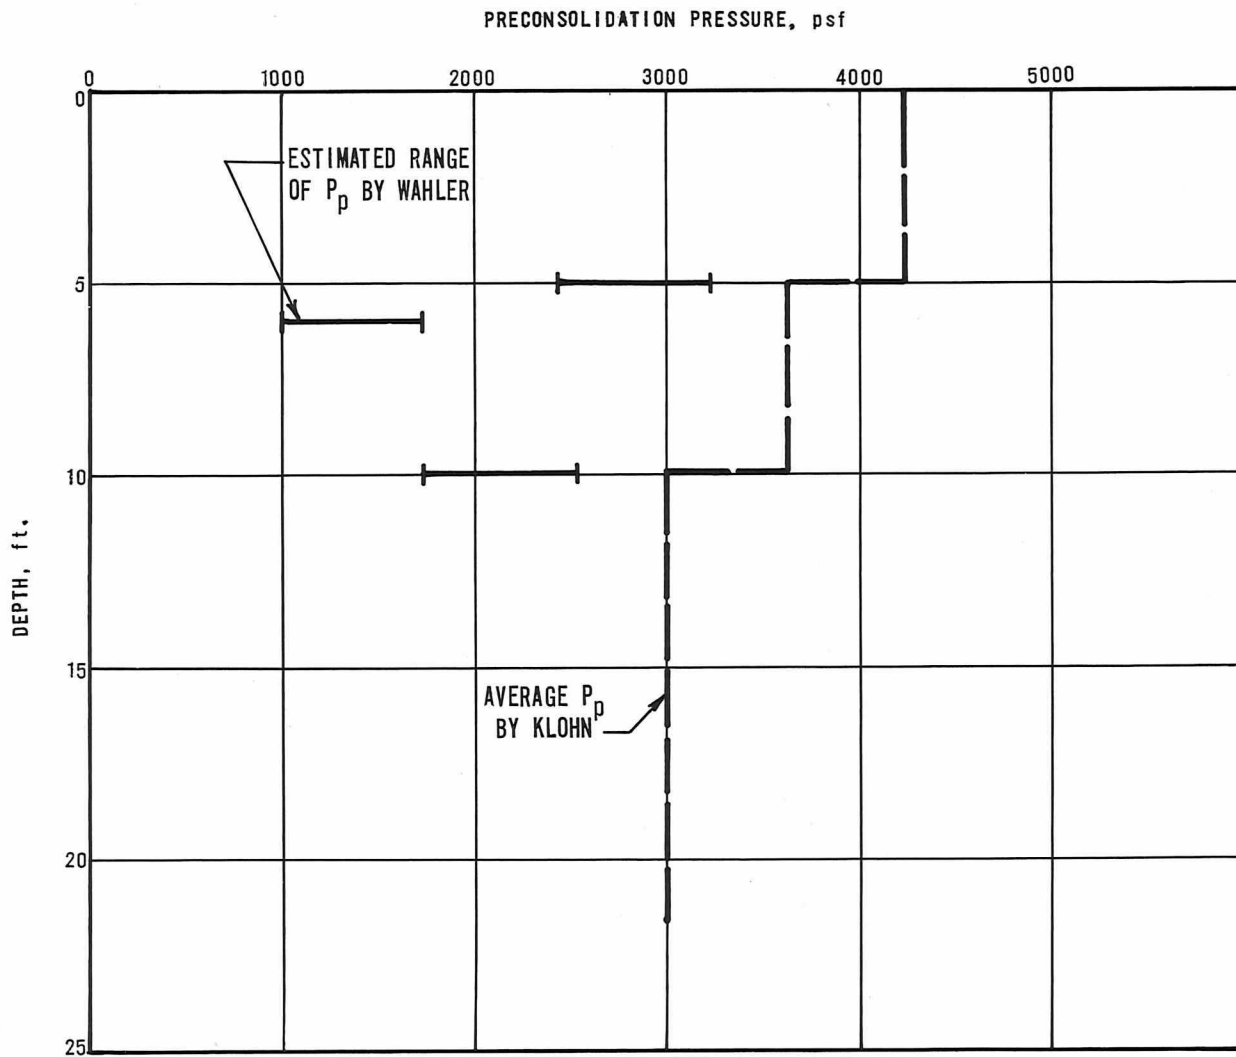
Values of compression index ( $C_c$ ) and recompression index ( $C_r$ ) from the three tests are also summarized and compared to the values of Kohn Leonoff on Drawing III-8. These values are in reasonably good agreement.

PROPERTY	WAHLER		KLOHN
	RANGE	AVERAGE	DESIGN VALUE
COMPRESSION INDEX, $C_c$	0.21-0.37	0.29	0.34
RECOMPRESSION INDEX, $C_r$	0.04-0.11	0.06	0.08

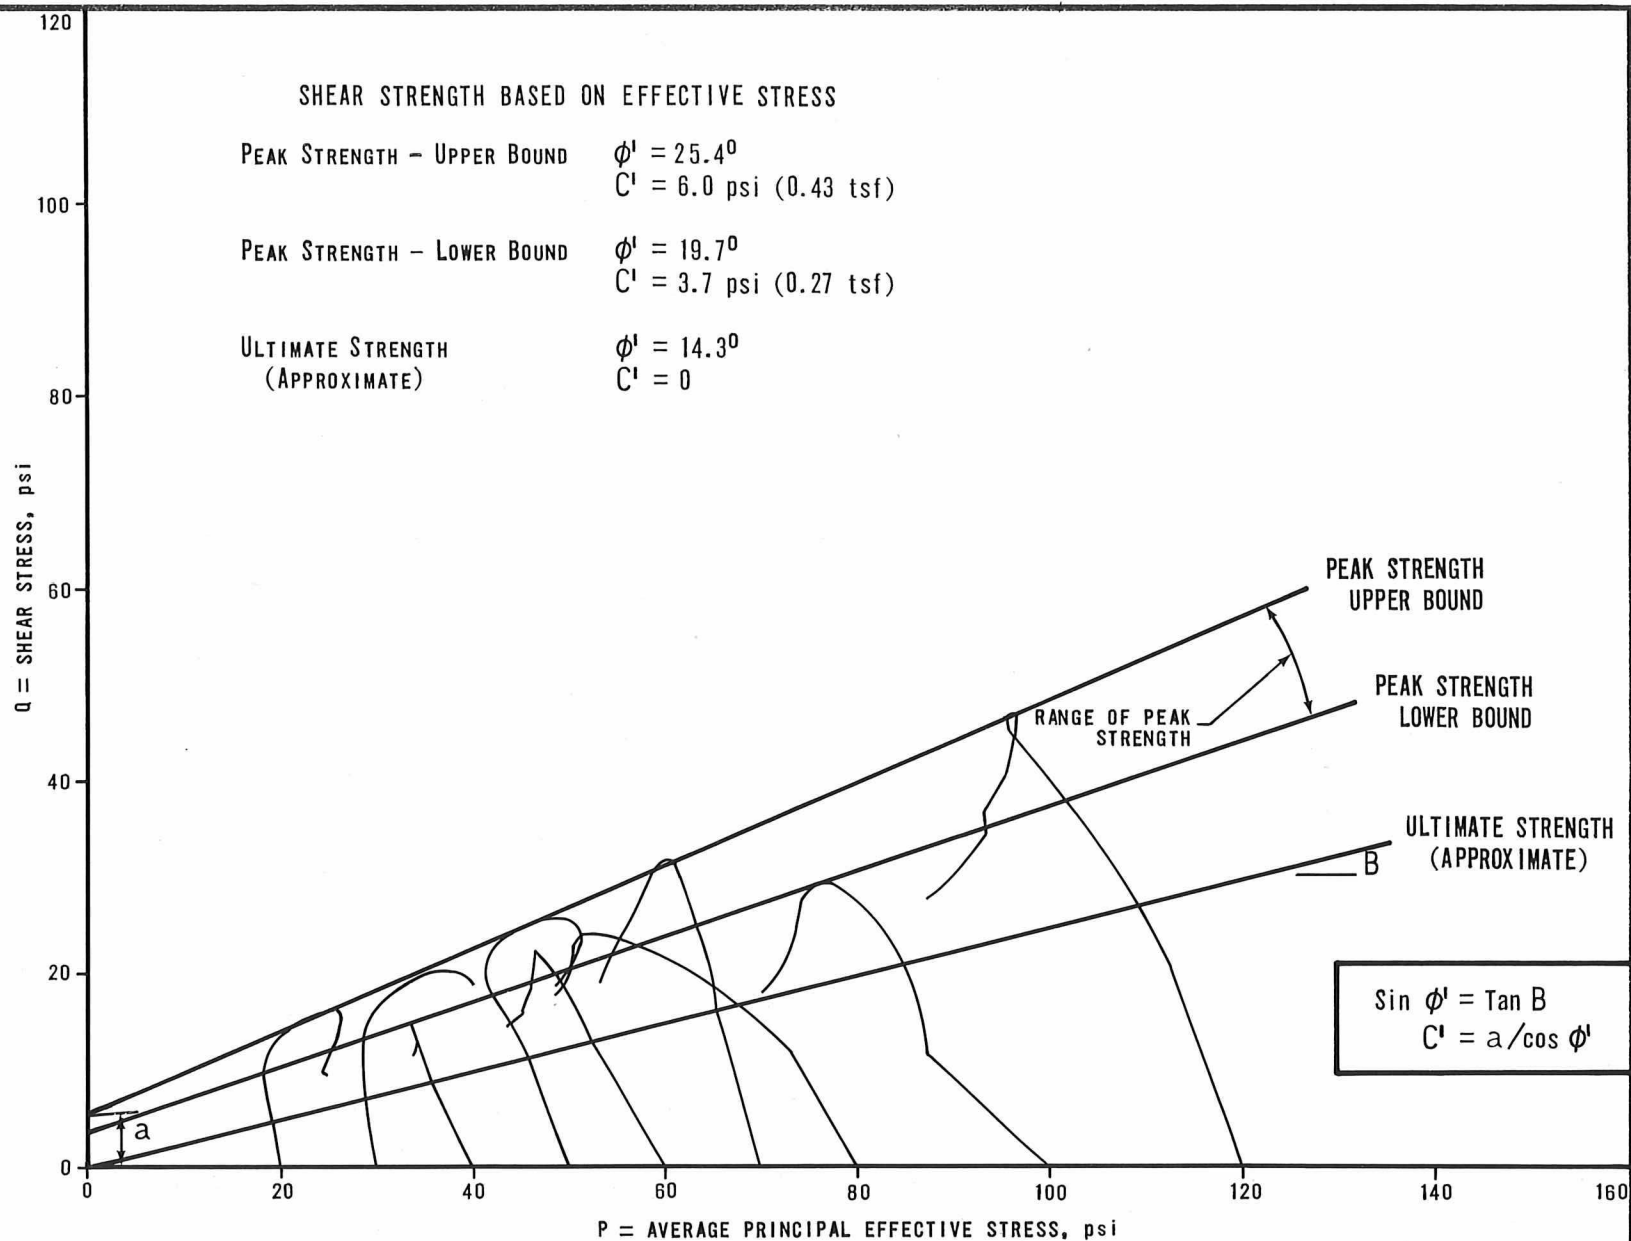
111-10

These parameters can be obtained by plotting the results of our ICU tests in an alternate form as summarized on Drawing III-10. The resulting effective strength parameters obtained from our testing program are compared with design values proposed by Klohn Leonoff in Table III-4, below.
