Subject: Revised Final Report Entitled "Assessment of Potential Corrosion Induced by Bromine Species Used for Mercury Reduction in a Taconite Facility"; Work Order Contract No. B24812; EERC Fund 14783

# **ASSESSMENT OF POTENTIAL CORROSION INDUCED BY BROMINE SPECIES USED FOR MERCURY REDUCTION IN A TACONITE FACILITY**

Final Report

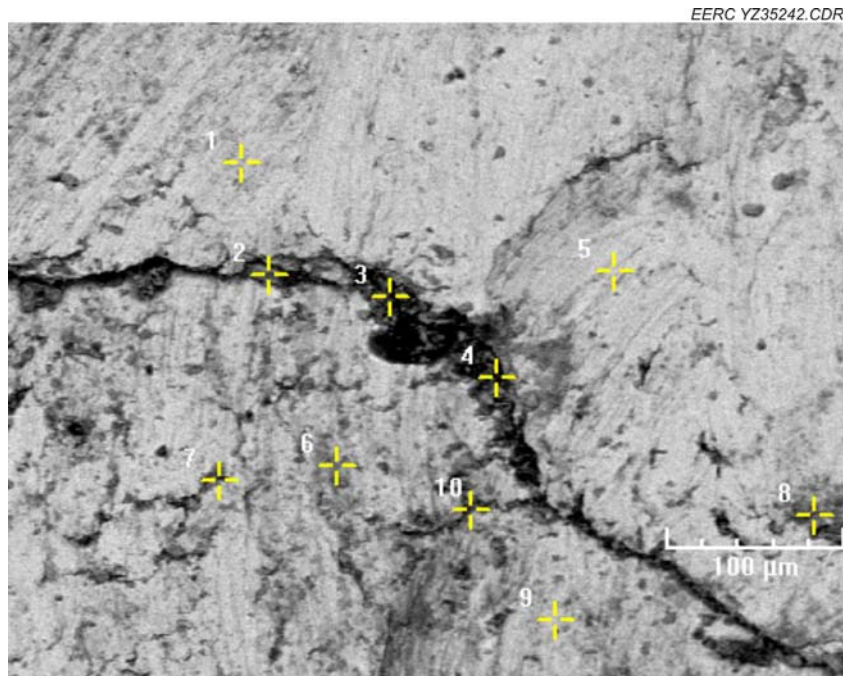
Figure 9. U2 surface SEM image.

Coupons that have been exposed to bromine and taconite flue gas, U1–6, all showed Br deposition in small percentages. As a result, iron, chromium, and nickel elemental averages show small gains/losses depending on the testing conditions. Sulfur and silicon were affected in very small percentages in some coupons. Plotted in Figures 8–11 are the surface SEM images for U1–4 respectively. Compared to surface striations observed on U4, small surface cracks, pits, and chipping on coupons U1–3 were mainly caused by drilling during coupon preparation. Elemental analysis data of the U1–4 surfaces indicate enrichment of Fe and losses of Cr and Ni due to HBr attack. SEM data of U5 and 6 surfaces indicate no large changes in morphology and elemental composition after exposure testing. The complete data set is included in Appendix A.

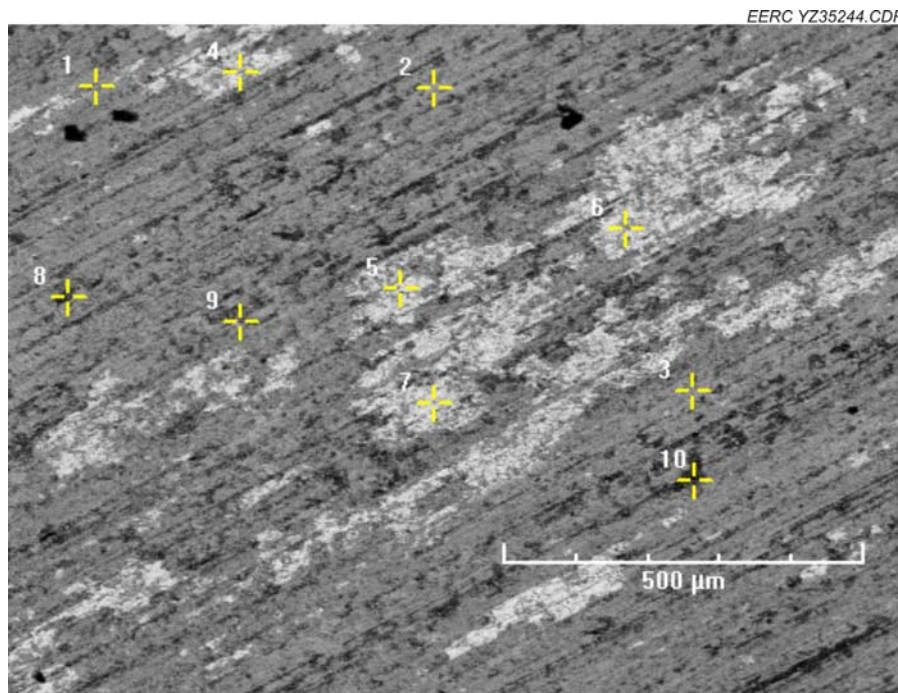
Figure 11. U4 surface SEM image.

The cross-sectional SEM data for United coupons, other than U4, indicate that bromine deposition was confined to the surface of the material and did not impact the elemental composition. Figure 12 is the cross-sectional SEM image for U4, and corresponding elemental distributions are listed in Table 7. The SEM data for U4 indicate slight penetration of bromine species with corresponding losses of Ni and Fe below the coupon surface under 500°C testing conditions. Other SEM cross-sectional data are reported in Appendix A.

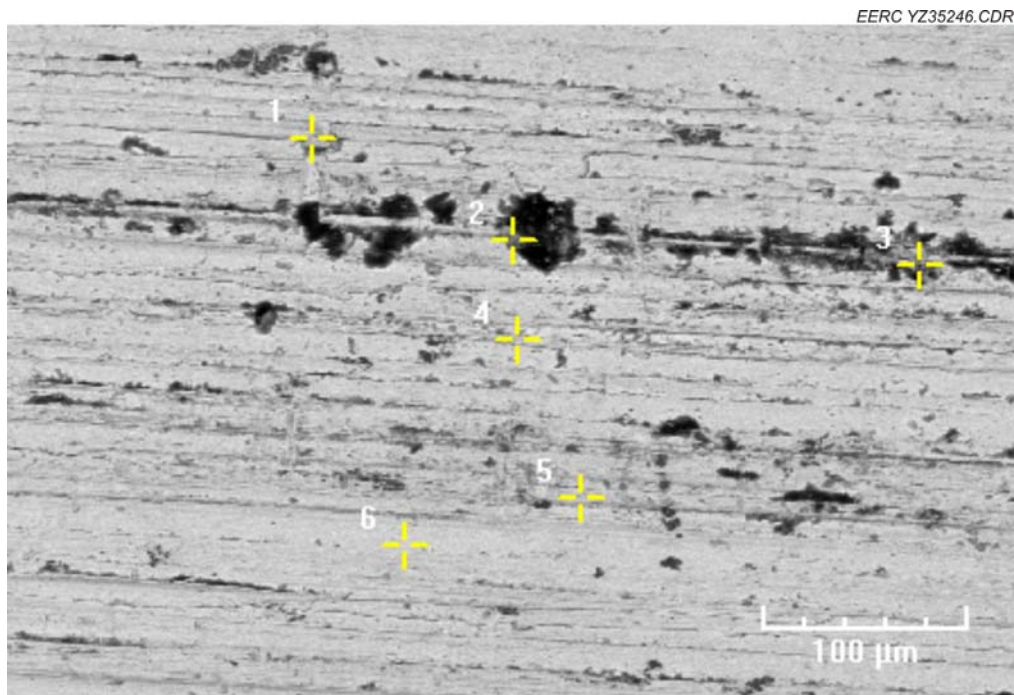
Figure 14. M8 surface SEM image.

SEM surface analysis of coupons M7–9, which were only exposed to taconite flue gas, indicates gain or loss of Ni, Fe, and Cr, depending on testing conditions. Both Fe and Ni were oxidized or vaporized on the M7 surface under 500°C testing conditions. This resulted in Cr enrichment while little elemental change was observed on M8 at 300°C. The M9 surface appears to have suffered sulfur attack, showing Fe and Cr losses. Plotted in Figures 13–15 are the microscopic surface images of coupons M7–9, respectively. No surface chips, cracks, or pits are visible, but surface striations were observed. Cross-sectional data for M7–9 (reported in Appendix B) show consistent elemental distribution similar to pretest data beyond the coupon surface, proving no penetrated corrosion occurred.

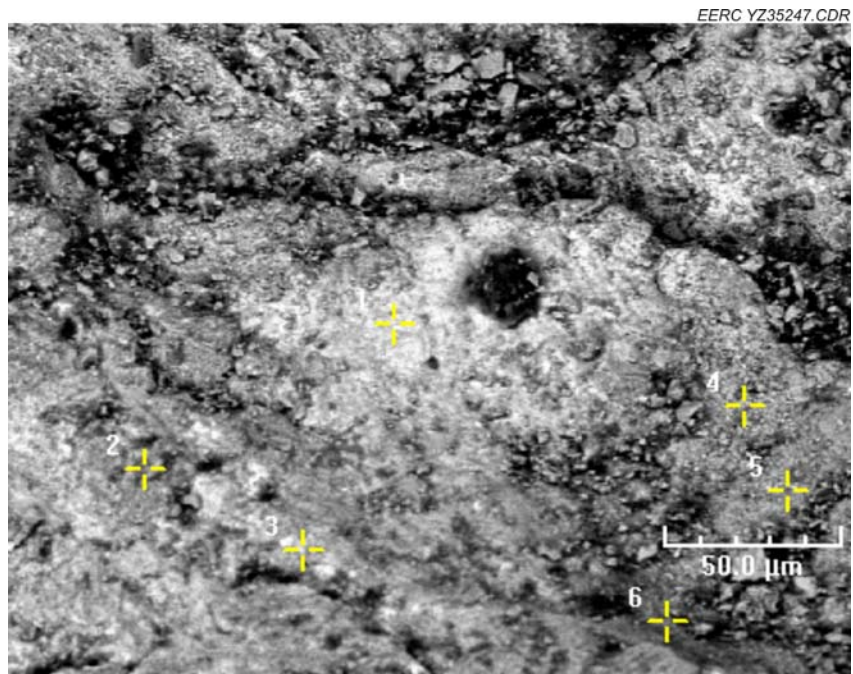
Figure 16. M1 surface SEM image.

The coupons exposed to bromine, M1–6, all showed Br deposition, while bromine concentrations on coupons with iron oxide deposit were less than that without deposition. Plotted in Figures 16–21 are the surface SEM images for coupons M1–6. Small cracking and pitting are observed on M1–3 surfaces, and this was most likely caused by the drilling process. M1 (Figure 16) shows slight blistering, an indication of vaporization at 500°C. Discoloration and striation were seen on M2 and M3. Similar surface striations were also observed for coupons M4–6. As shown in Table 8, consistent losses of Ni were detected on coupon surfaces where they contacted HBr. Iron loss was only detected at the 500°C testing temperature, i.e., M1 and 4.

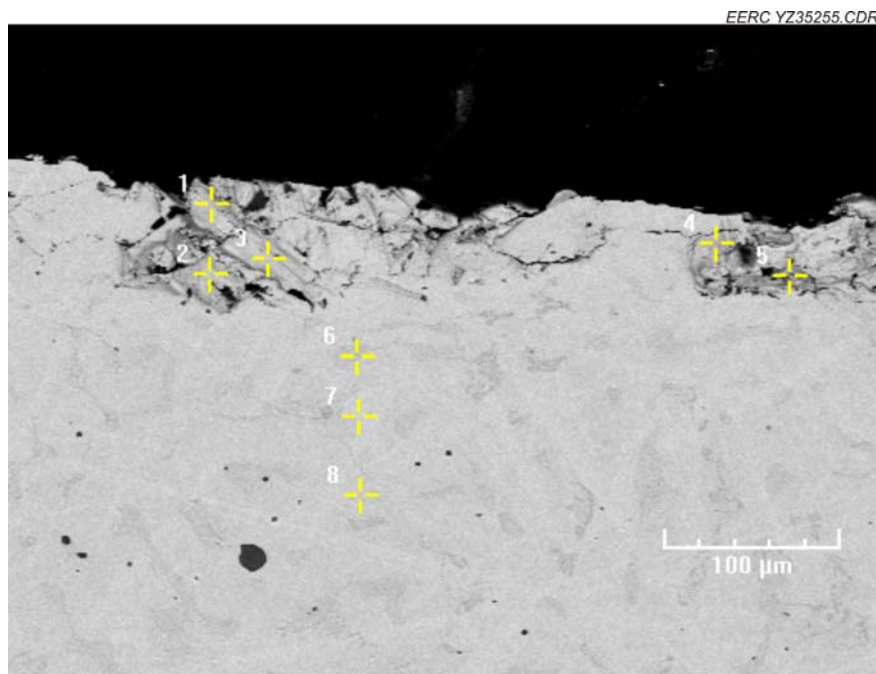
Figure B-12. M6 cross-sectional SEM image.

Cross-sectional SEM analysis on M1–6 was performed; the complete data set is included in Appendix B. Figures 22–25 are the cross-sectional SEM images for M1, 3, 5, and 6 and show notable changes. M2 and 4 cross-sectional SEMs indicate no corrosion and/or elemental variation compared to pretest data. Cracking through the M1 cross section was due to drilling. However, elemental data (Table 9) show HBr deposits on the surface and no further penetration occurred. Cross-sectional data of M3 (Figure 23 and Table 10) indicate slight Br penetration through intact surface with corresponding Ni loss. Both M5 and M6 cross-sectional SEMs show slight cracking on the coupon surface with elevated Br deposition, but no further elemental changes were observed beyond the surface as listed in Tables 11 and 12.

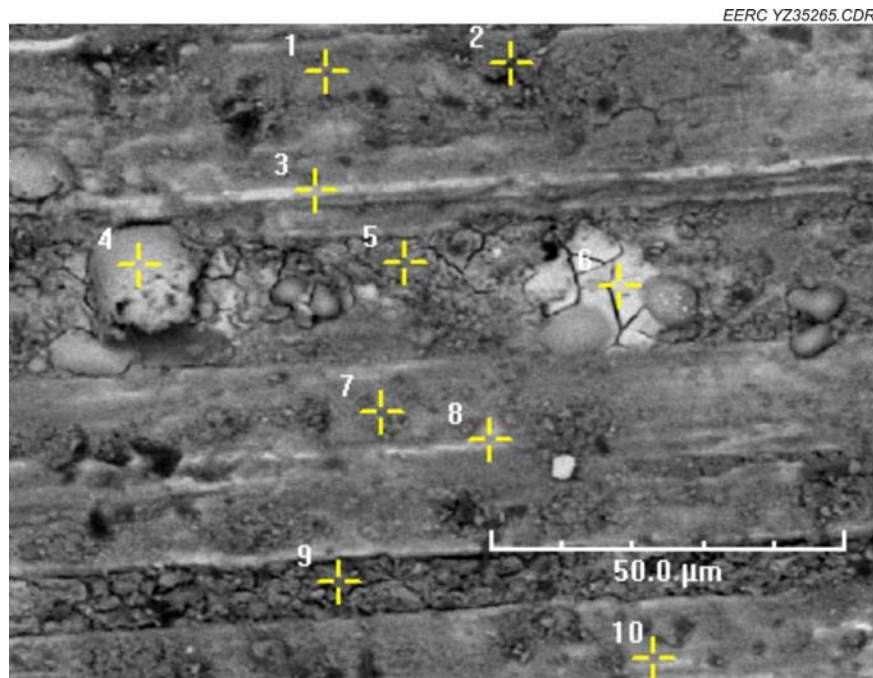
Figure C-9. UM5 surface SEM image.

The coupons exposed to bromine, UM1–6, all showed Br deposition with Ni, Fe, or Cr losses, depending on testing conditions. The highest Br surface concentration was 30.09%, measured on UM5. Figures 26 and 27 and Table 14 are the UM5 microscopic images and cross-sectional analysis, respectively. The UM5 surface shows blistering and cracking, with losses of Ni, Cr, and Fe. Further cross-sectional analysis indicates that although slight Br penetration occurred, no significant elemental disruptions occurred. All other UM coupons exposed to bromine show surface striation but no further corrosion beyond the surface.

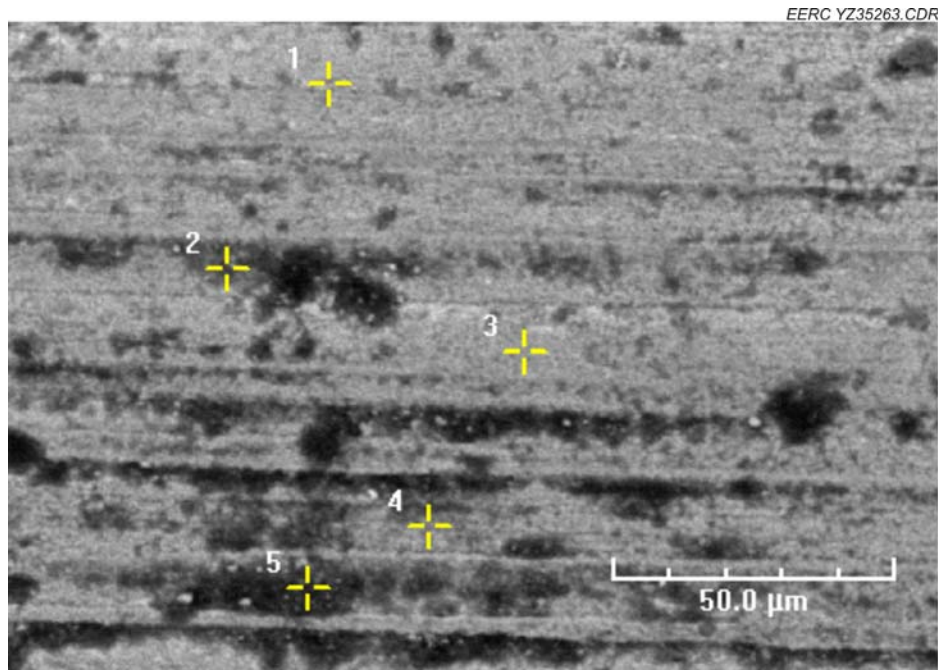
Figure C-13. UM7 surface SEM image.

Without HBr in the taconite flue gas, SEM analysis indicates that UM coupons only suffer surface loss of Ni and Fe in a 500°C environment. Discoloration and surface striation were observed for UM7–9. Additional cross-sectional SEM–EDX data show that UM7–9 were well protected and did not experience significant oxidative deterioration.
