STREAM
REACH
INVENTORY
AND
CHANNEL
STABILITY
EVALUATION

A Watershed Management Procedure

United States
Department of
Agriculture

Forest Service
Northern Region

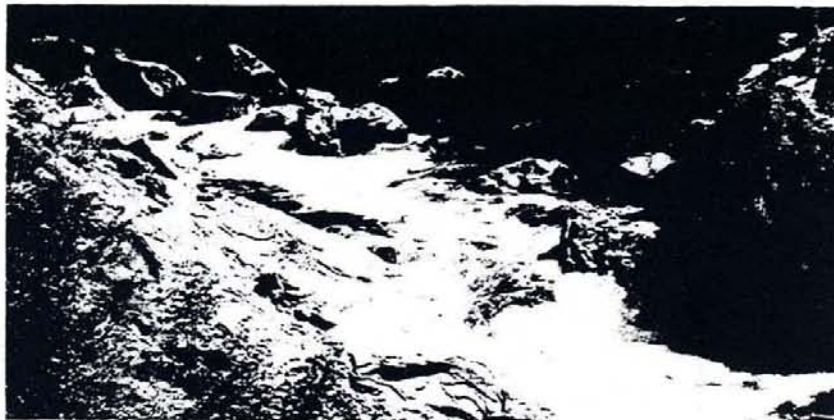
NOTE: Channels cut to bedrock are always rated Excellent.

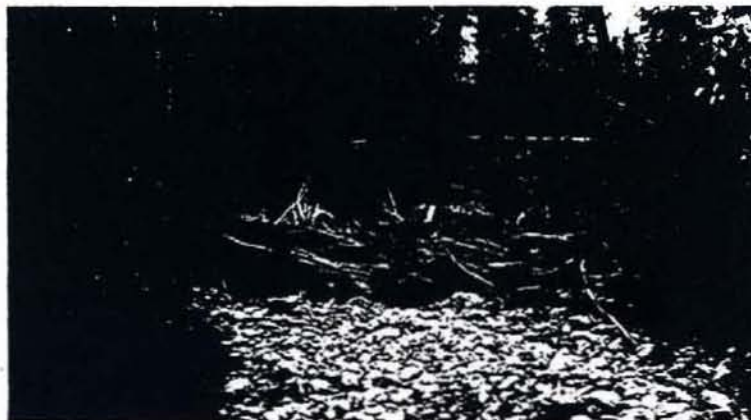
A series of debris jams of small size materials like the one shown in the center of this photo cause this item to be rated "Poor".

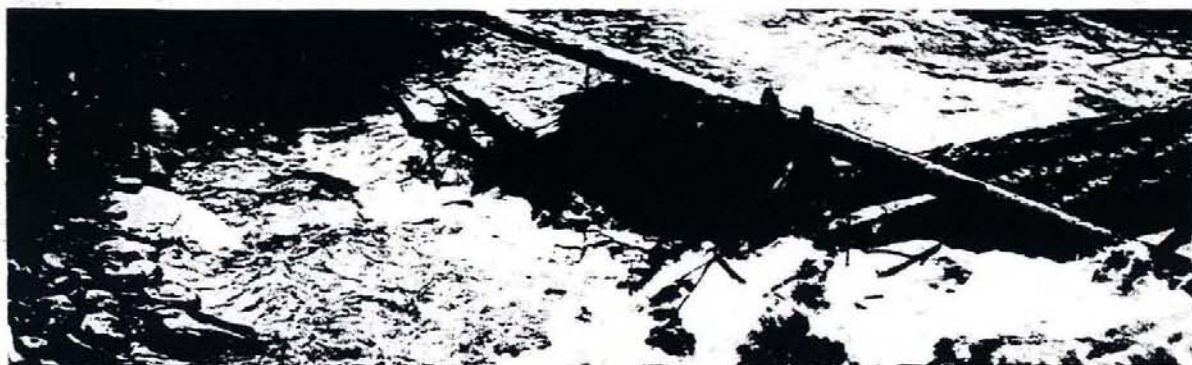
Overtured shoreline trees become obstructions and flow deflectors as shown here. If frequent in the reach, rate this item "Poor".

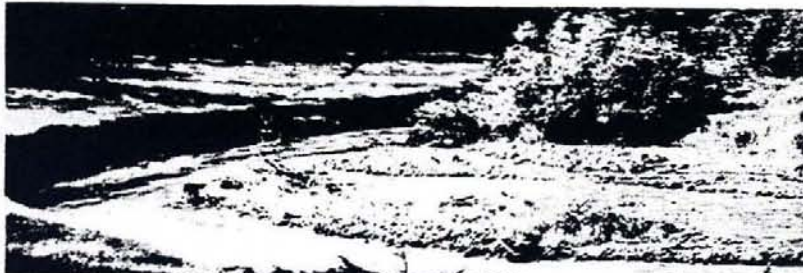
Poor bank conditions at this bend are evident.

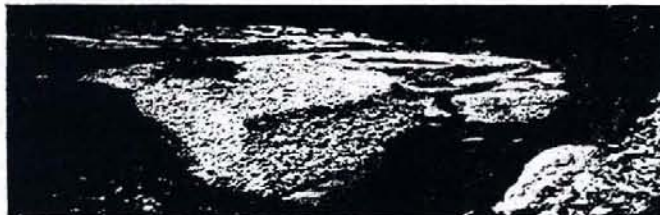
Poor conditions are illustrated here.

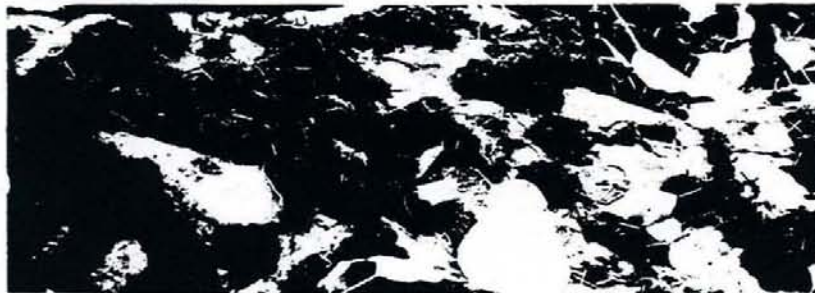
Clinging Moss and Algae: These lower plant forms do not have roots but cling to the substrate. They are low growing and may first appear as a green to yellow-green slick spot on the bottom rocks. Moss plants continue with slight variation in color but no great change in mass form season to season. Algae by contrast have a peak of growth activity and then die off in great numbers. The slippery conditions they produce persist after death, however.

1. Excellent: Clinging plants are abundant throughout the reach from bank to bank. A continuous mat of vegetation is not required but moss and/or algae are readily seen in all directions across the stream.
2. Good: Plants are quite common in the slower portions of the reach but thin out or are absent in the swift flowing portions of the stream.
3. Fair: Plants are found but their occurrence is spotty. They are almost totally absent from rocks in the swifter portions of the reach and may also be absent in some of the slow and still water areas.
4. Poor: Clinging plants are rarely found anywhere in the reach. (This is an unusual situation but could happen under a combination of adverse environmental conditions).

Channels with this much moss are rated "Excellent"

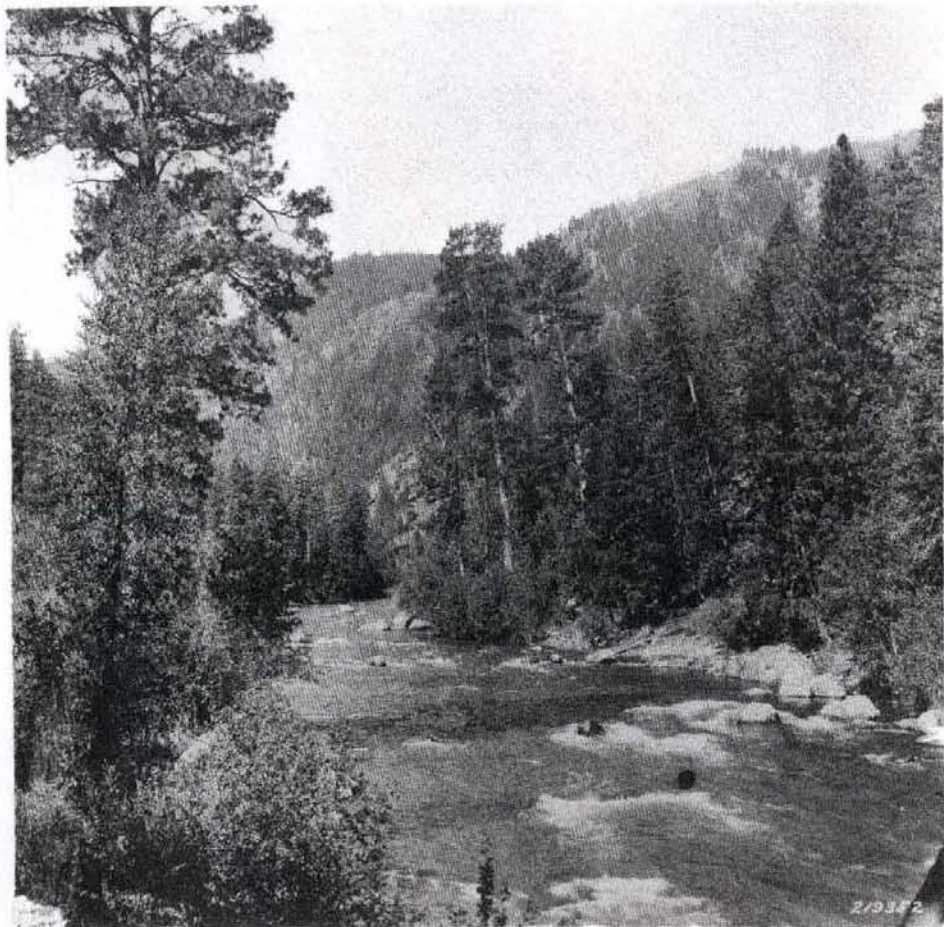
*This large stream channel reach
would be rated "excellent" overall.*
