# **Five-Year Operations Plan Years 2019-2023**

## ***Milepost 7 Tailings Basin***

Prepared for  
Northshore Mining Company  
Silver Bay, Minnesota

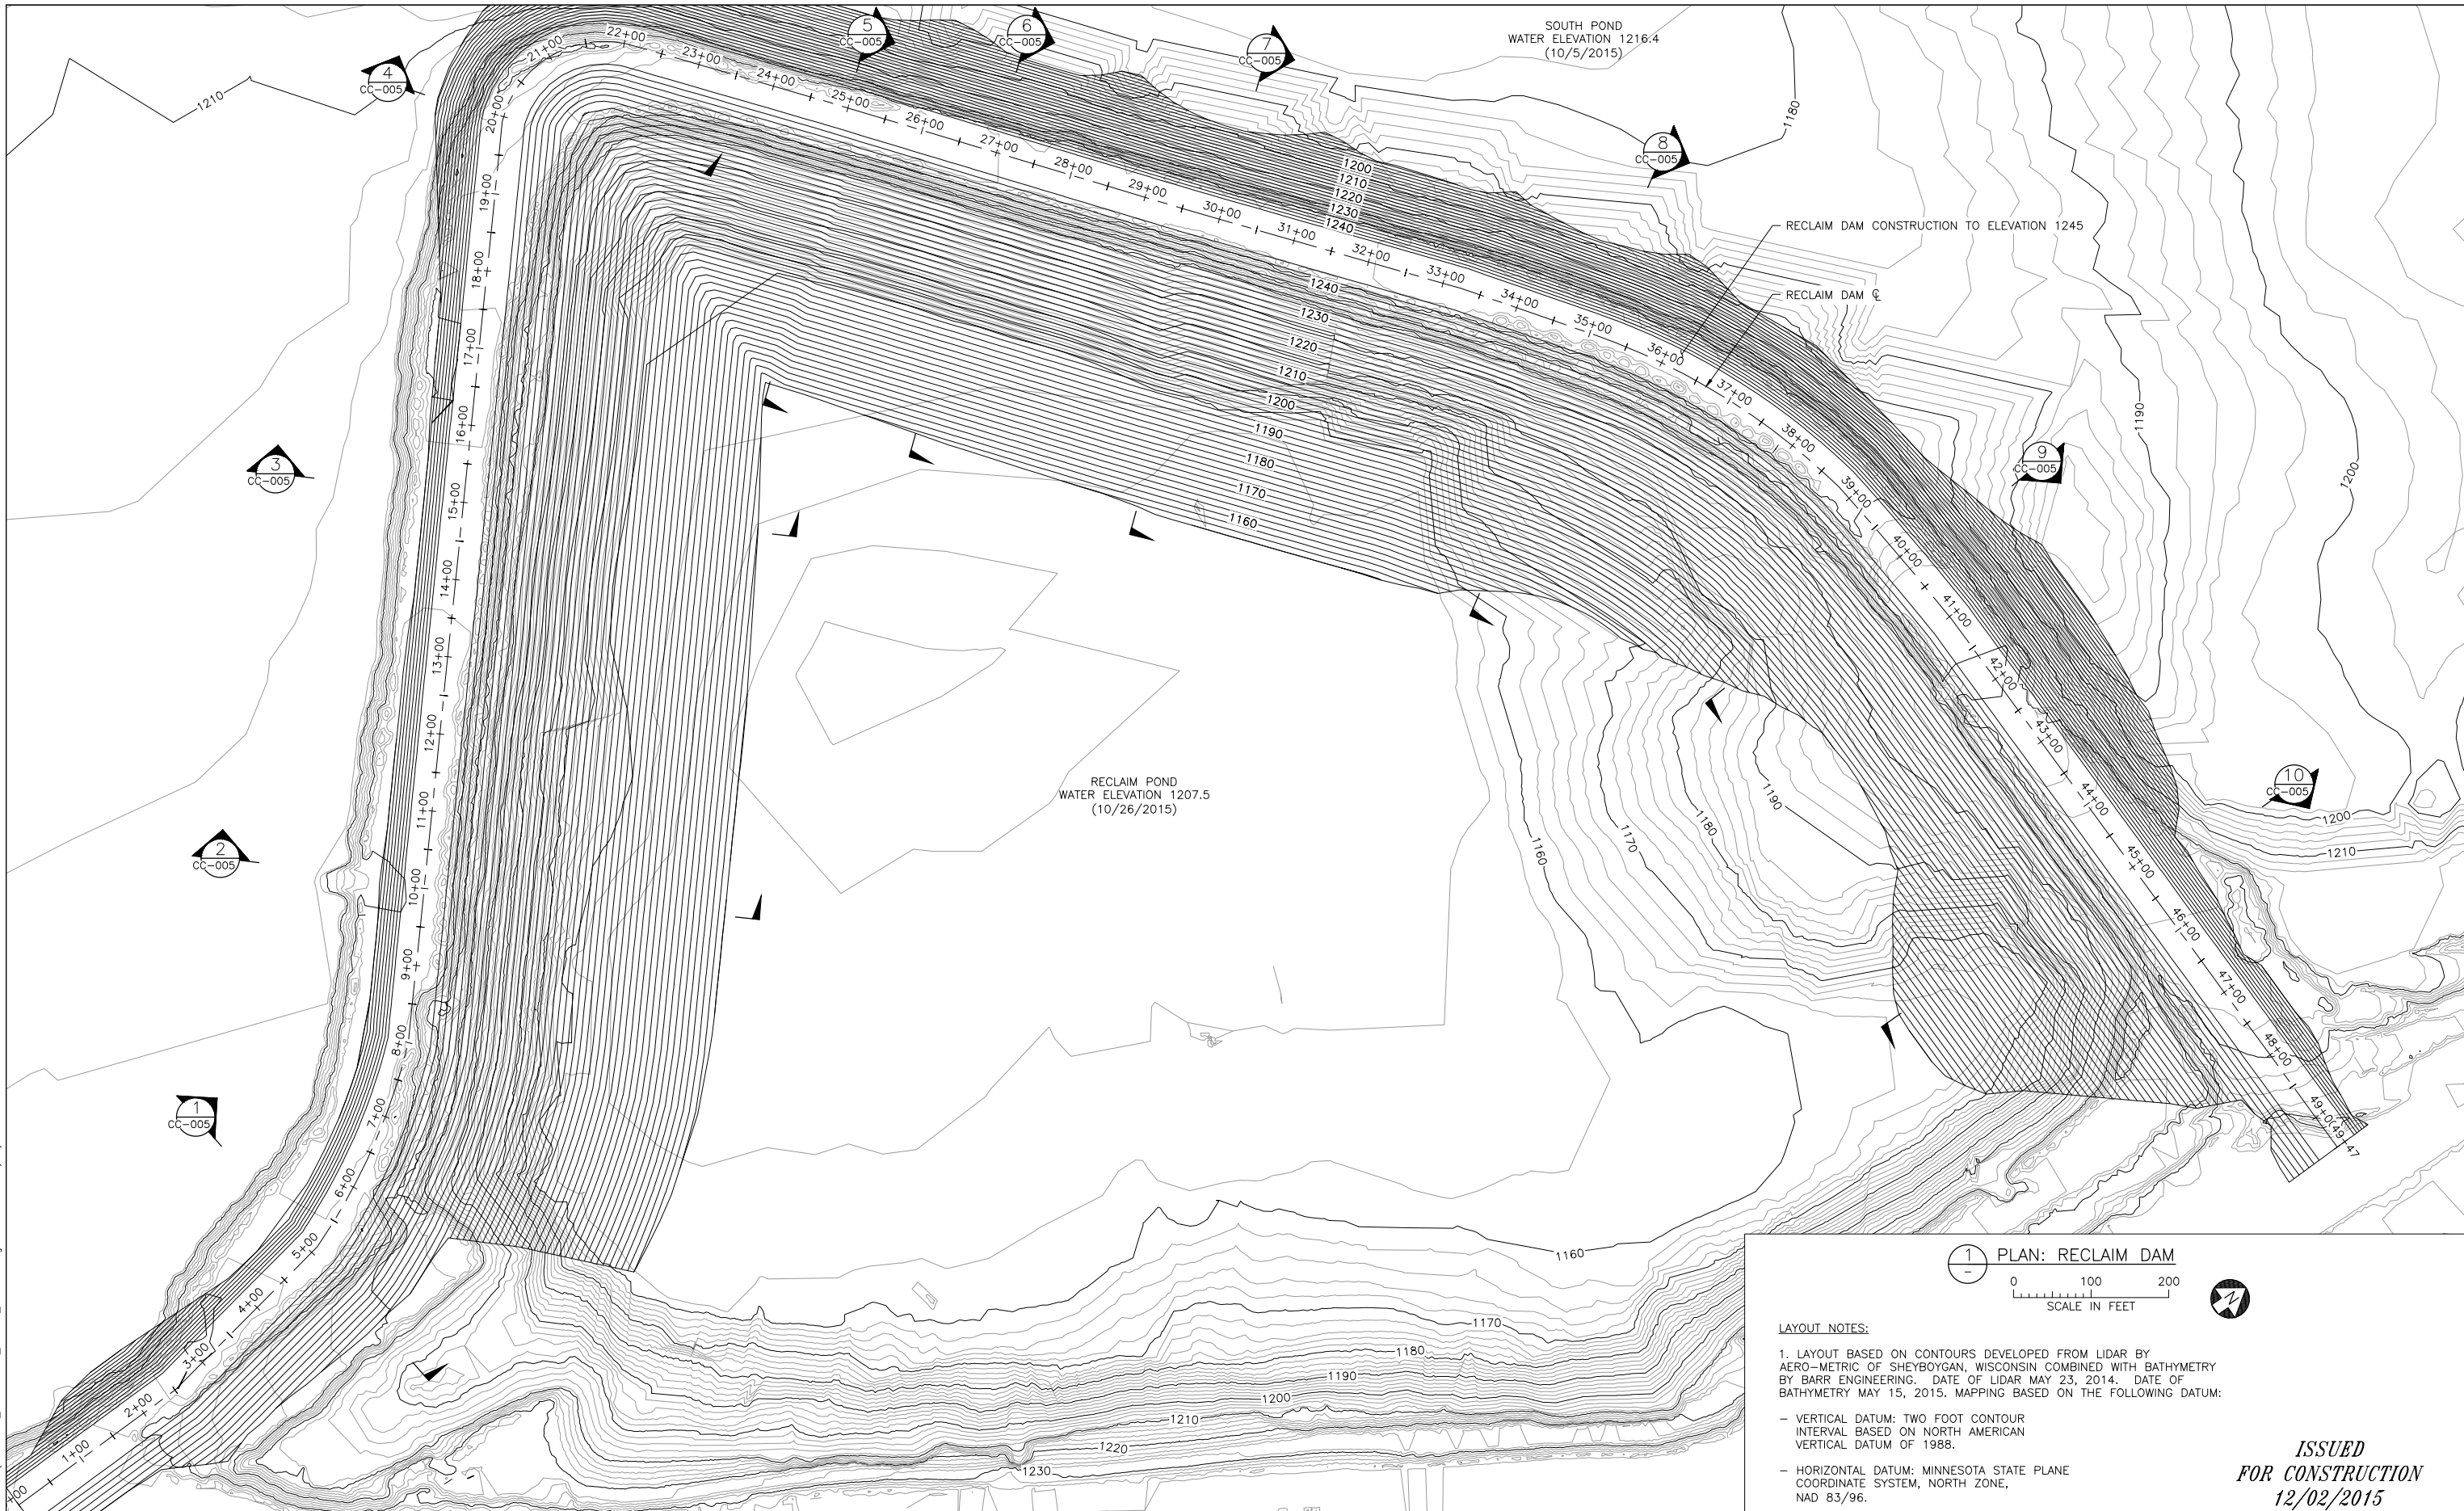
1 PLAN: RECLAIM DAM  
0 100 200  
SCALE IN FEET

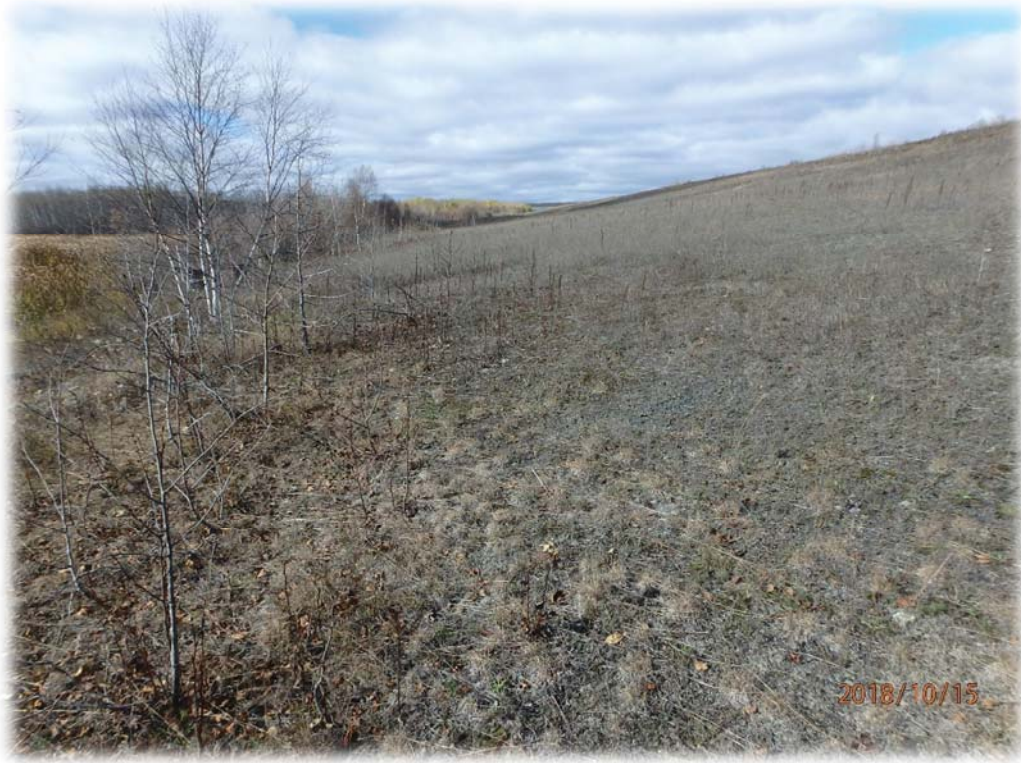
Looking west along the toe of Dam 1

Along the toe of the dam (below the seepage collection ditch) there was no visible evidence of piping or internal erosion, as no seepage was observed to be exiting the face of the slope and seepage observed at the toe of the slope did not contain fines. Visible or apparent seepage was limited to the flow from the relief wells. No sand boils were observed, and the toe was firm. As has been observed since 2015, one relief well on the eastern edge of the pond, R-11, is broken off at the ground surface and should be repaired. The ditch supporting the flow from the R-11 well should be cleaned to promote drainage and the general area beyond the toe cleared so the relief wells are more visible. Additionally, it would be advantageous if one approximate excavator bucket of material was removed from beneath each relief well to allow use of a larger container for flow measurement during monitoring events.

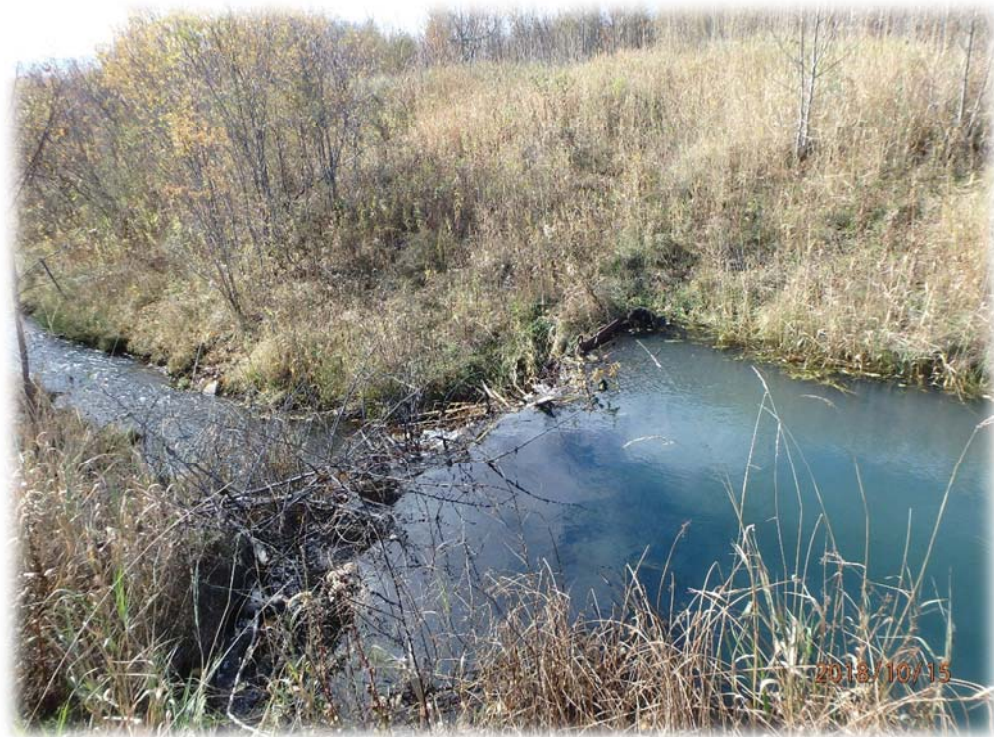
Upstream side of west weir at Dam 1

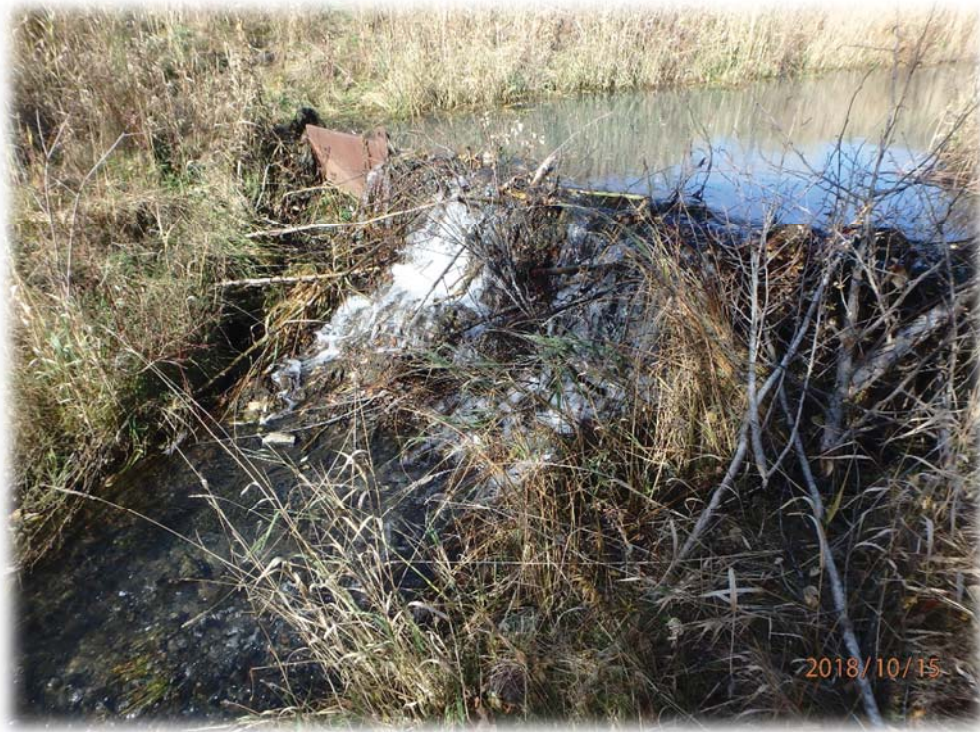
Downstream side of west weir at Dam 1

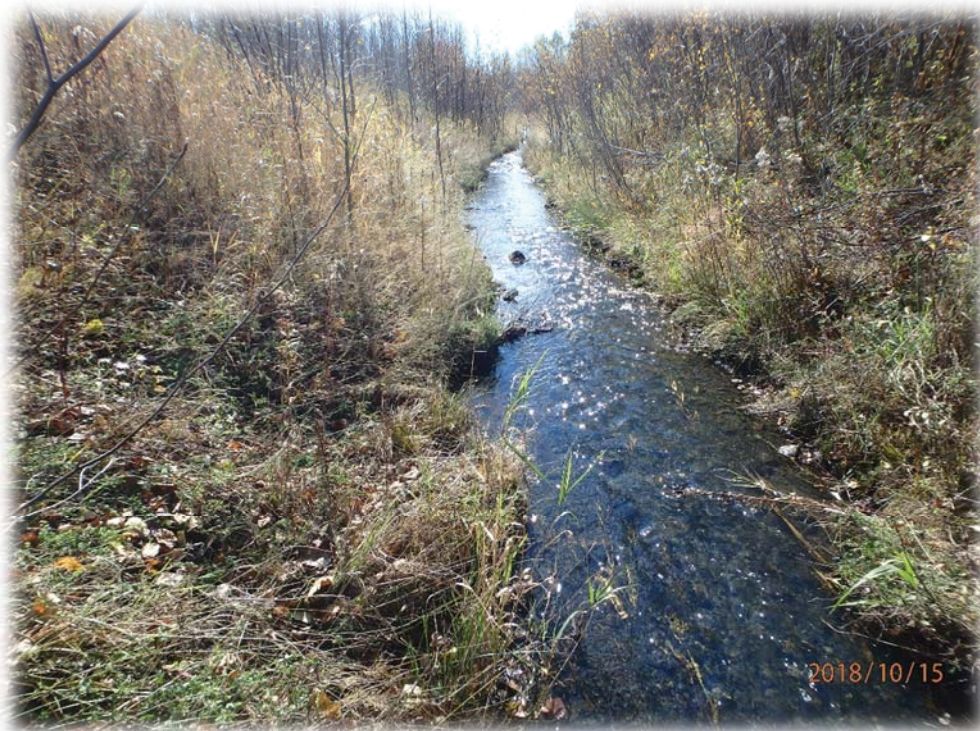
Looking downstream at channel to divert seepage recovery ditch water away from west end of Dam 1

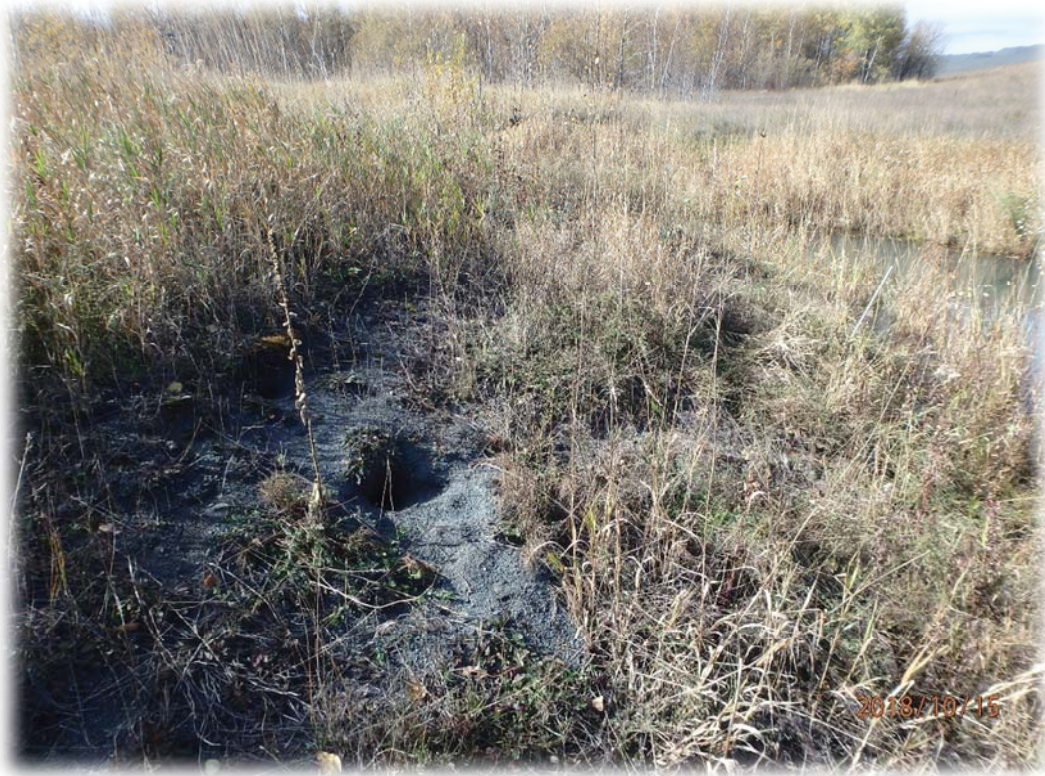
Animal burrows in core at west end of Dam 1, near weir

A few apparent animal burrows approximately 3 inches in diameter and partially obscured by vegetation were observed to be present on the west edge of the core near the west weir. These animal burrows should be filled in accordance with FEMA *Technical Manual for Dam Owners: Impacts of Animals on Earthen Dams* (2005) to help prevent creation of preferential drainage paths in the dam.

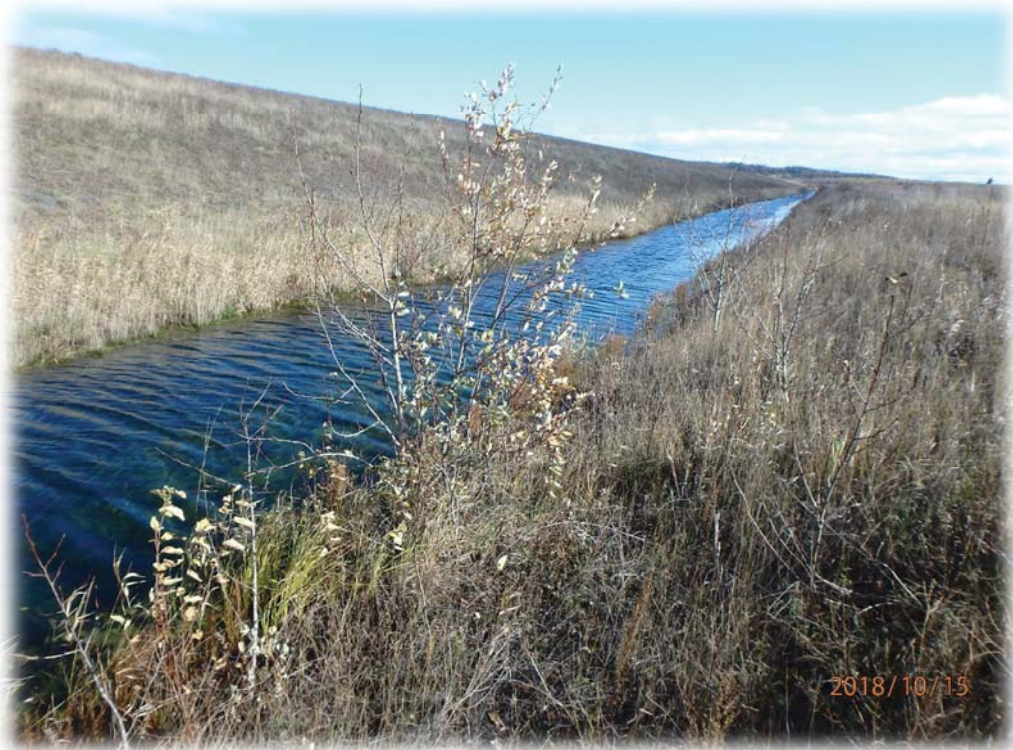
Looking east along seepage recovery ditch with sporadic brush and abundance of algae at Dam 1

A visible phreatic line was observed on the upstream side of the seepage collection ditches about one foot above the ditch water level along the entire ditch alignment. The core and filter were observed to generally be relatively clear of brush, though some tall brush was observed to be present near the east end of the main portion of Dam 1, which should be removed. It appeared as though some work had been performed to remove some of the brush on the core at Dam 1E, though large brush is still present to the west of approximate station 92+00. A notch appeared to have been cut out of the core as part of the previous brush clearing activities. This notch should be regraded to prevent collection of water from precipitation at this location.

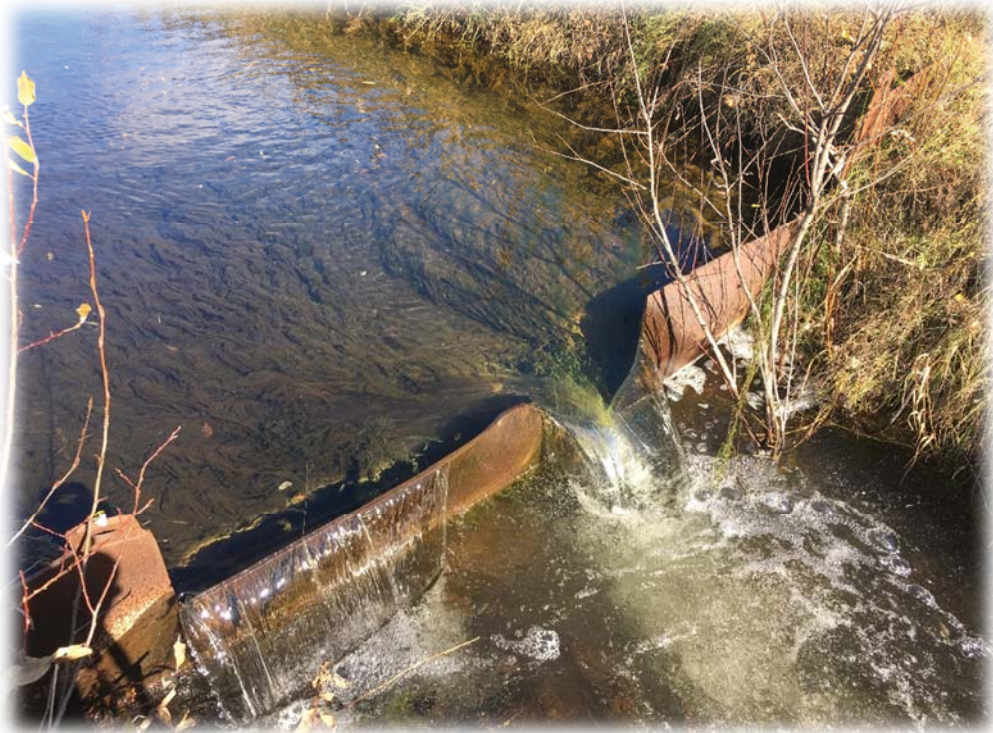
Weir at east end of seepage recovery ditch for main segment of Dam 1

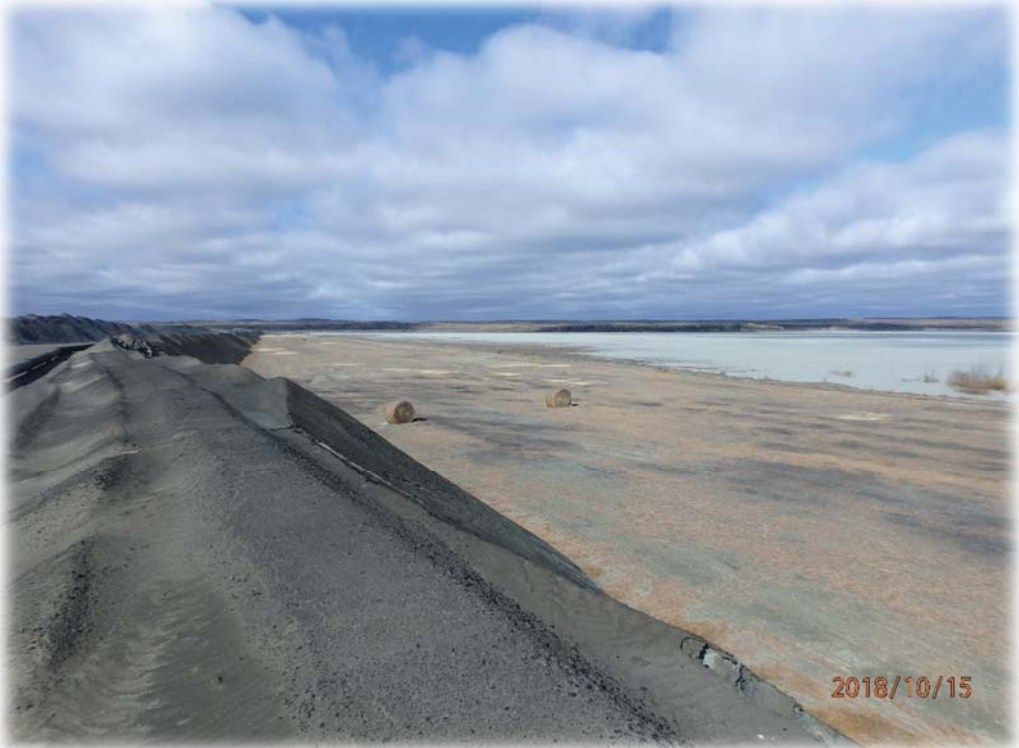
Looking west along the filter berm near intersection of Dam 1 and Dam 1E at new section of mulched super cell beach

The crest of the dam was reviewed and found to be generally level across the alignment with the exception of grading between the new railroad embankment and the filter berm/backer on the upstream side and the old railroad embankment on the downstream side. There appeared to be a narrow point in the filter berm at an access ramp location for the SCB near approximately station 25+00; however, the filter berm is typically constructed wider than plan. The minimum filter berm width should be maintained per plans.

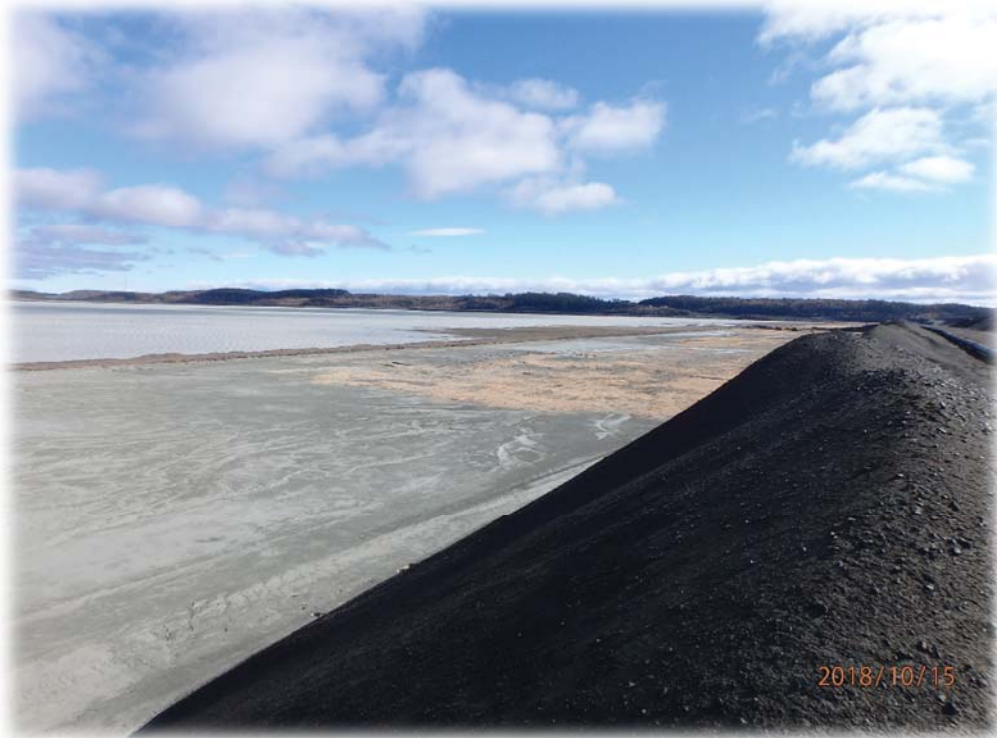
Looking east at area of new super cell beach where fine tailings were recently spigotted

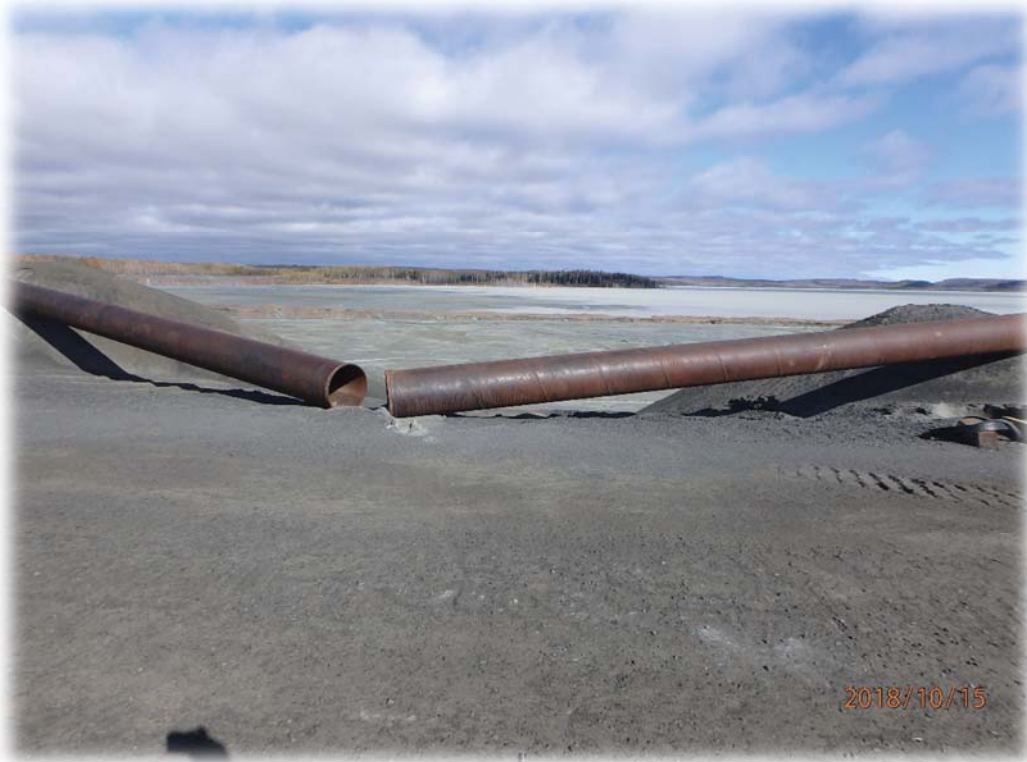
Access ramp to new super cell beach through filter berm near west end of Dam 1

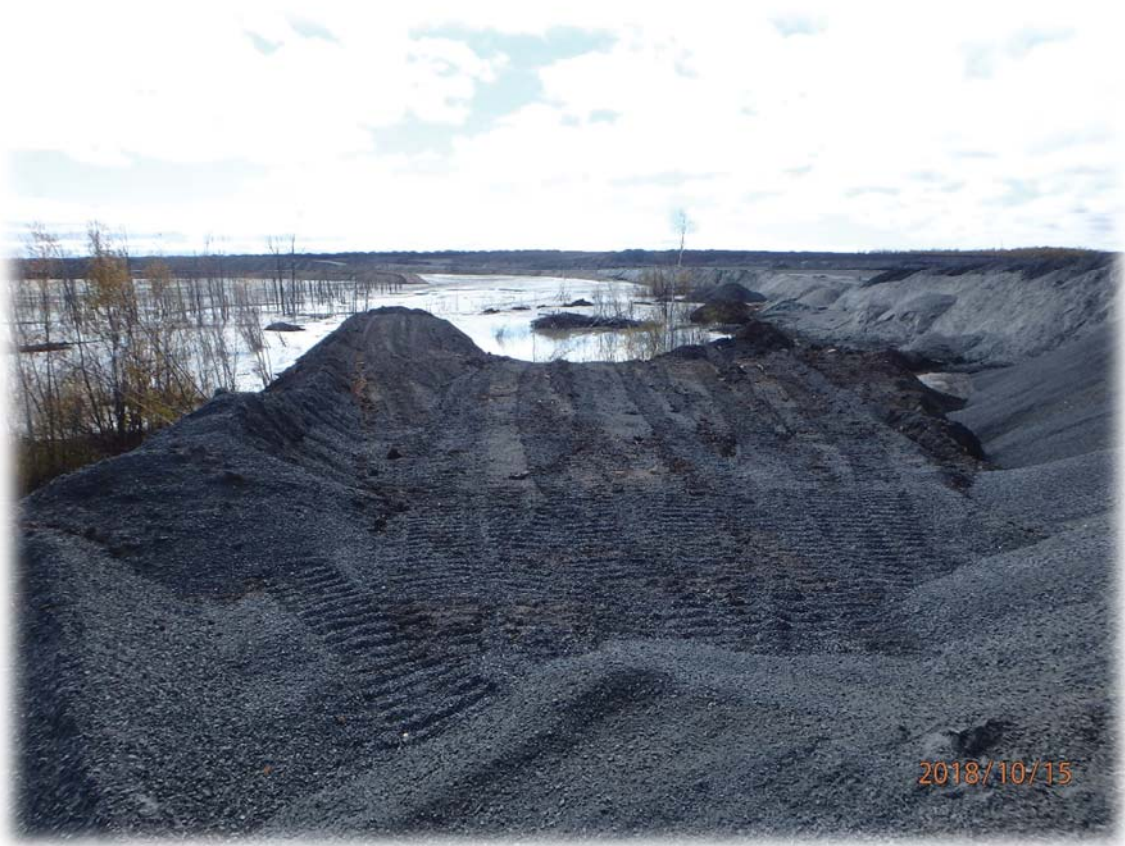
Looking east at filter berm placement at the west end of Dam 1

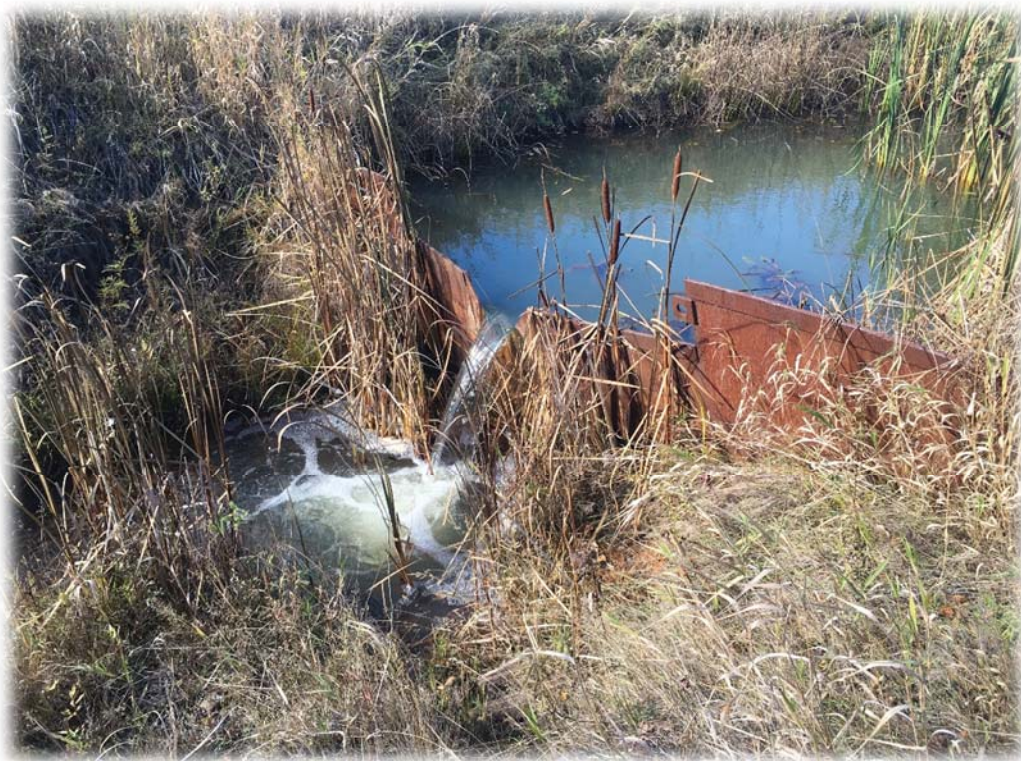
Weir at the eastern end of Dam 1

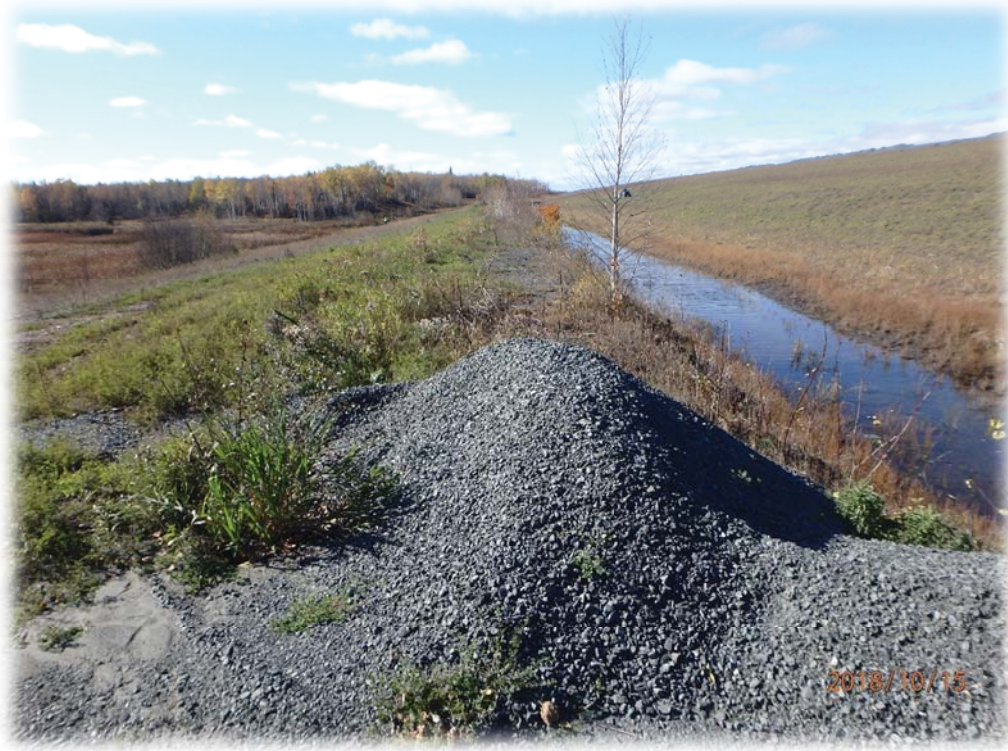
Looking west along clay core at the east end of Dam 1

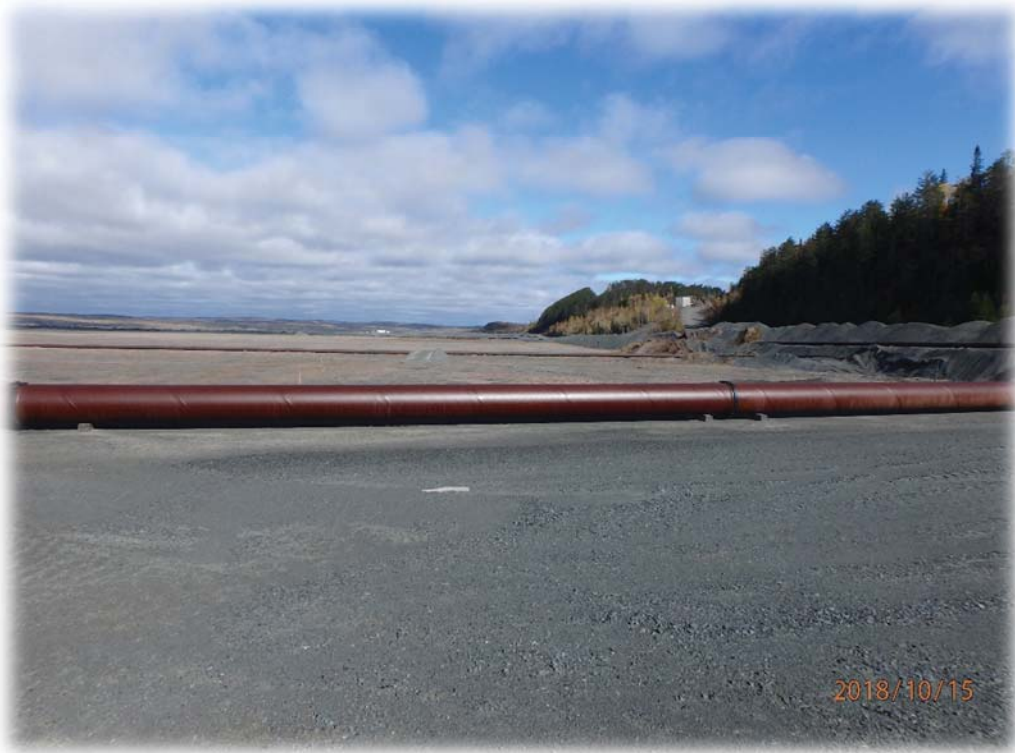
Looking northeast at the filter berm and fine tailings in Super Cell Beach area north of the eastern end of Dam 1

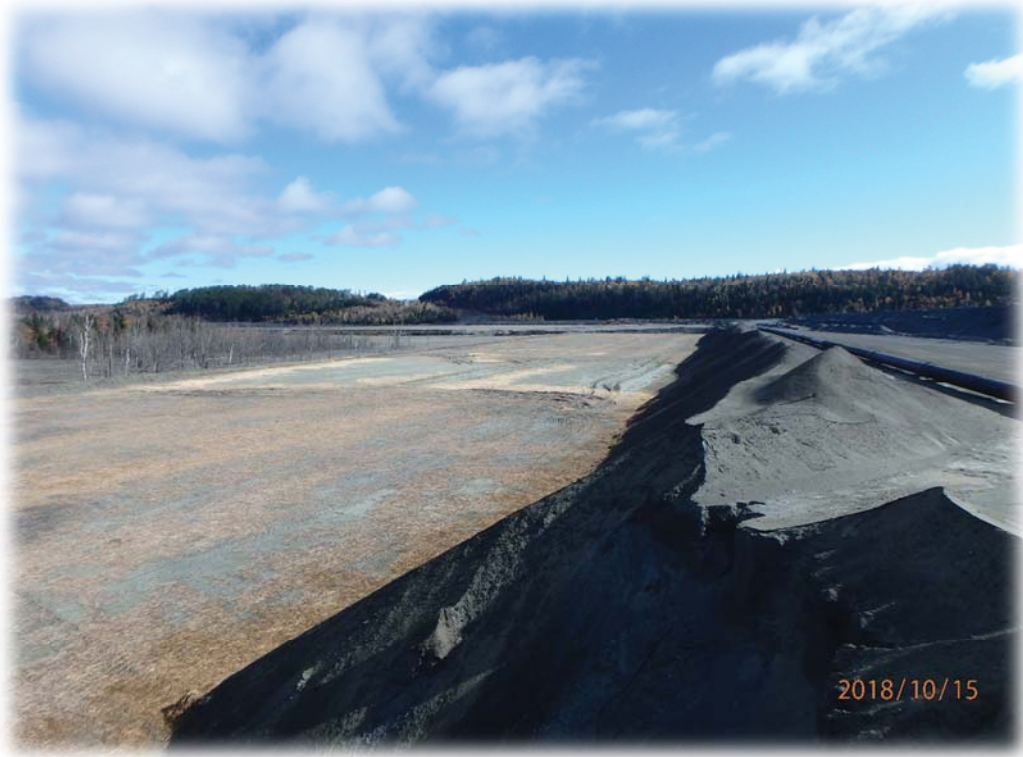
Looking east along filter berm at new super cell beach with original super cell beach in the distance at the eastern end of Dam 1

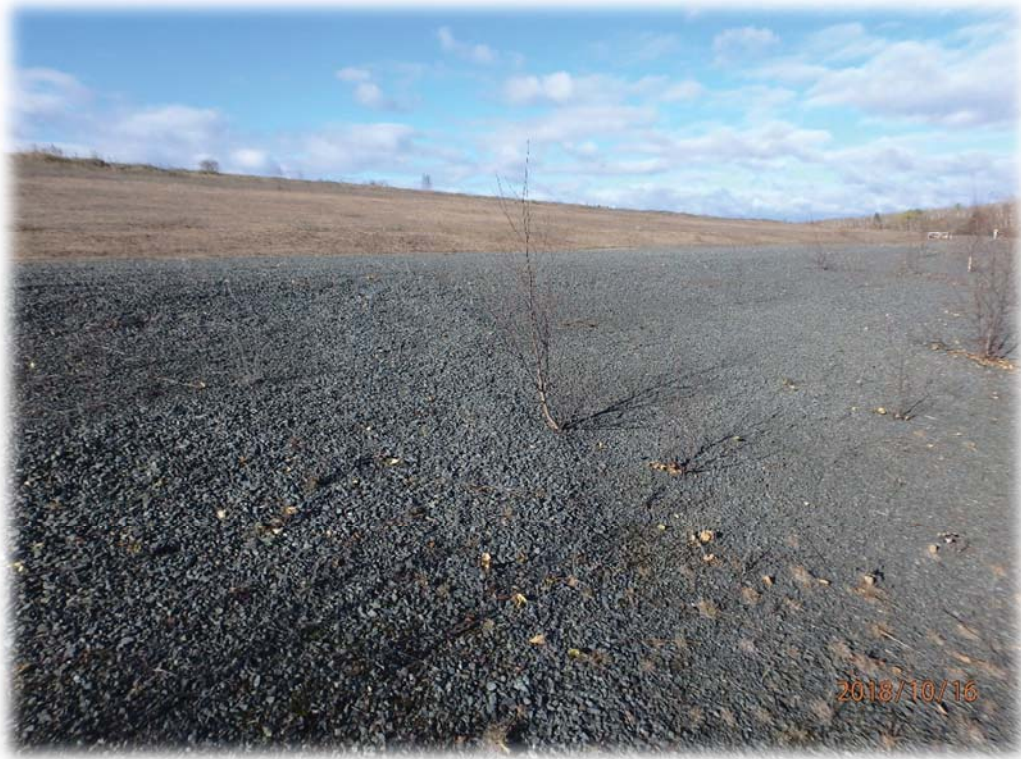
Looking southwest at buttress and downstream slope of Dam 2

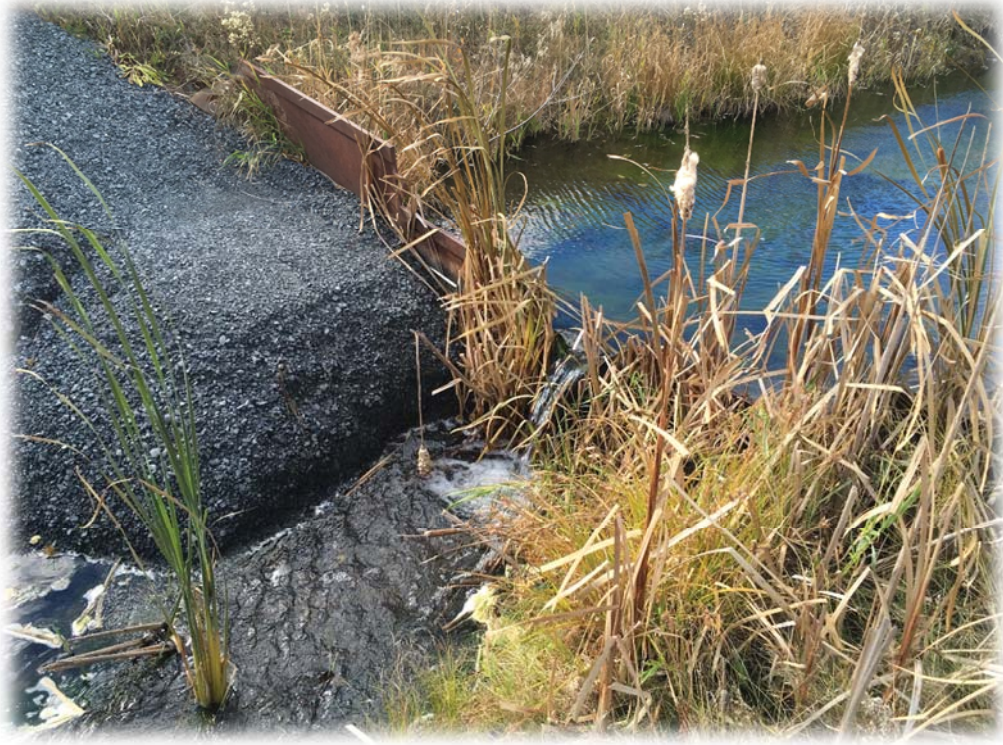
East weir for seepage collection ditch at Dam 2

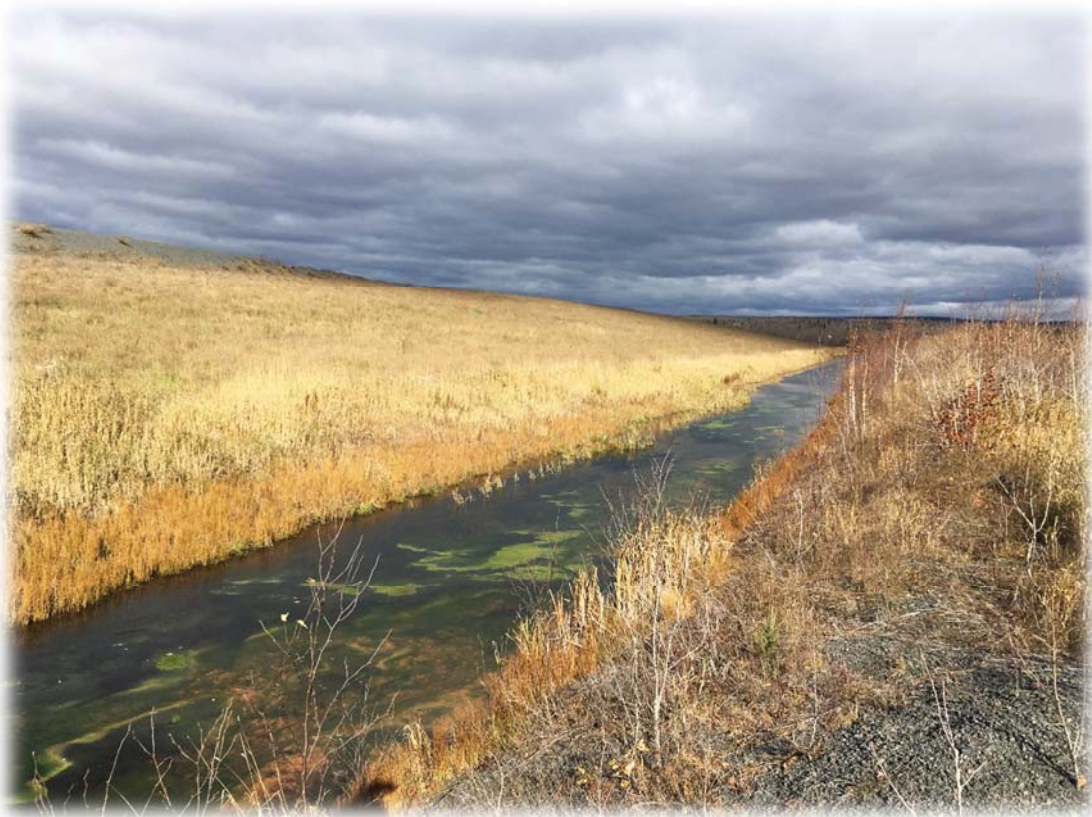
Looking northwest along seepage collection ditch from near east end of Dam 2

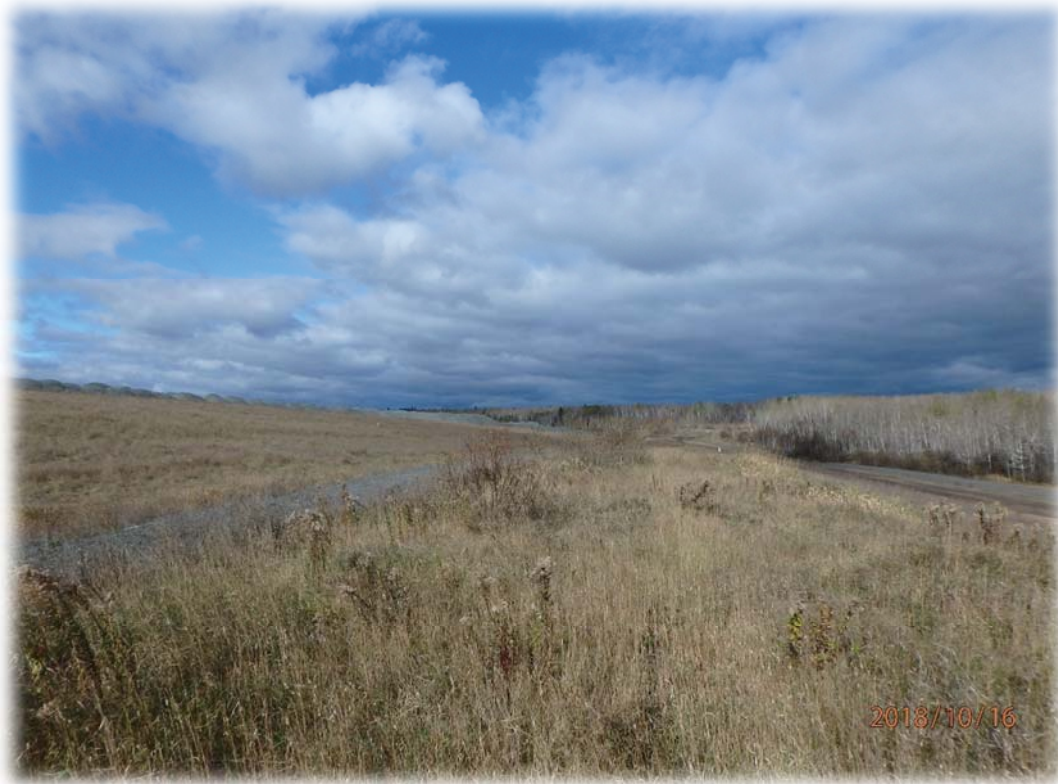
Looking west along core at downstream slope of Dam 2

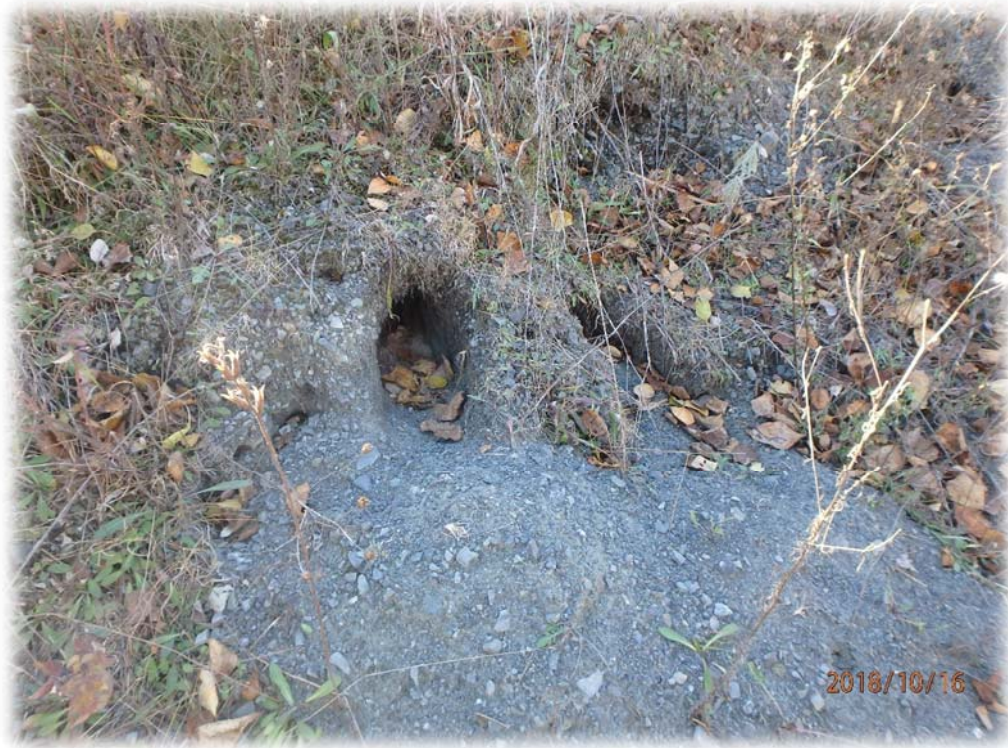
Animal burrows in the filter berm near the weir at the west end of Dam 2

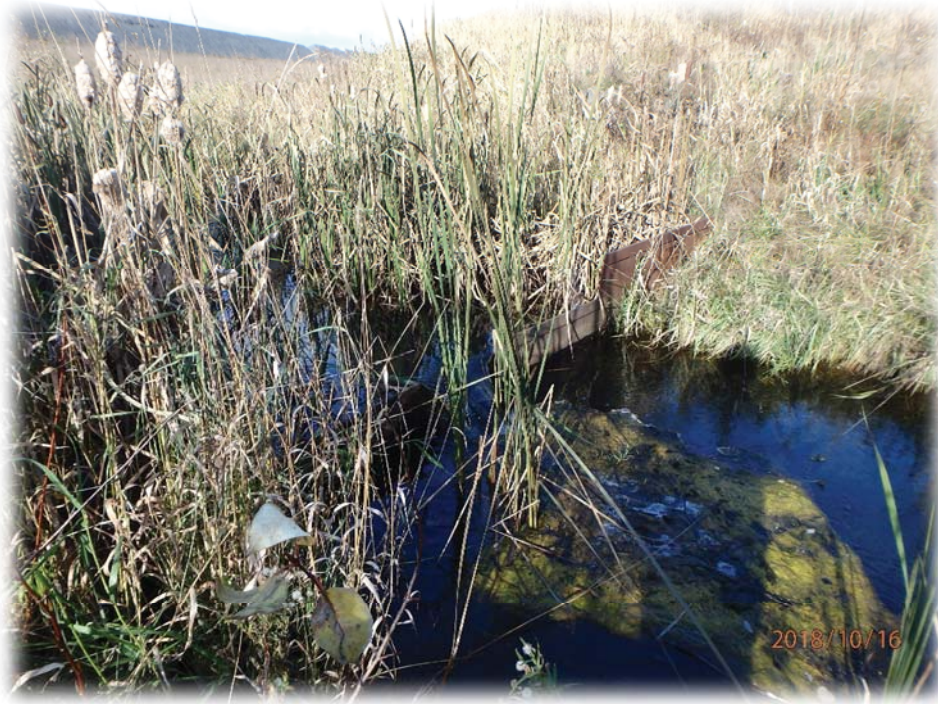
Weir at the west end of Dam 2

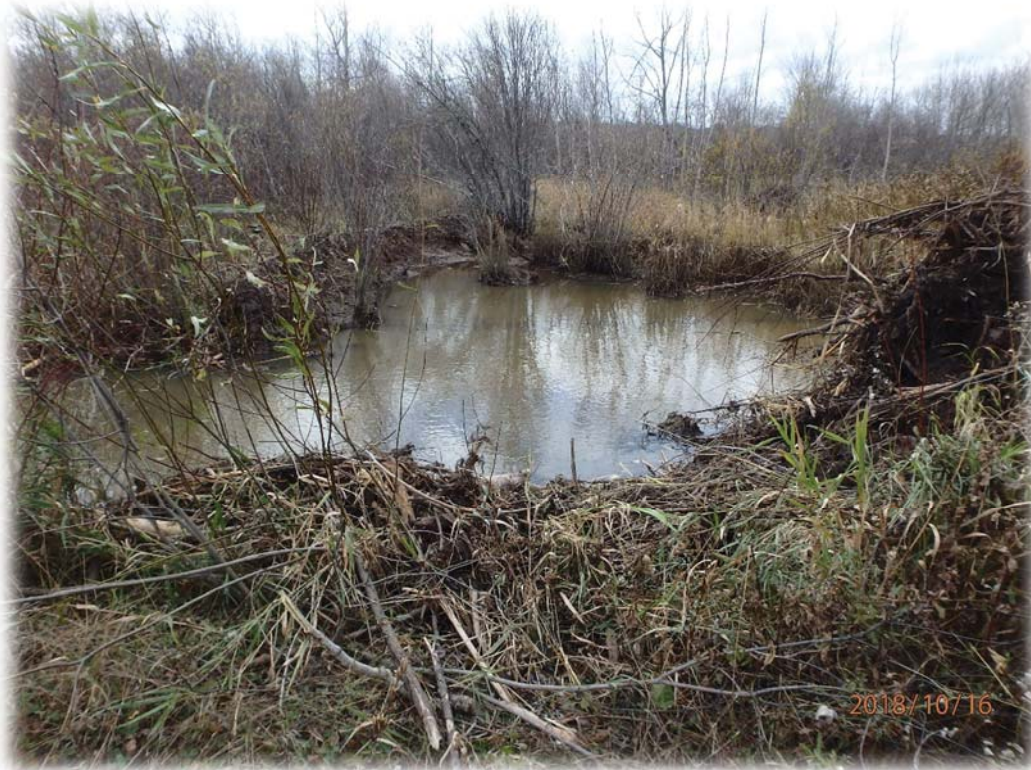
Widened area of drainage ditch off the toe of Dam 2 just upstream of seepage recovery pond 2-3 where beaver dams were removed

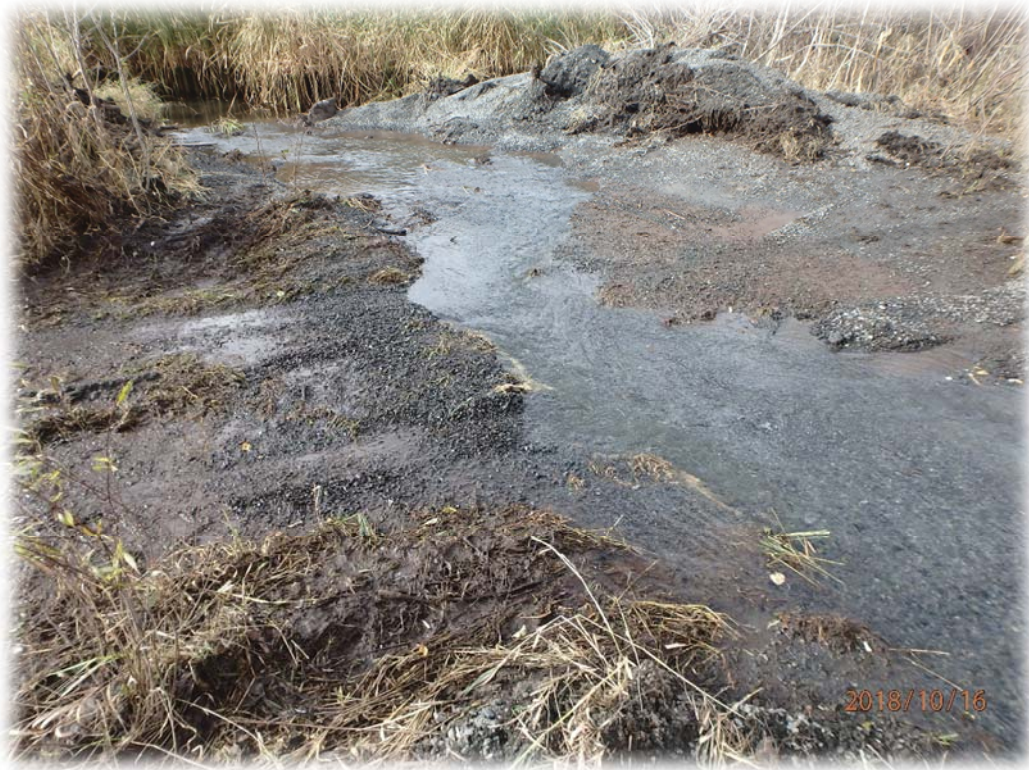
Another area off the toe of Dam 2 just upstream of seepage recovery pond 2-3 where a beaver dam was removed
