# **Five-Year Operations Plan Years 2019-2023**

## ***Milepost 7 Tailings Basin***

Prepared for  
Northshore Mining Company  
Silver Bay, Minnesota

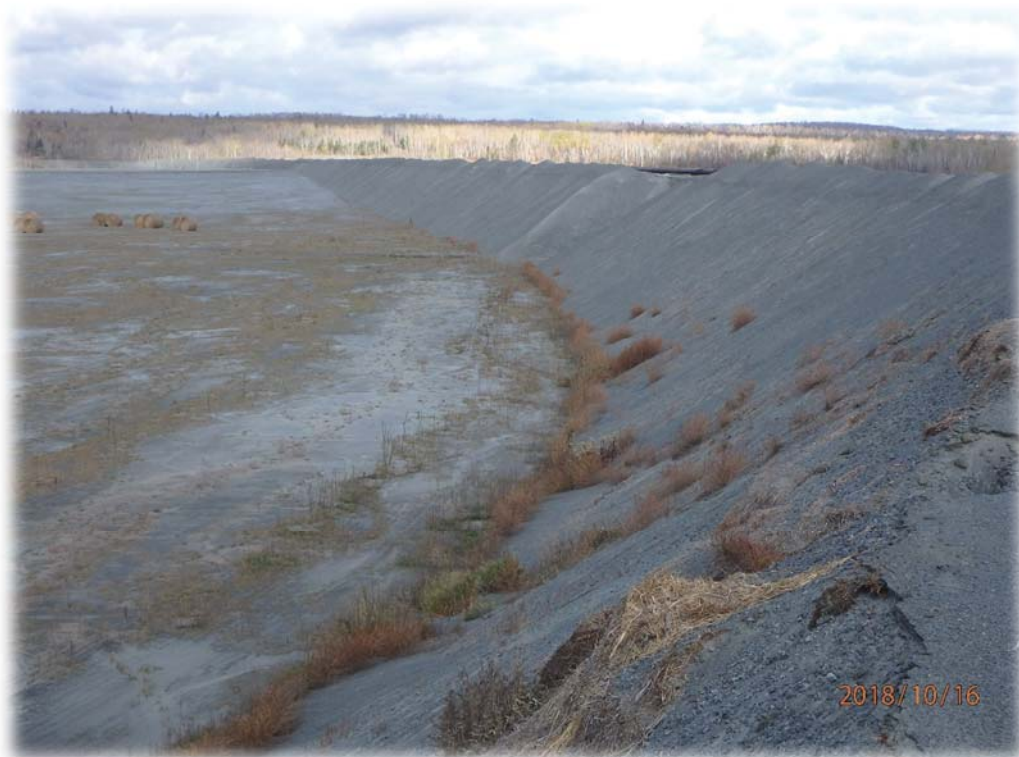
Looking west along upstream slope of filter berm at Dam 2

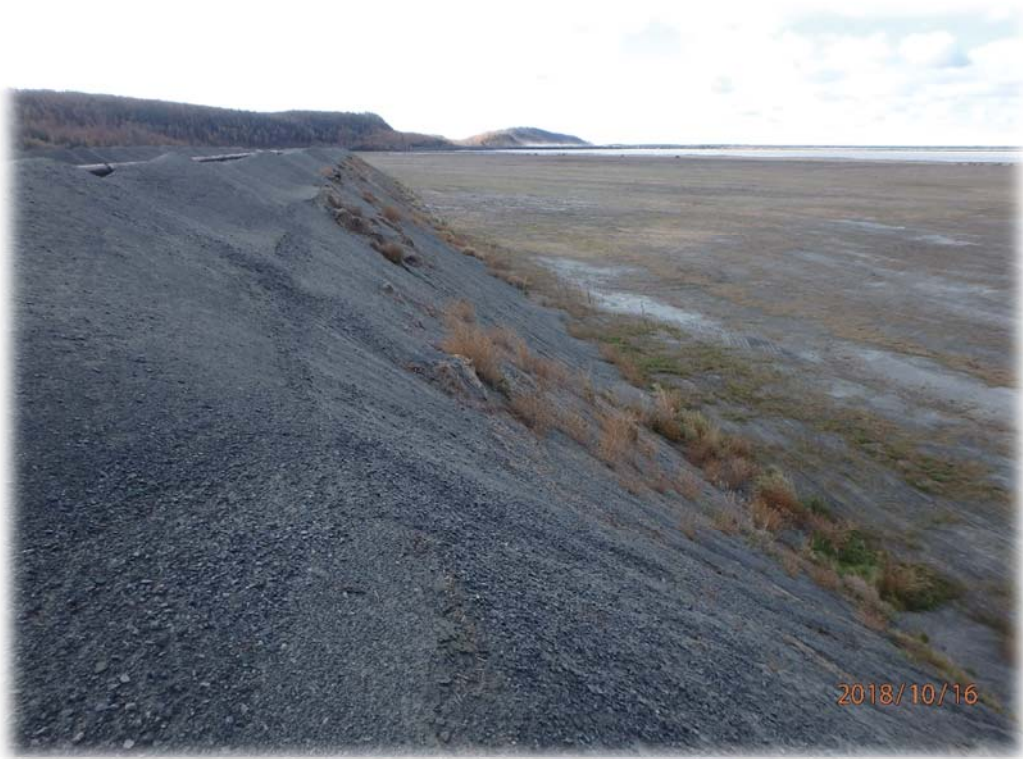
Looking east-southeast at upstream slope of the filter berm of Dam 2

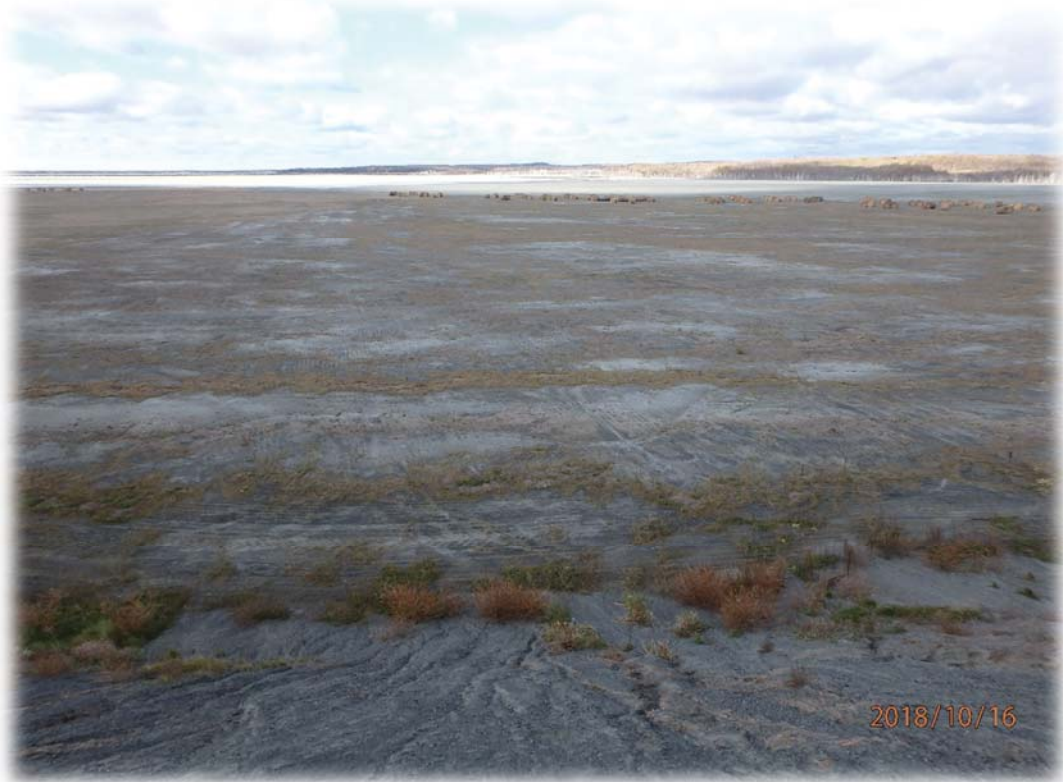
Looking south at the beach along the upstream side of Dam 2

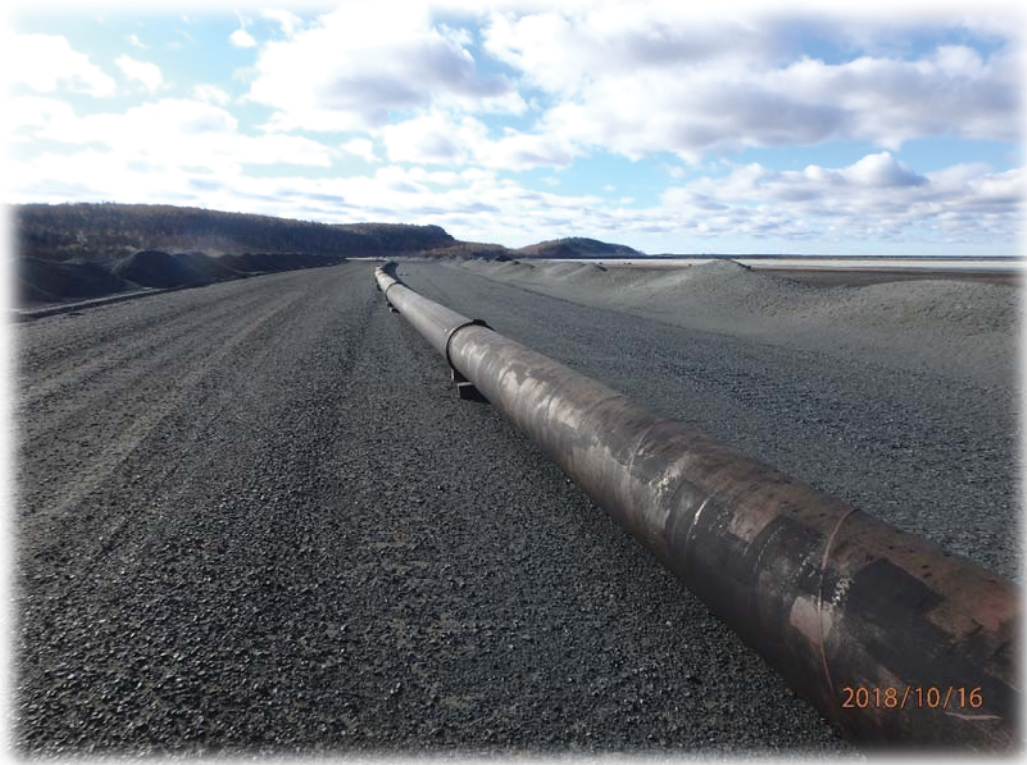
Looking east at the crest of Dam 2

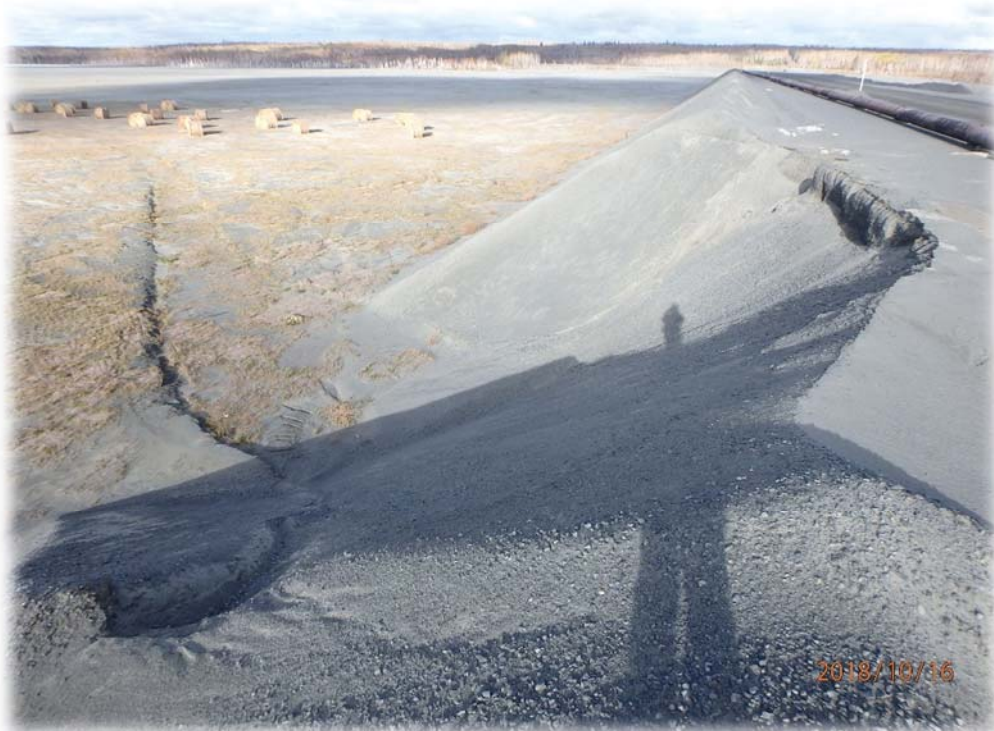
Looking west at some erosion on the filter berm at Dam 2 approximately near station 40+00

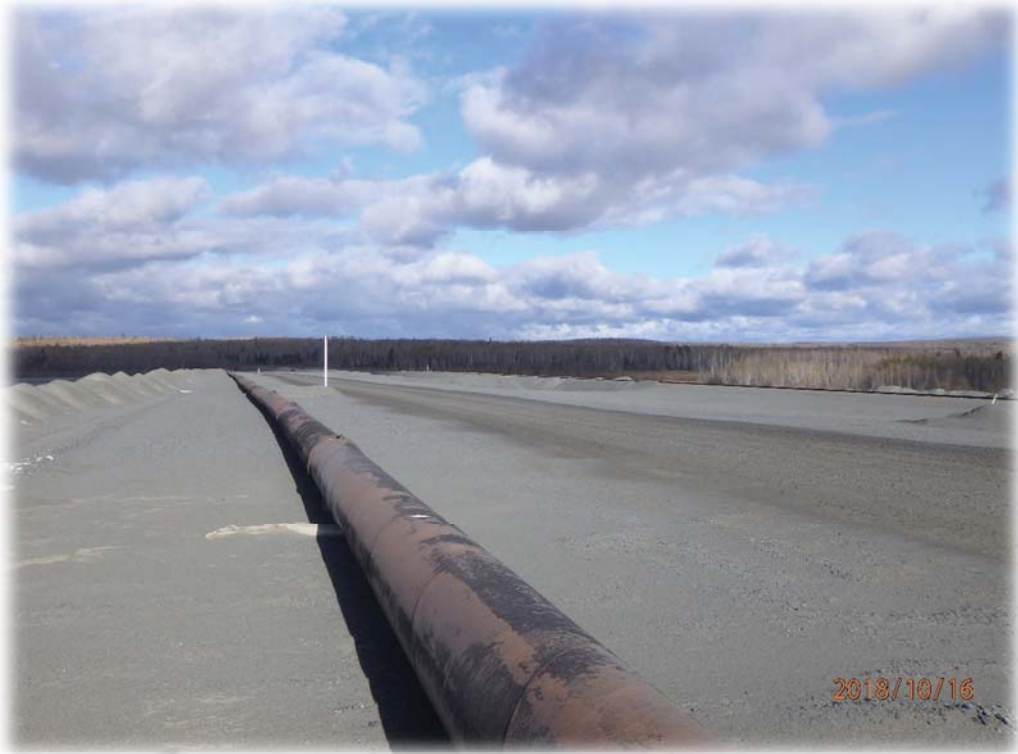
Looking west at the crest of Dam 2

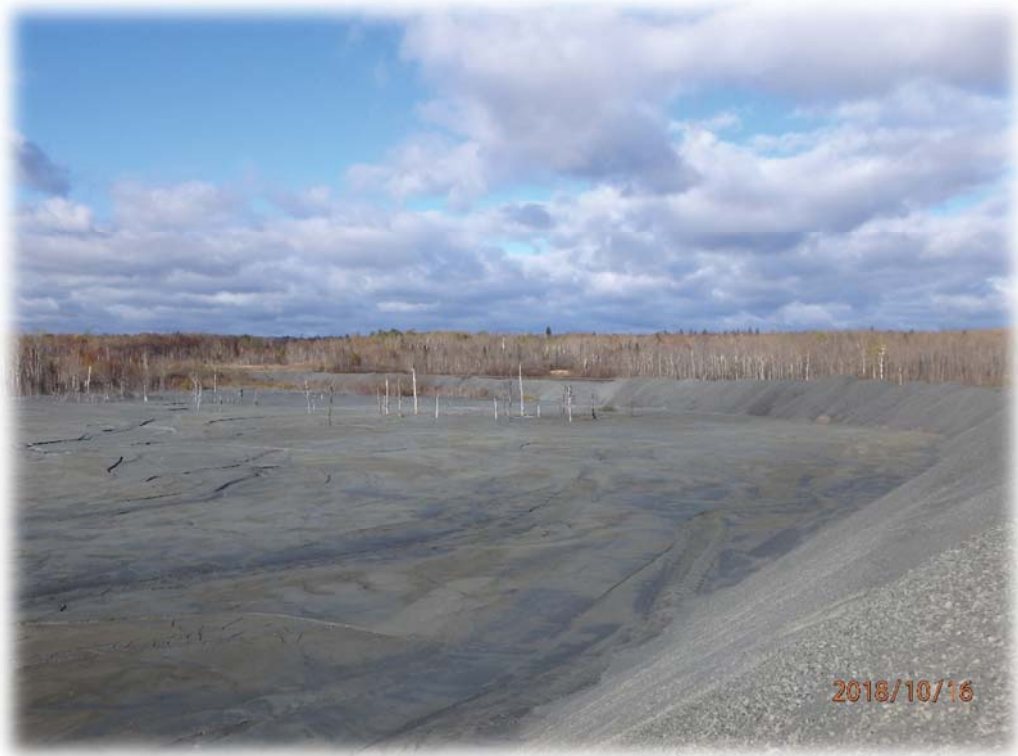
Recently spigotted beach area in northwest corner of Dam 2

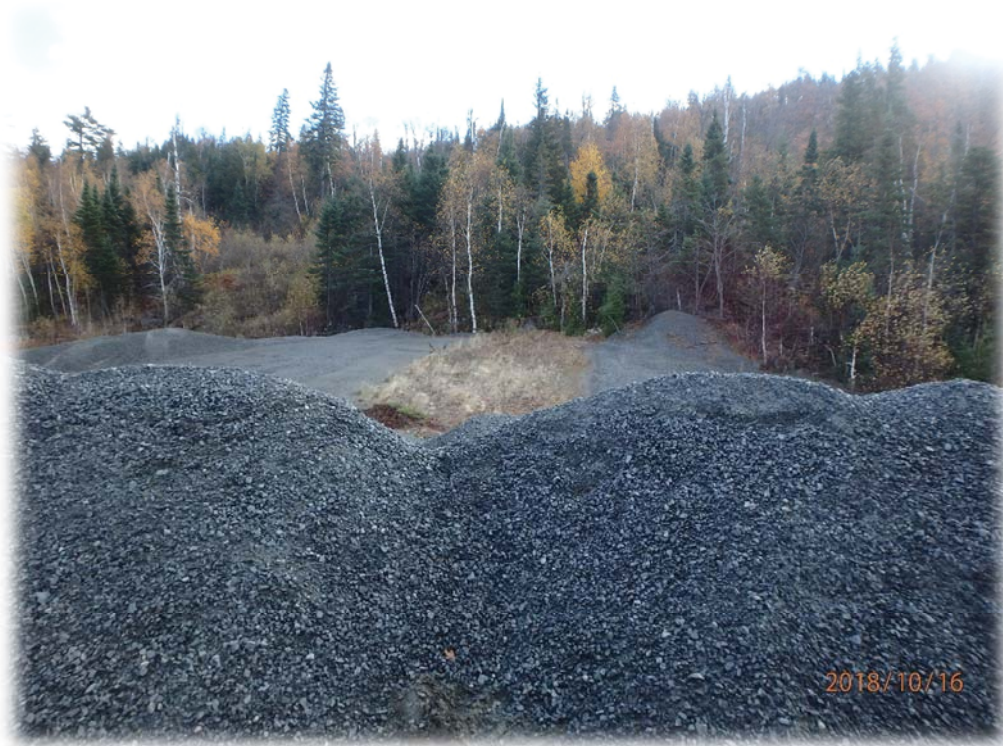
Looking east at the seepage cutoff on east side of Dam 2

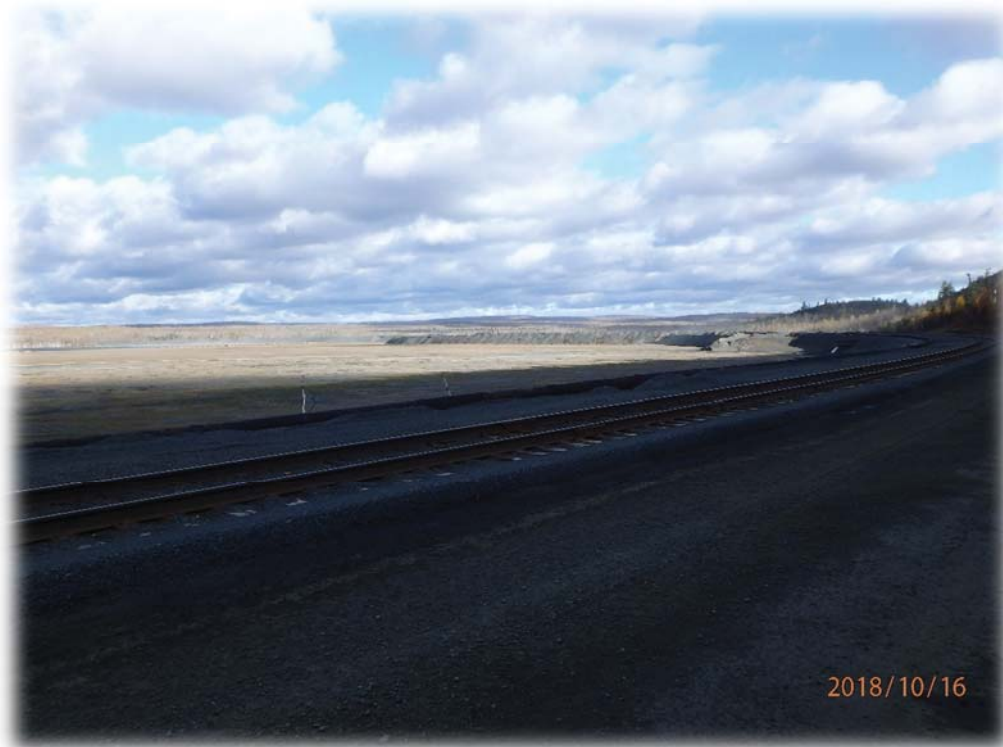
Looking northwest at the eastern end of Dam 2

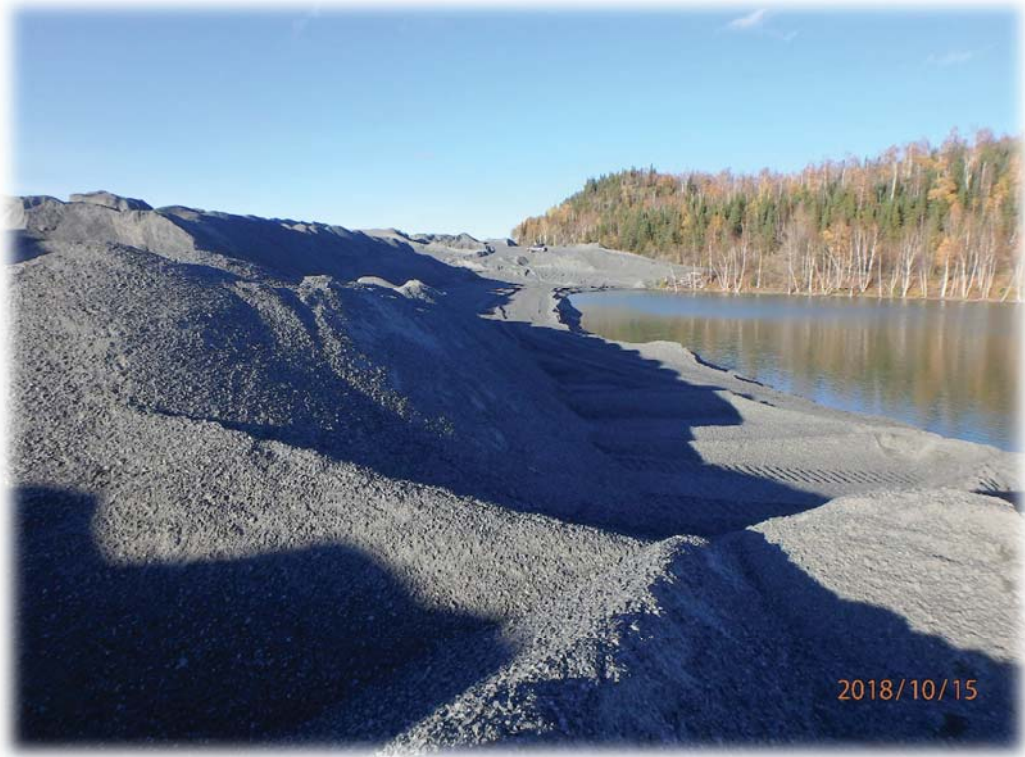
Looking north at buttress extension at the toe of Dam 5

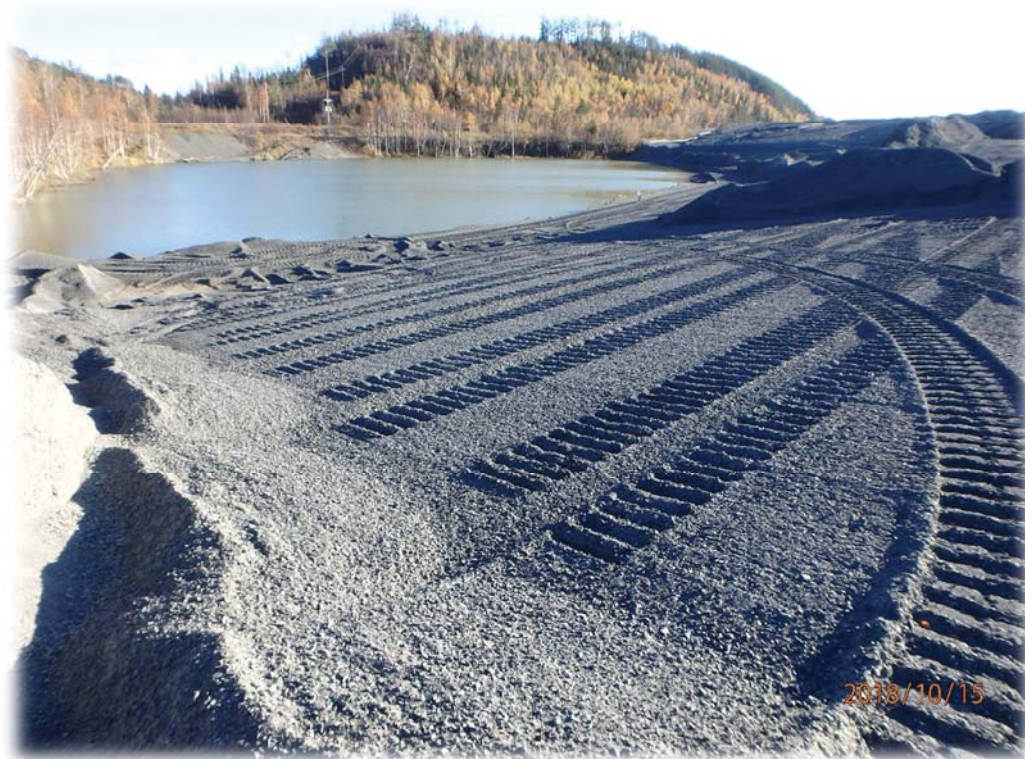
Looking southeast at downstream slope of Dam 5

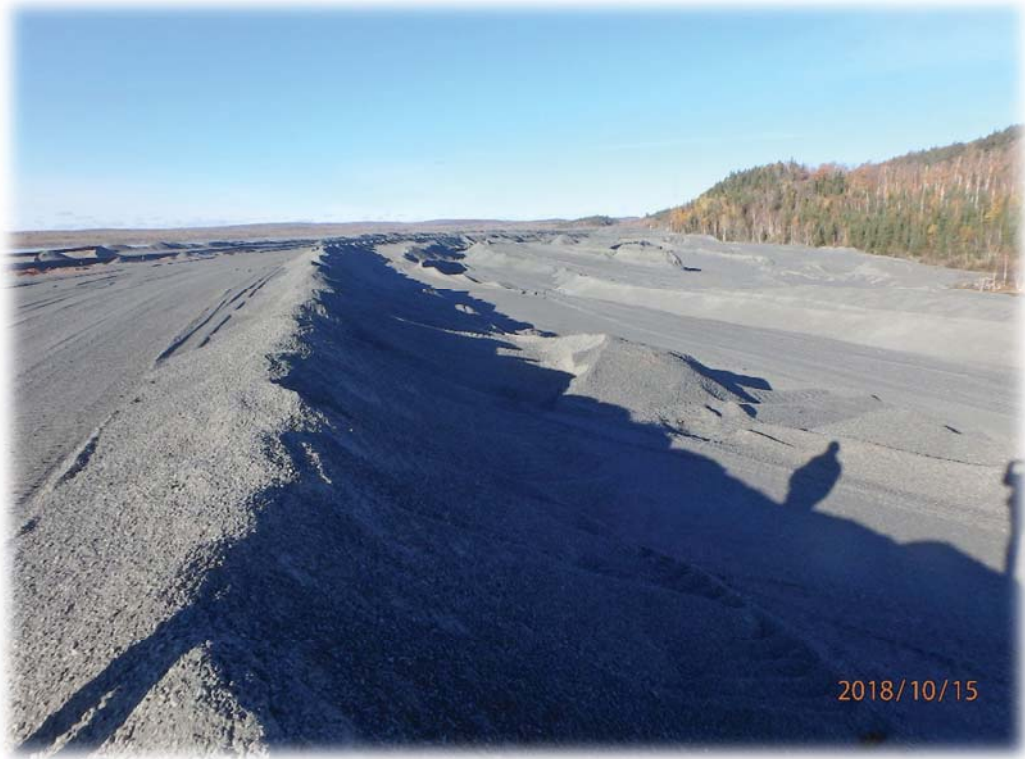
Looking north at downstream slope of Dam 5

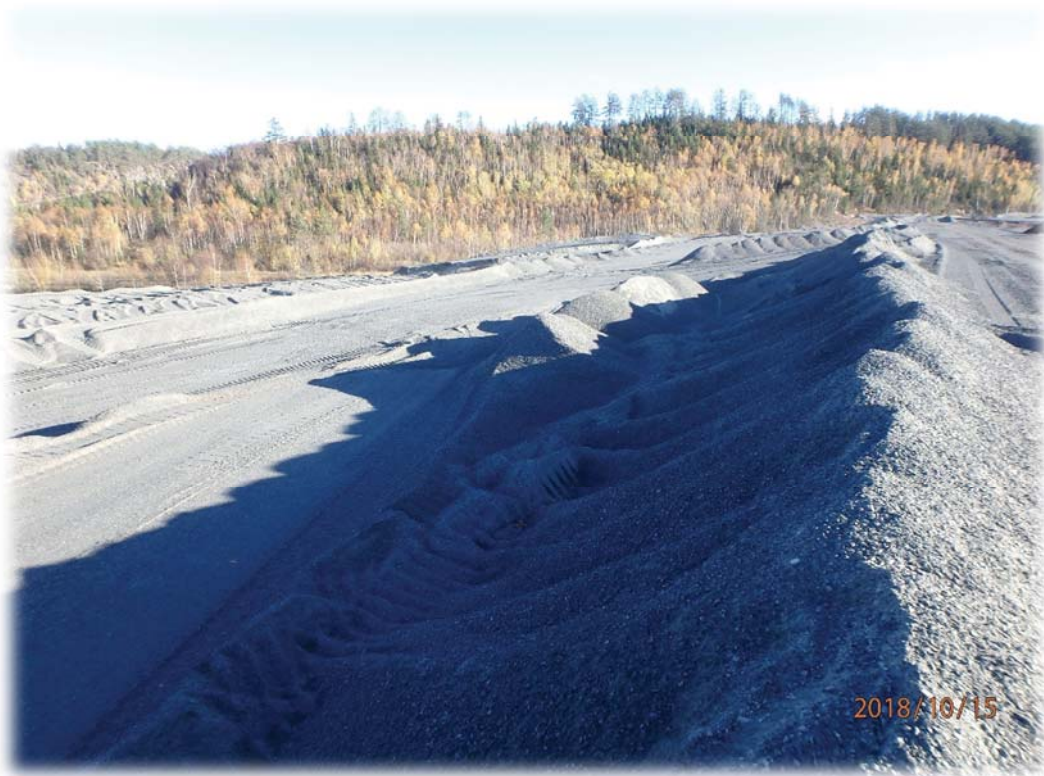
Looking south at downstream slope of Dam 5

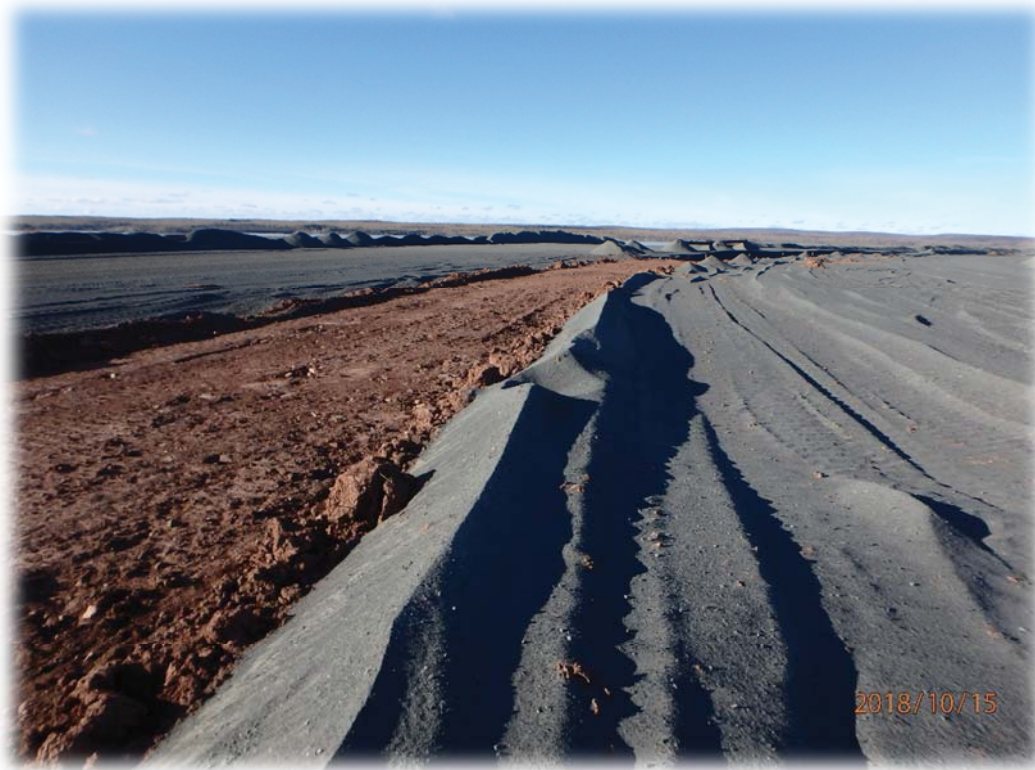
Looking northwest at recently raised southern portion of the crest of Dam 5

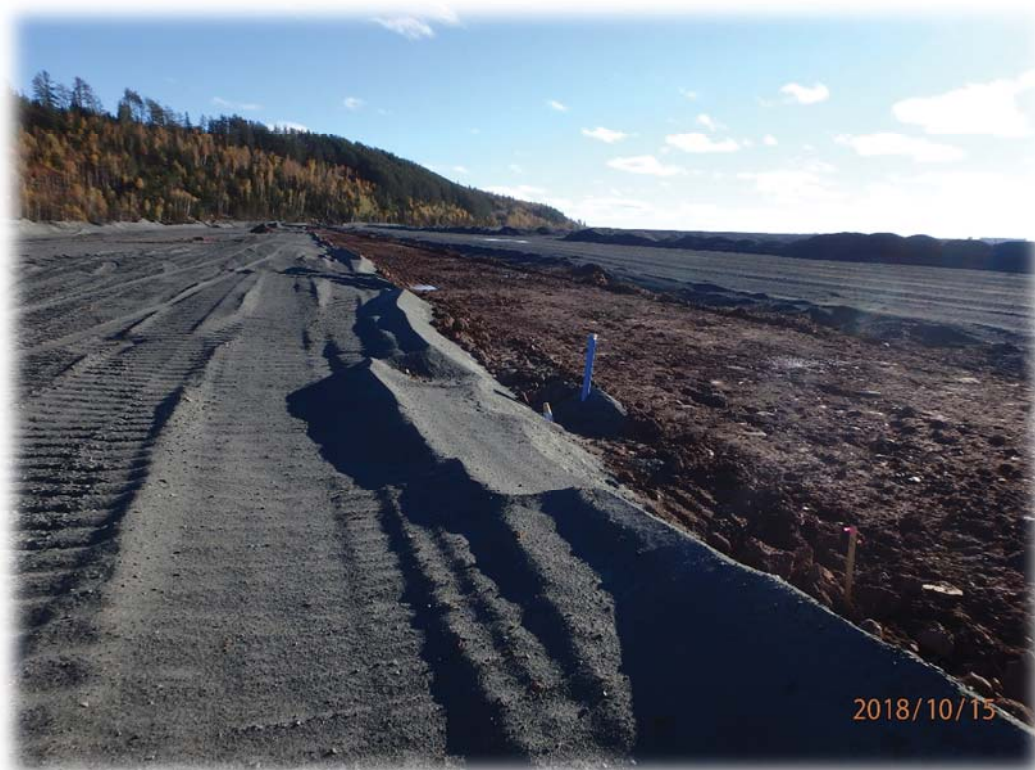
Looking south at recently raised southern portion of Dam 5 near station 14+00

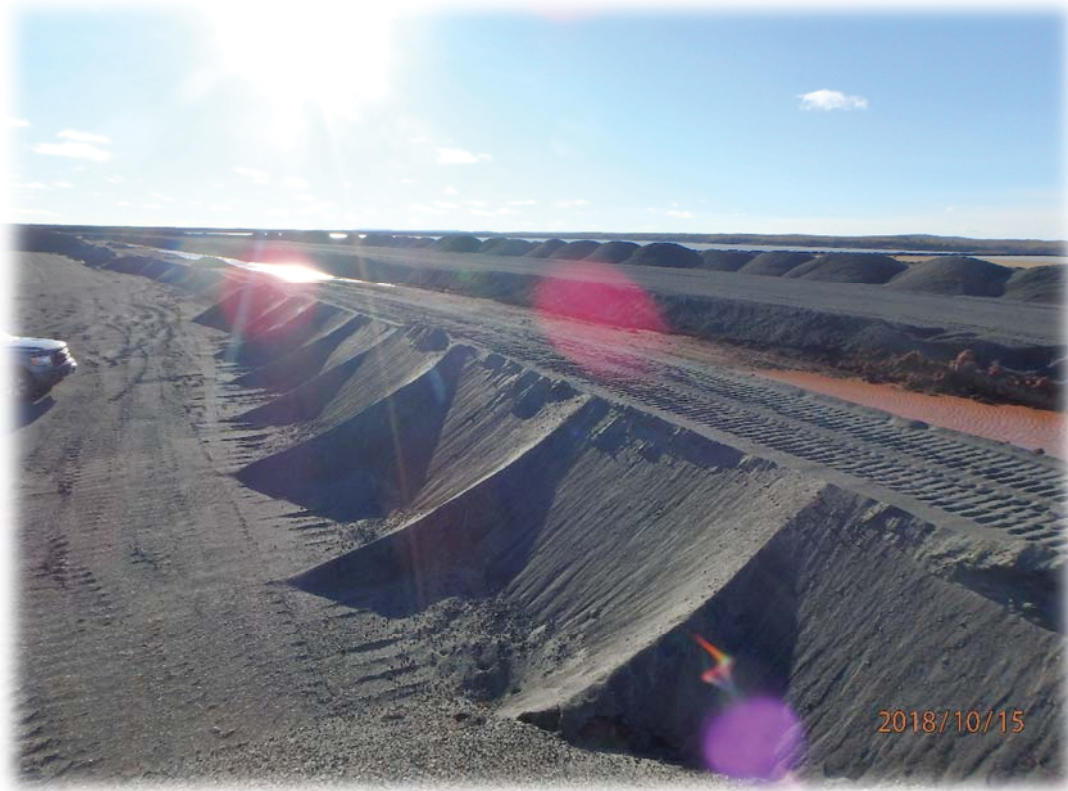
Looking southwest at northern portion of the crest of Dam 5 under construction

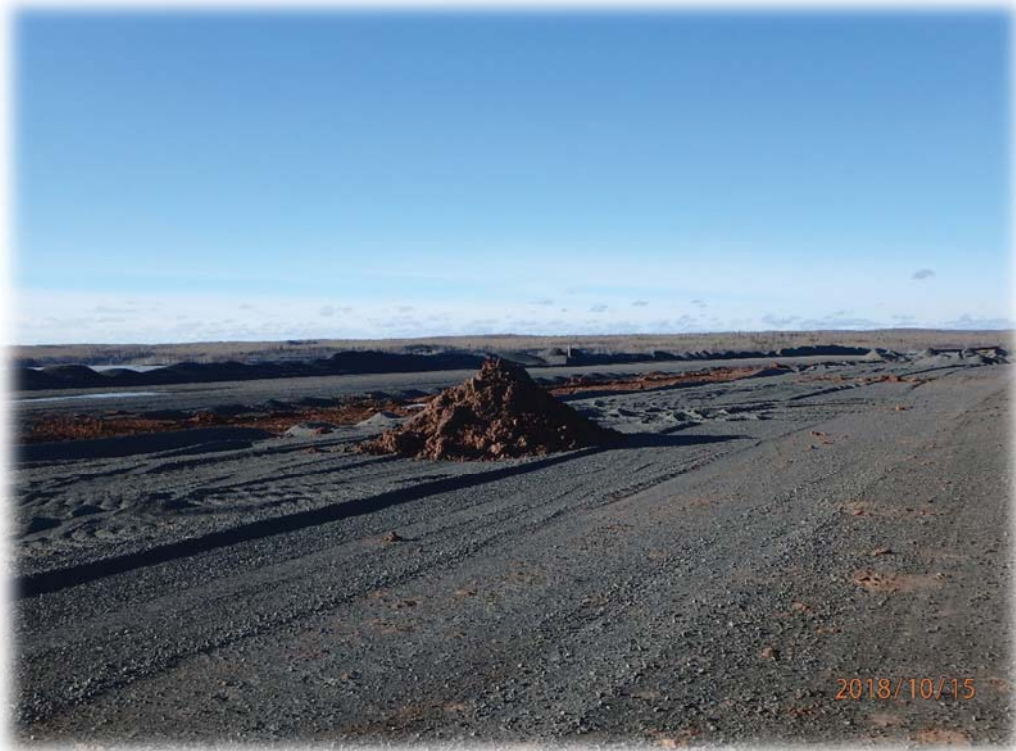
Looking northwest at clay stockpiled on filter material at Dam 5

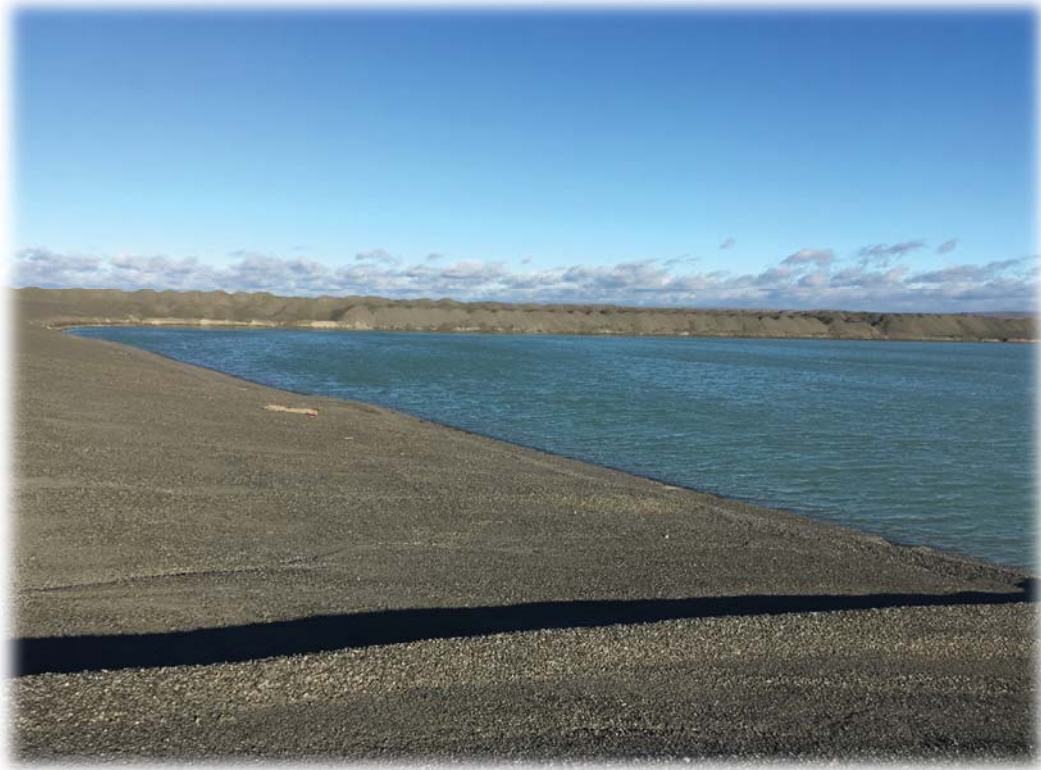
Looking northwest at downstream slope of the reclaim dam

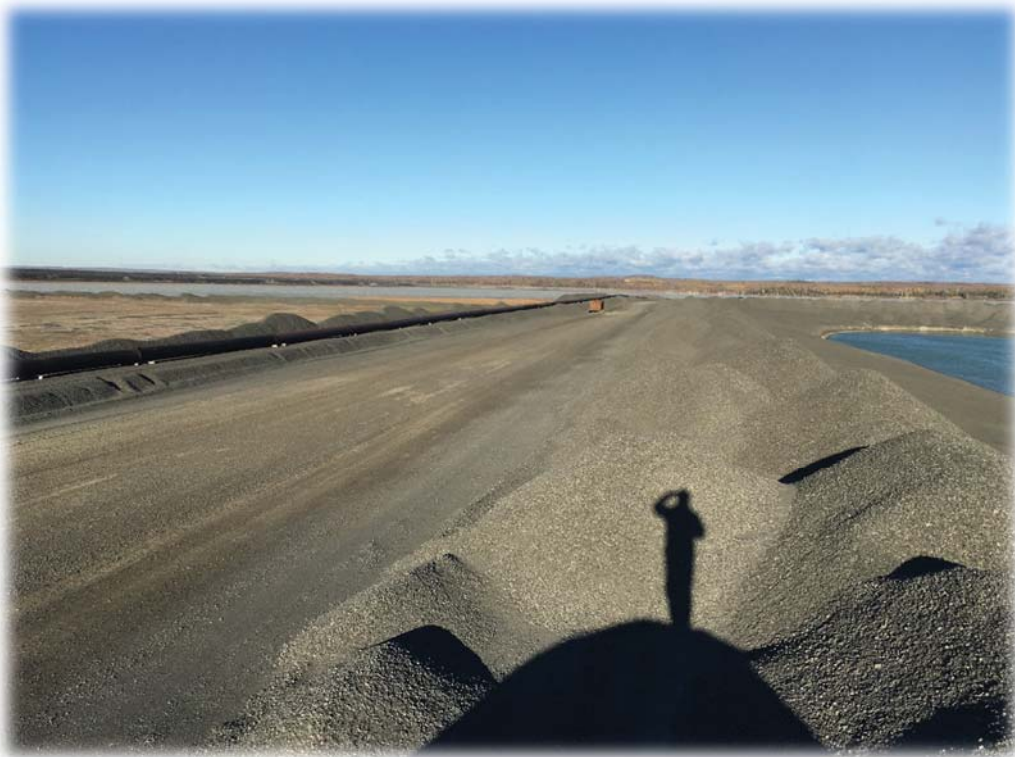
Looking west at crest along east-west portion of the reclaim dam

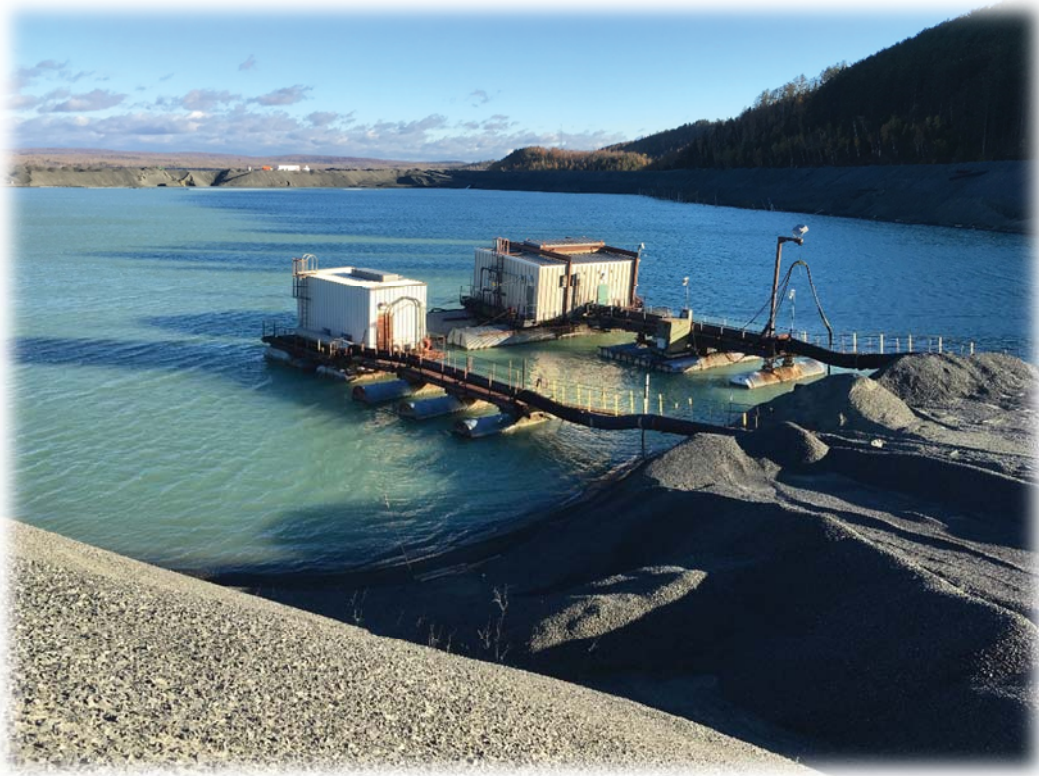
Looking northwest at pump stations in the southeastern corner of the reclaim pond

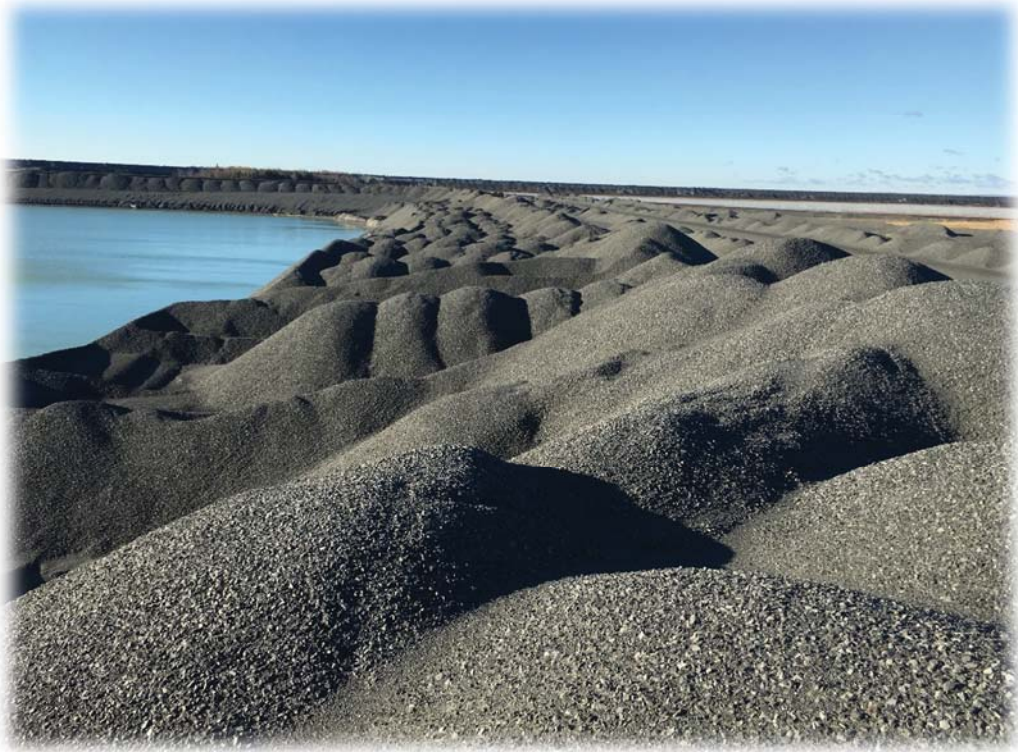
Looking south along downstream slope of the reclaim dam

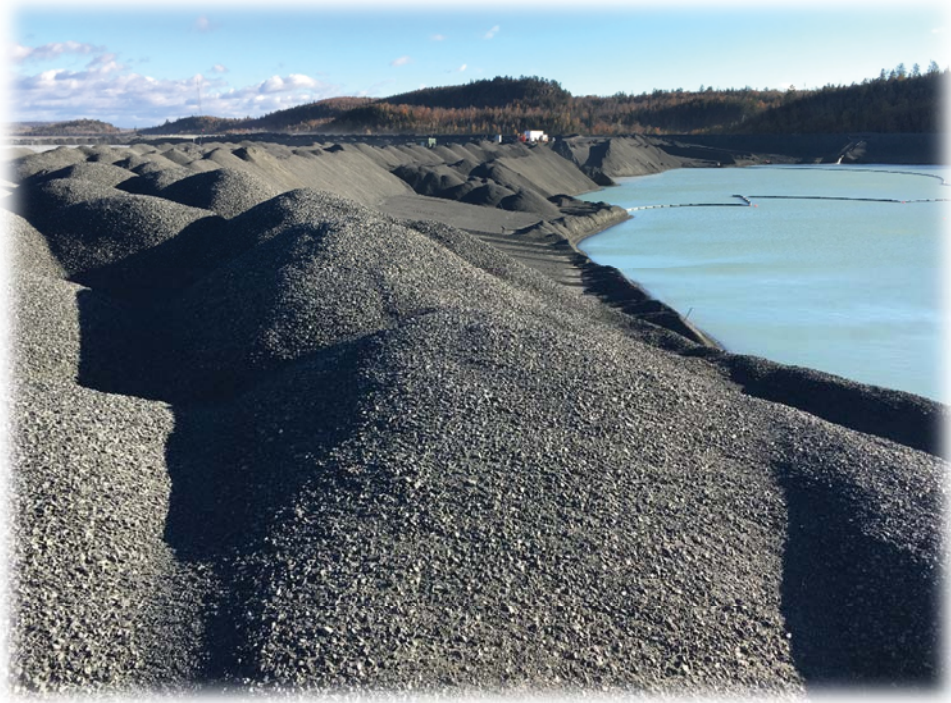
Looking northeast at downstream slope of the reclaim dam and weir area

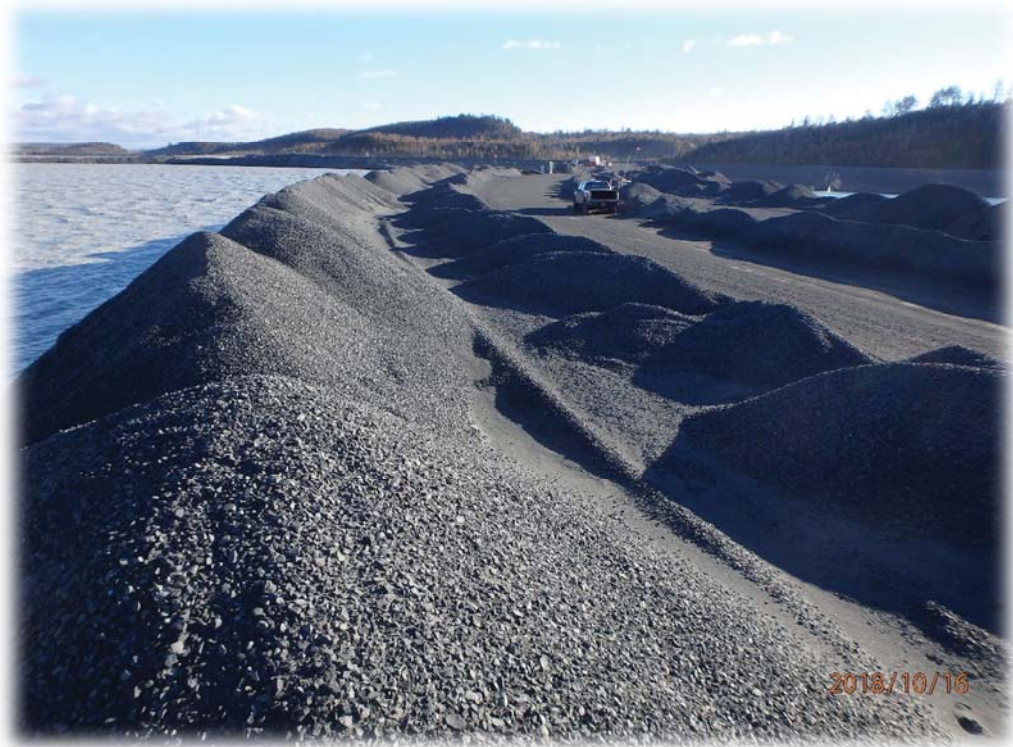
Looking northeast at the crest of the reclaim dam

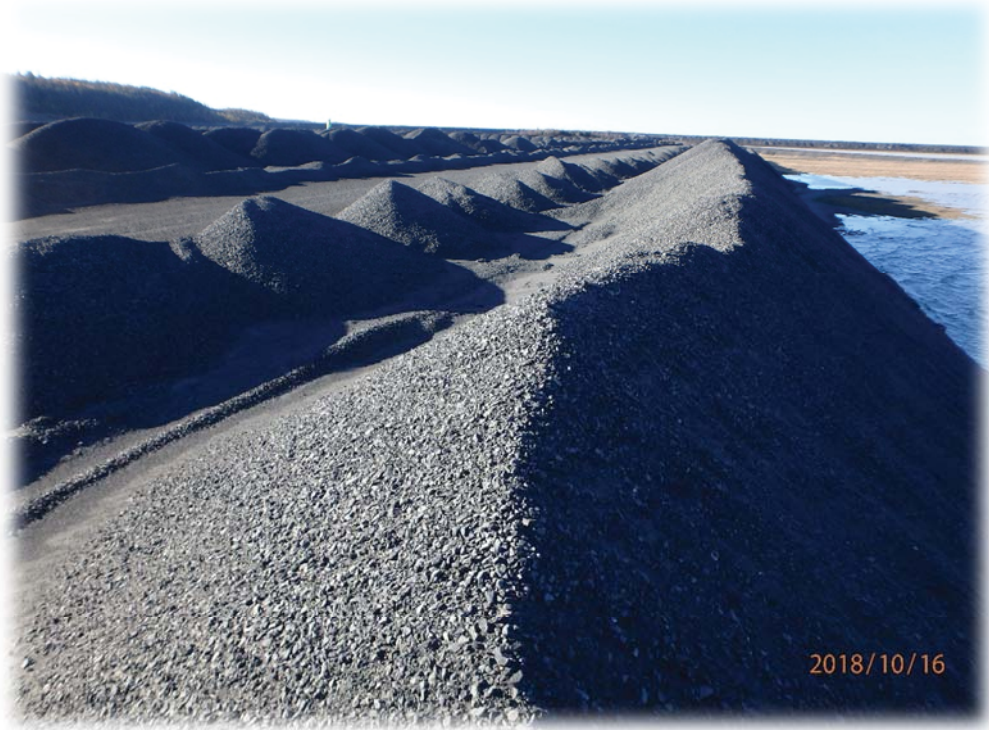
Looking south at crest and upstream slope of the reclaim dam

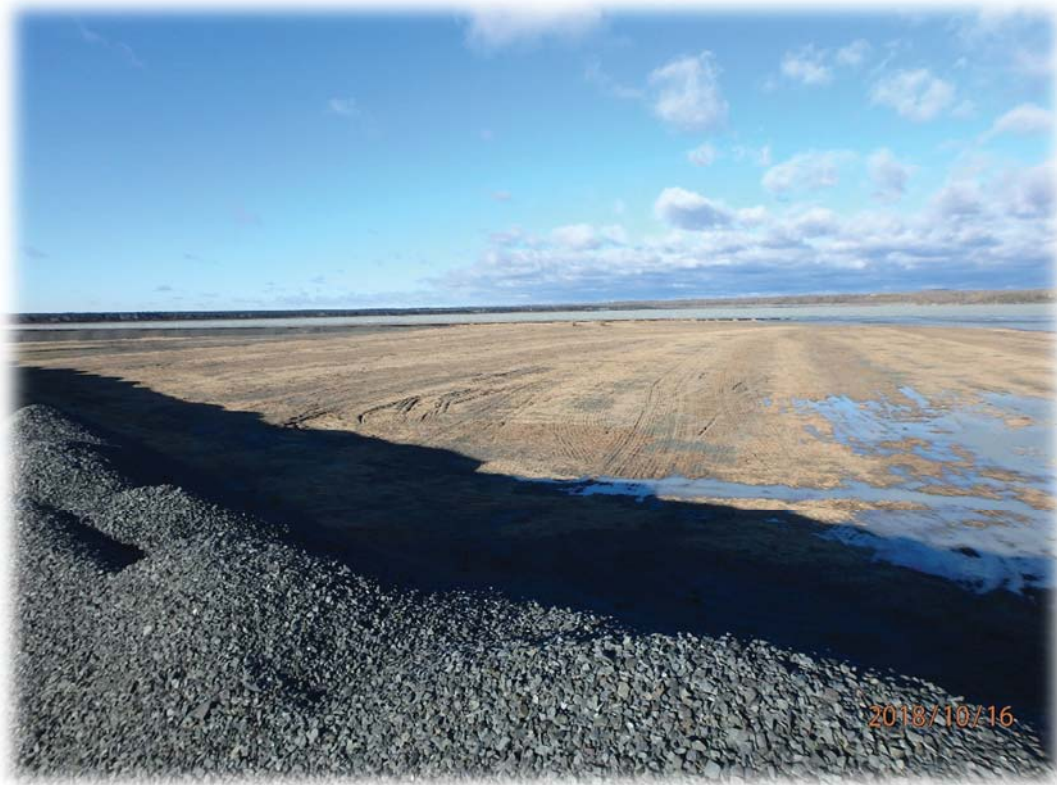
Looking west-southwest at the fine tailings beach from near station 28+00

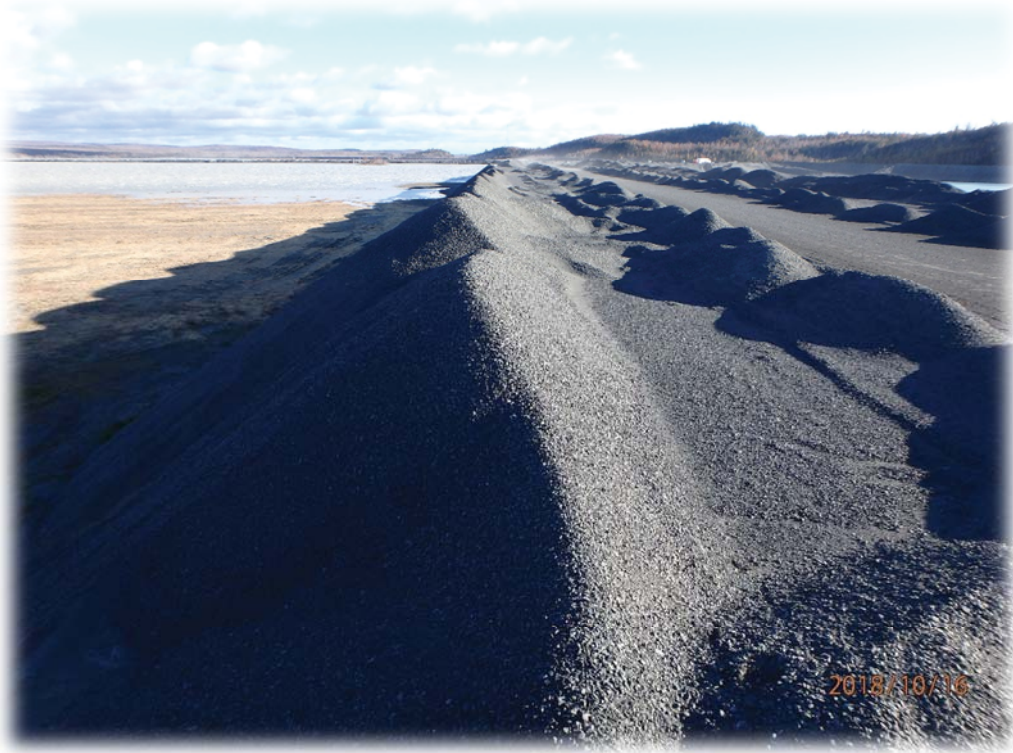
Looking north at the crest and upstream slope of the reclaim dam from near the southwest corner of the dam

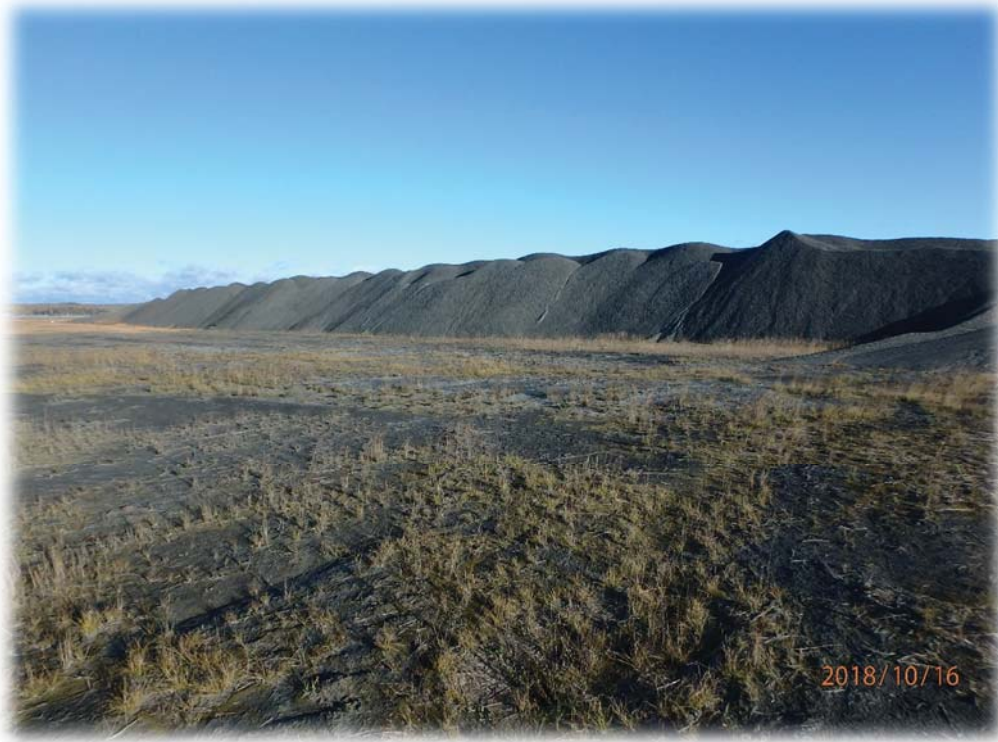
Looking northwest at the upstream slope of the reclaim dam from the adjacent beach approximately near station 17+00

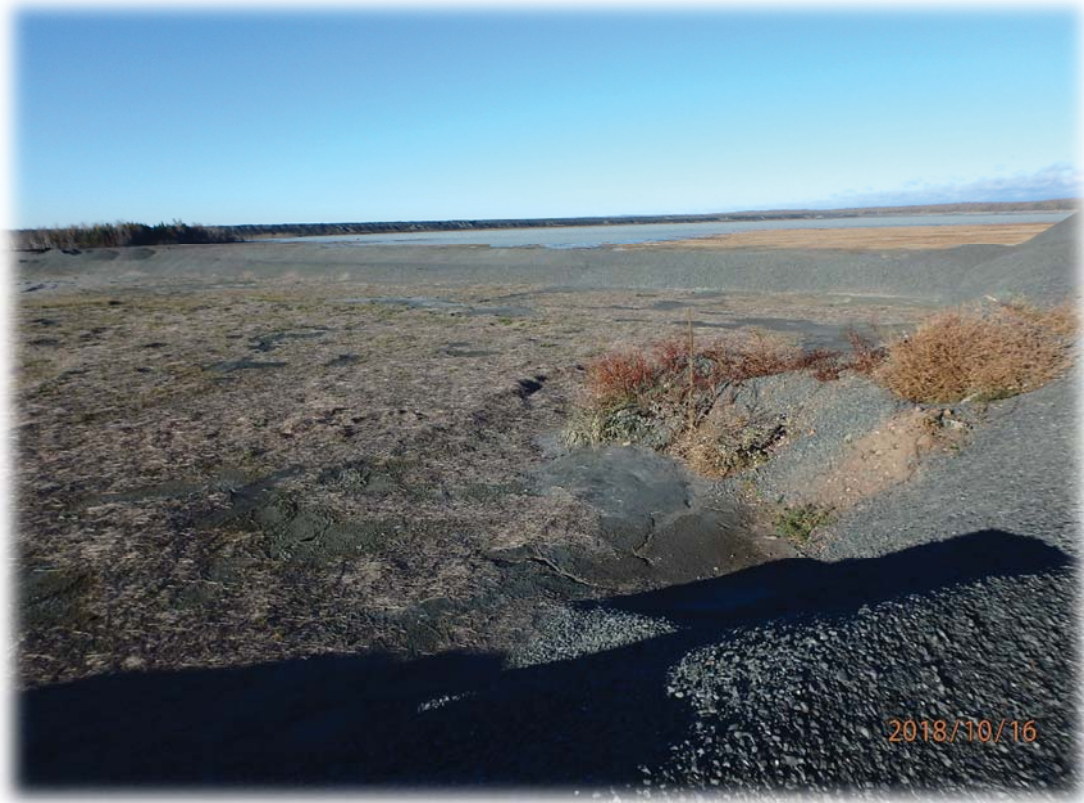
Looking southwest at super cell beach at upstream side of the reclaim dam from approximate station 13+00

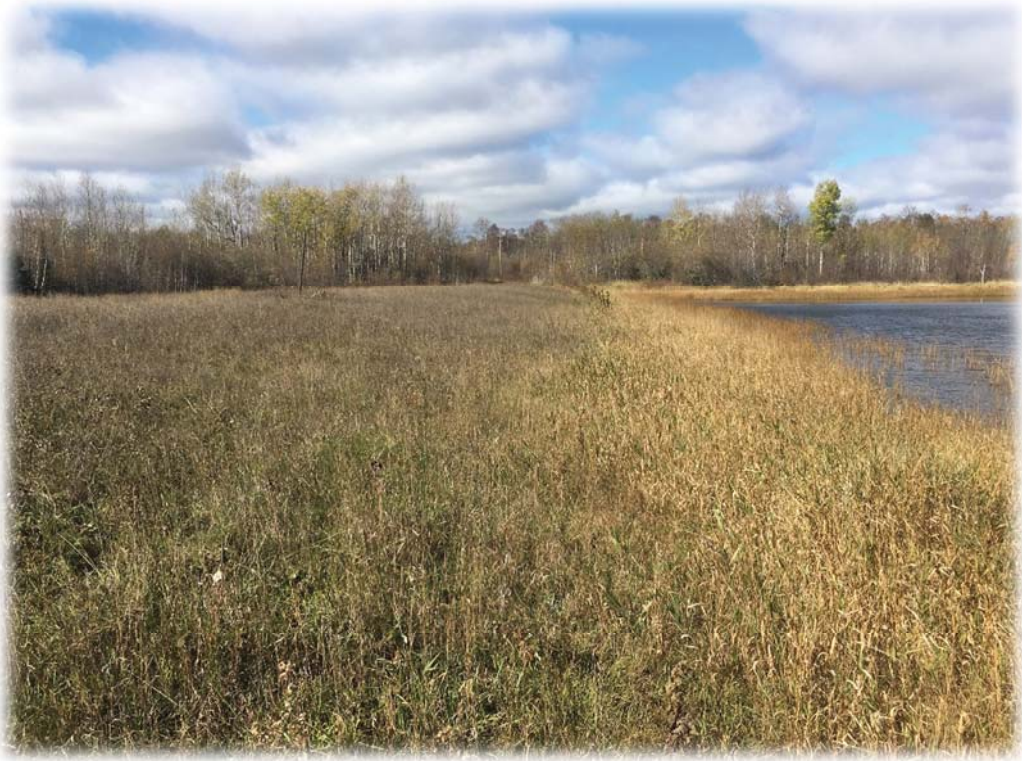
Looking west at upstream slope of dam
