# **Five-Year Operations Plan Years 2019-2023**

## ***Milepost 7 Tailings Basin***

Prepared for  
Northshore Mining Company  
Silver Bay, Minnesota

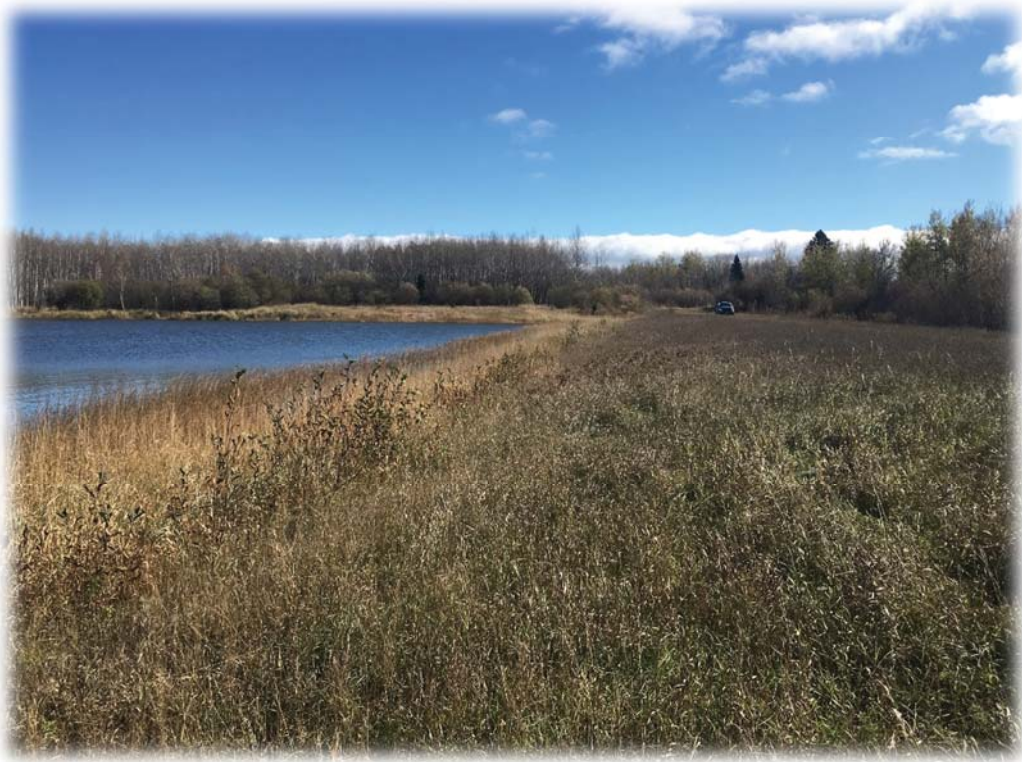
Looking east at crest and upstream slope of dam

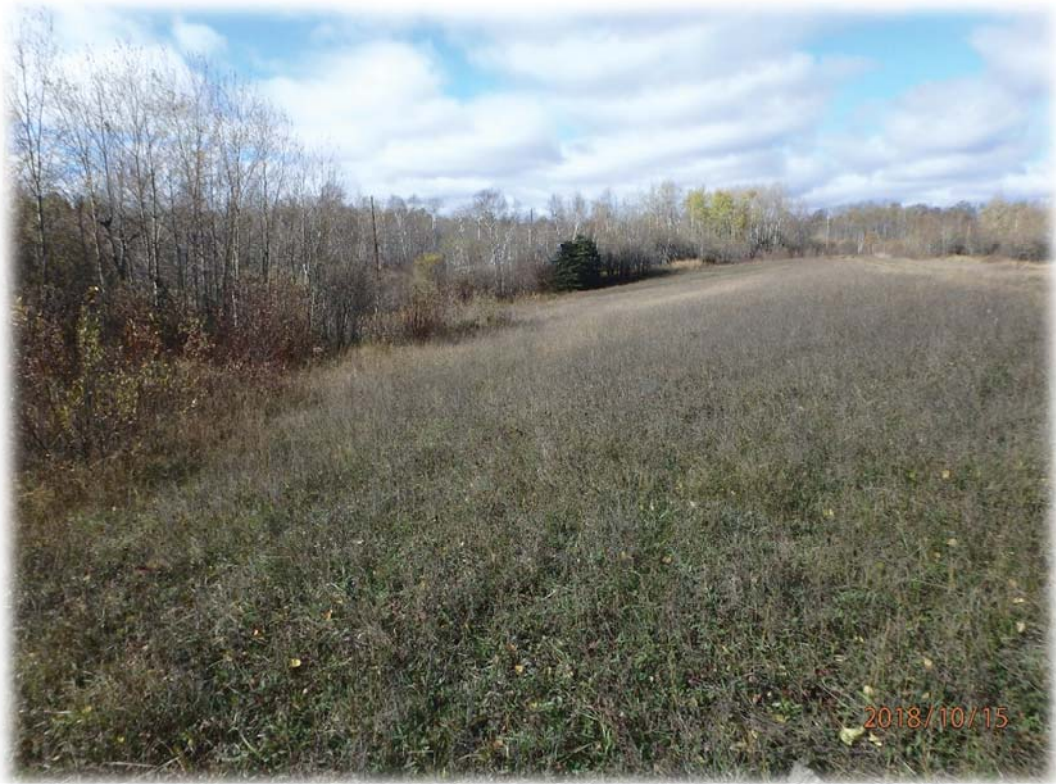
Looking west at downstream slope of dam

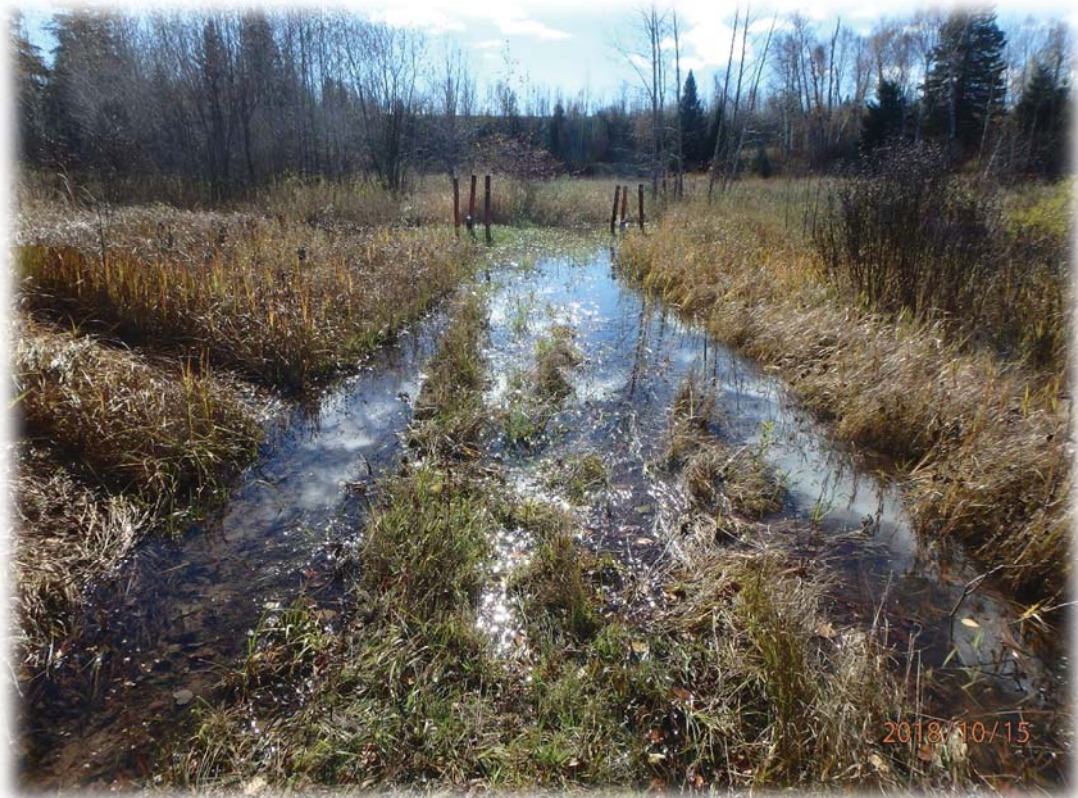
Flooding at west end of the toe of the dam, by monitoring wells

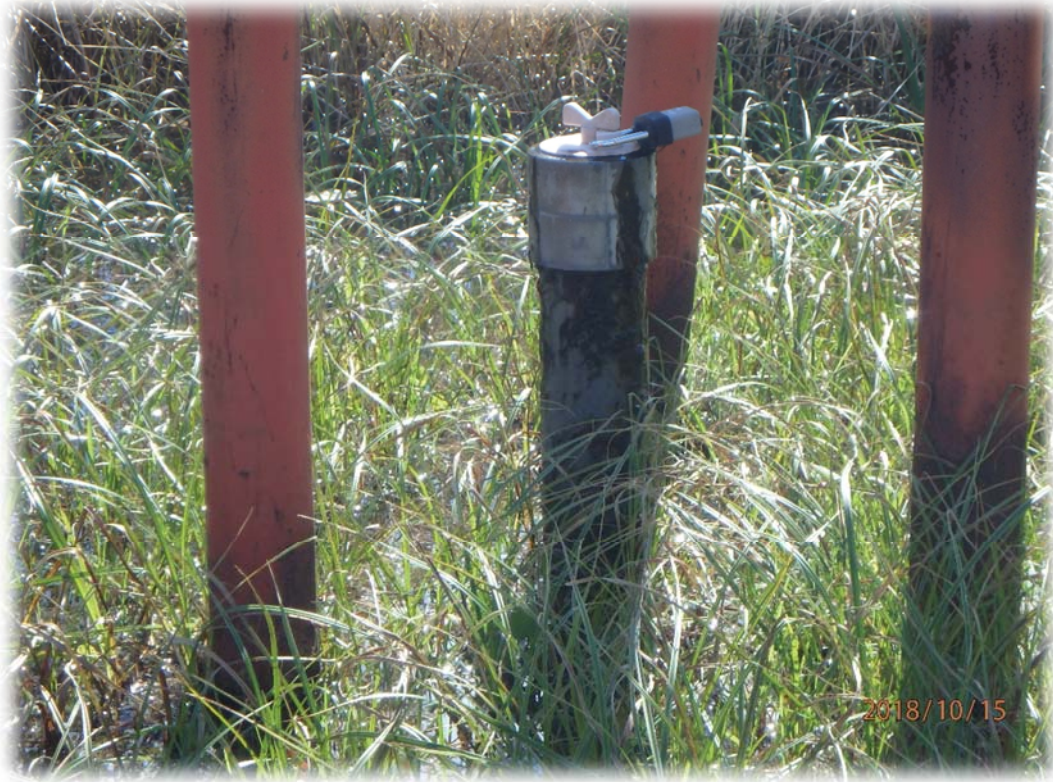
Monitoring well off the toe of the dam with locked cap

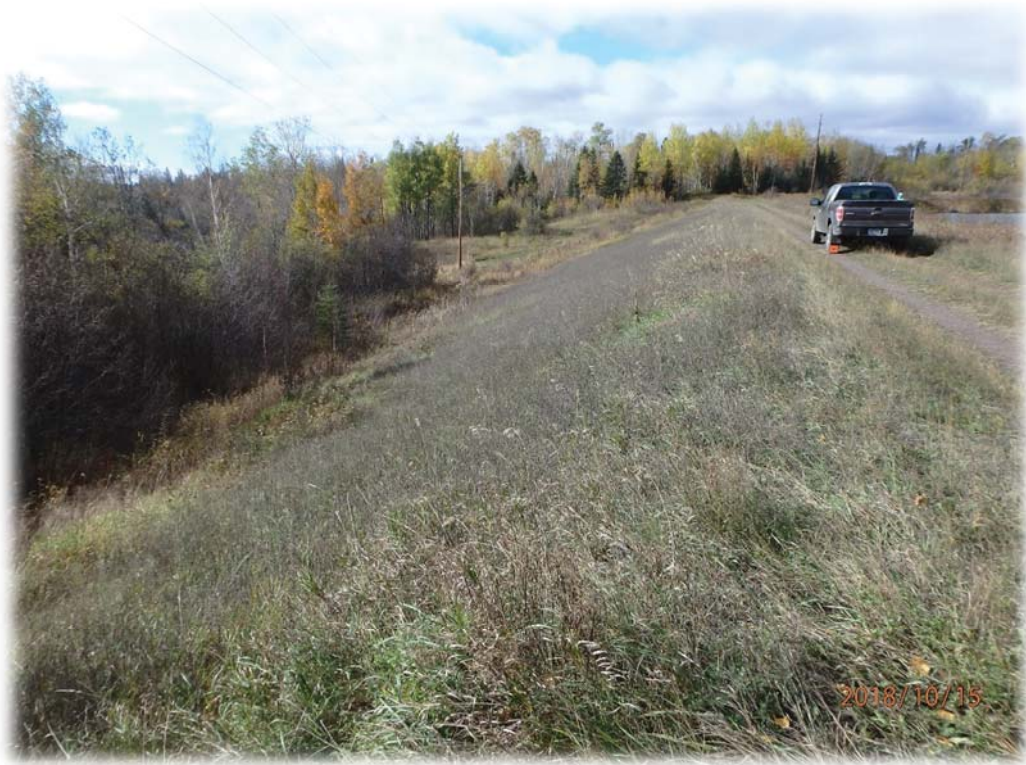
Looking west at dam crest and downstream slope

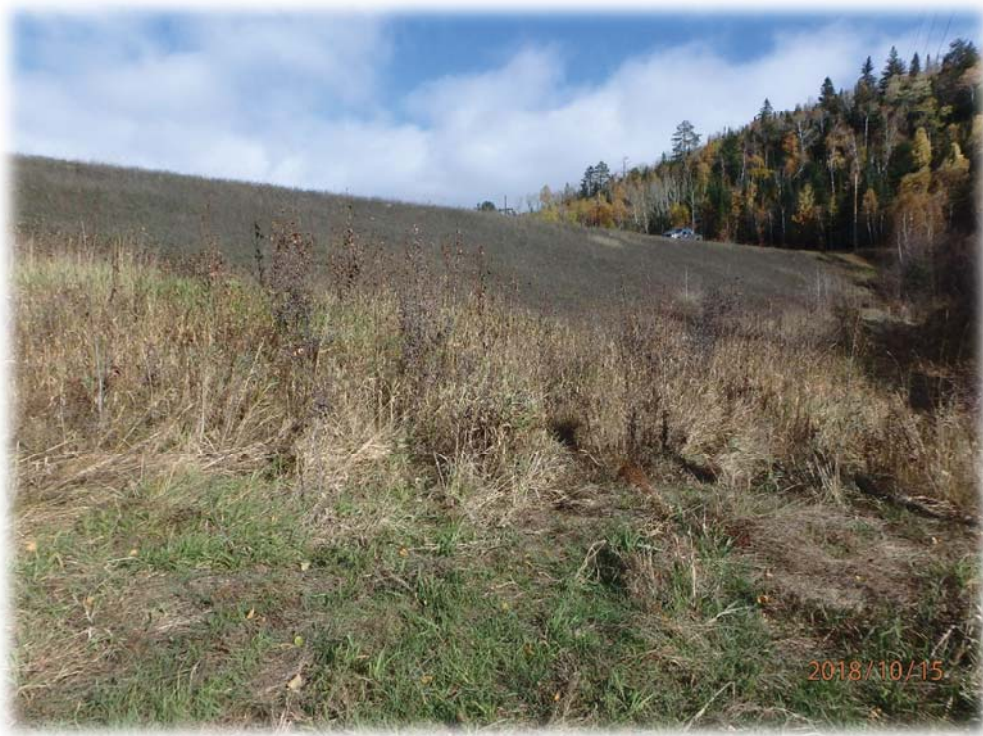
Downstream slope of dam looking east

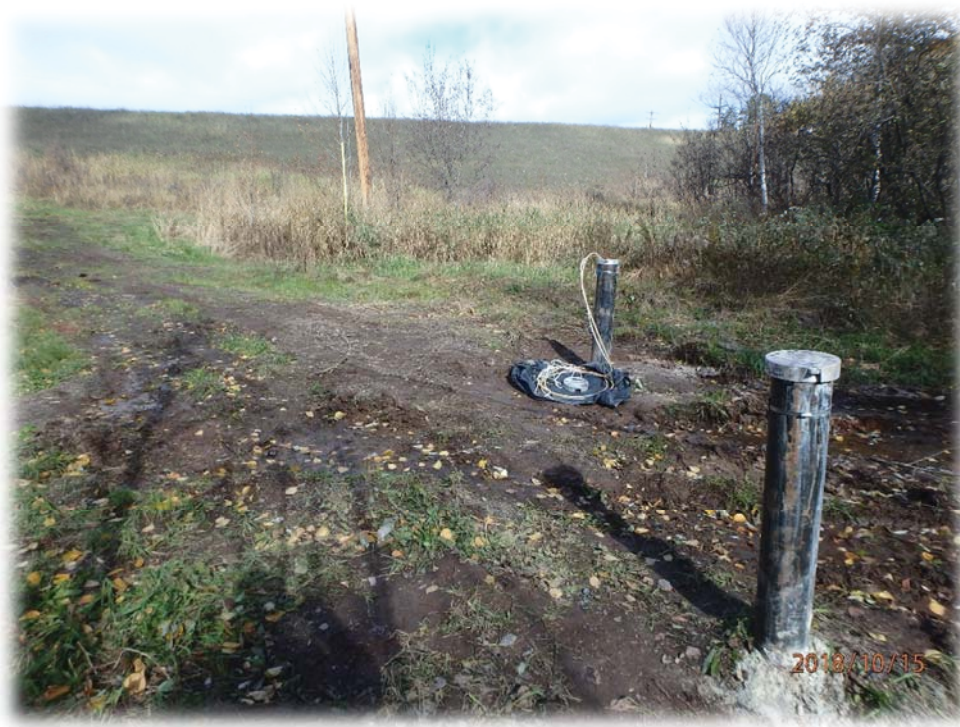
New monitoring wells at the toe of the dam

As has been noted for the past several monitoring events, apparent artesian conditions have been observed in the monitoring wells at the toe of seepage recovery dam 1A and 1B and flowing relief wells are present at the toe of seepage recovery dam 2-3. To better assess conditions at the toe of all three seepage recovery dams, a nest of VW piezometers was installed at the toe of each of these three dams in the late fall of 2018. Information from these piezometers will be incorporated into the spring 2019 monitoring event.

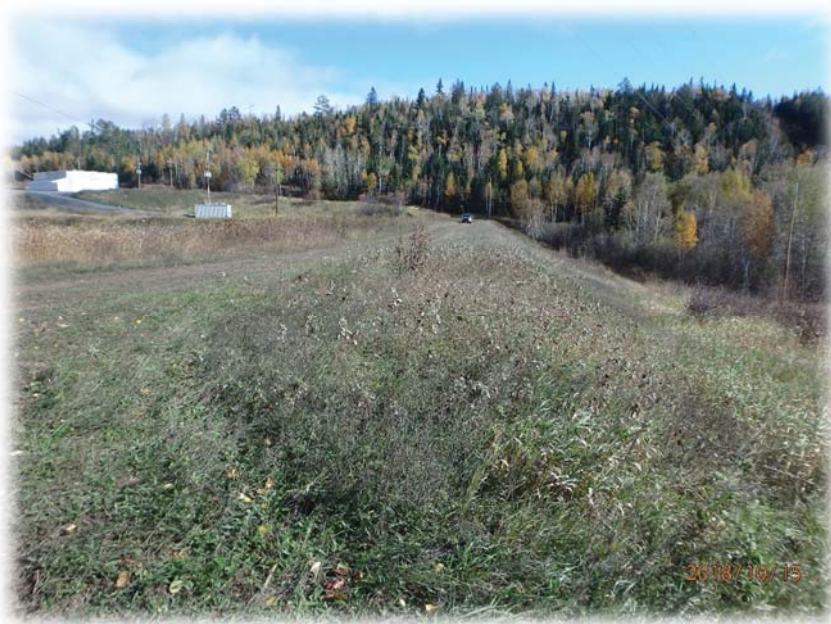
Looking east at the downstream slope and crest of the dam

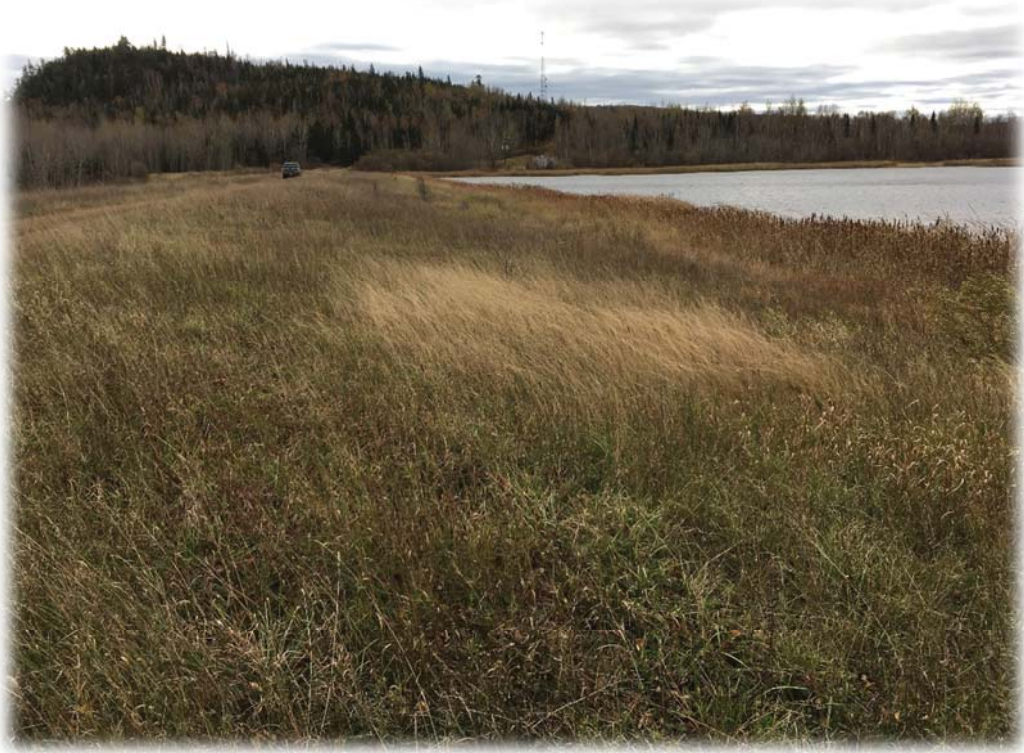
Looking east at the upstream slope of the dam

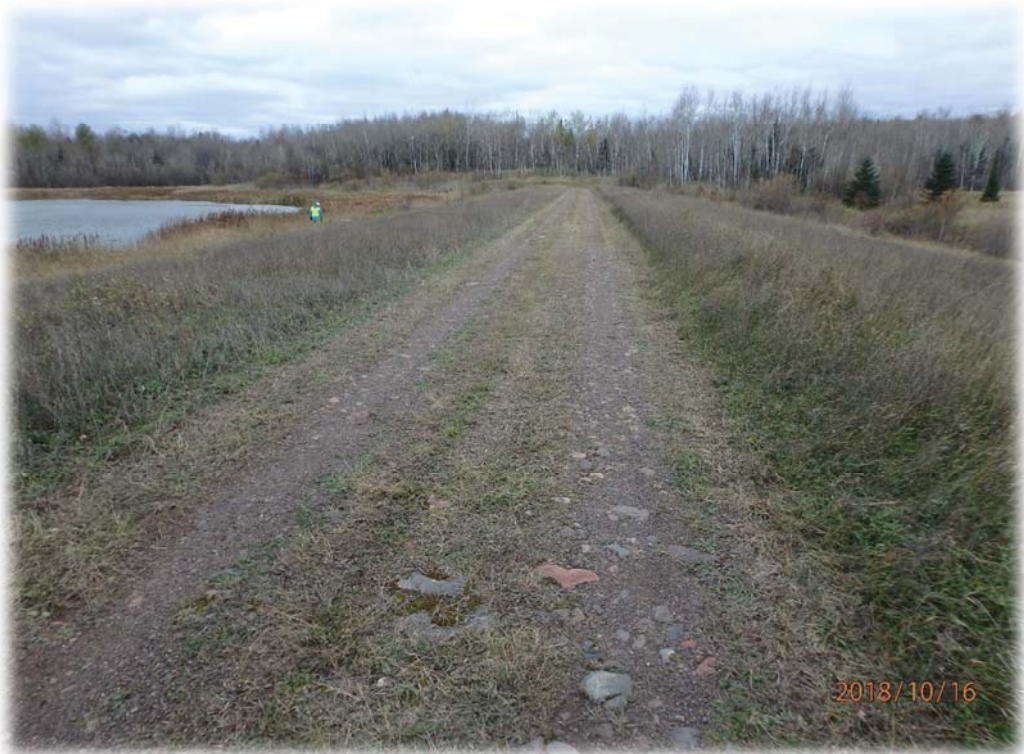
Dam crest looking west

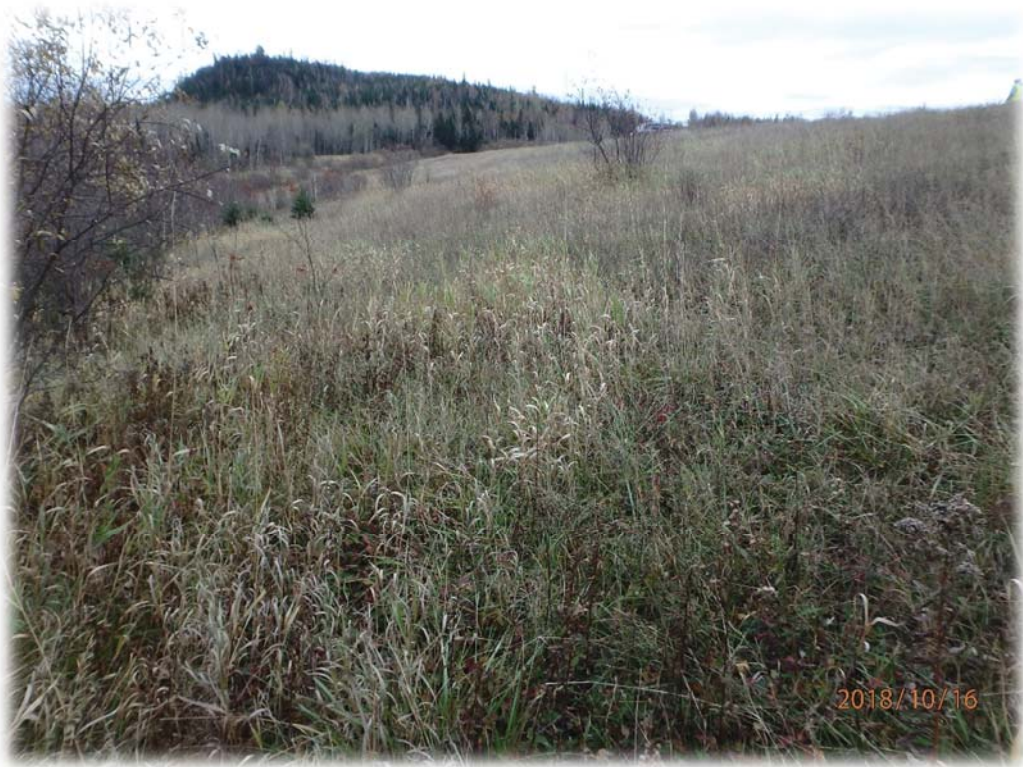
Downstream slope of dam looking east

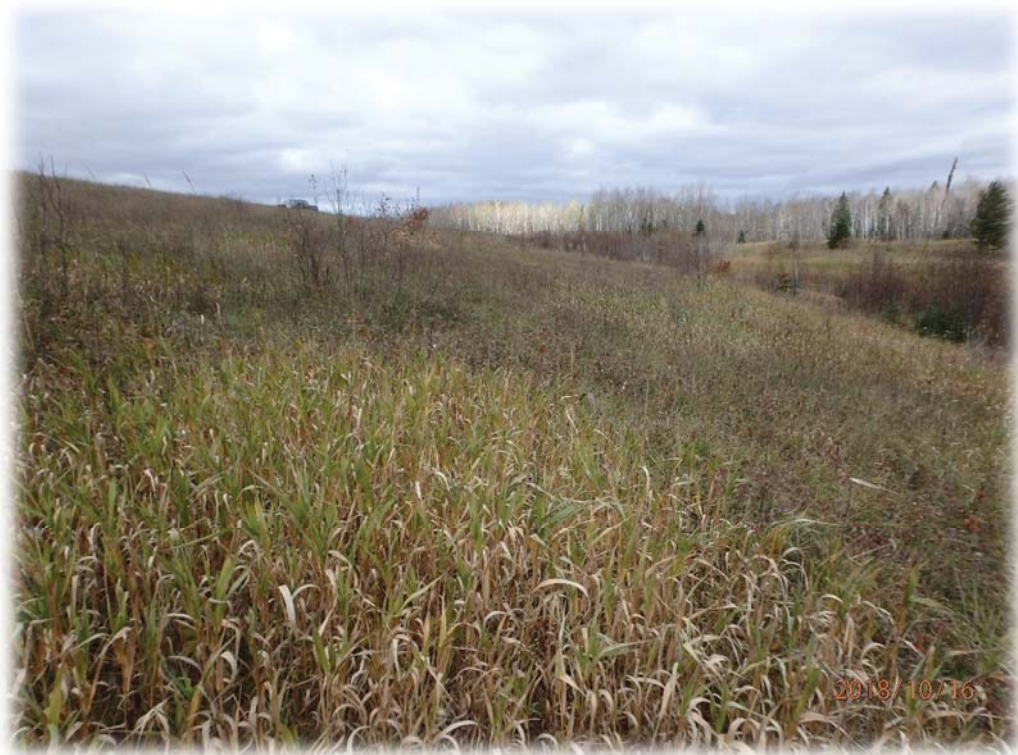
Downstream slope looking west

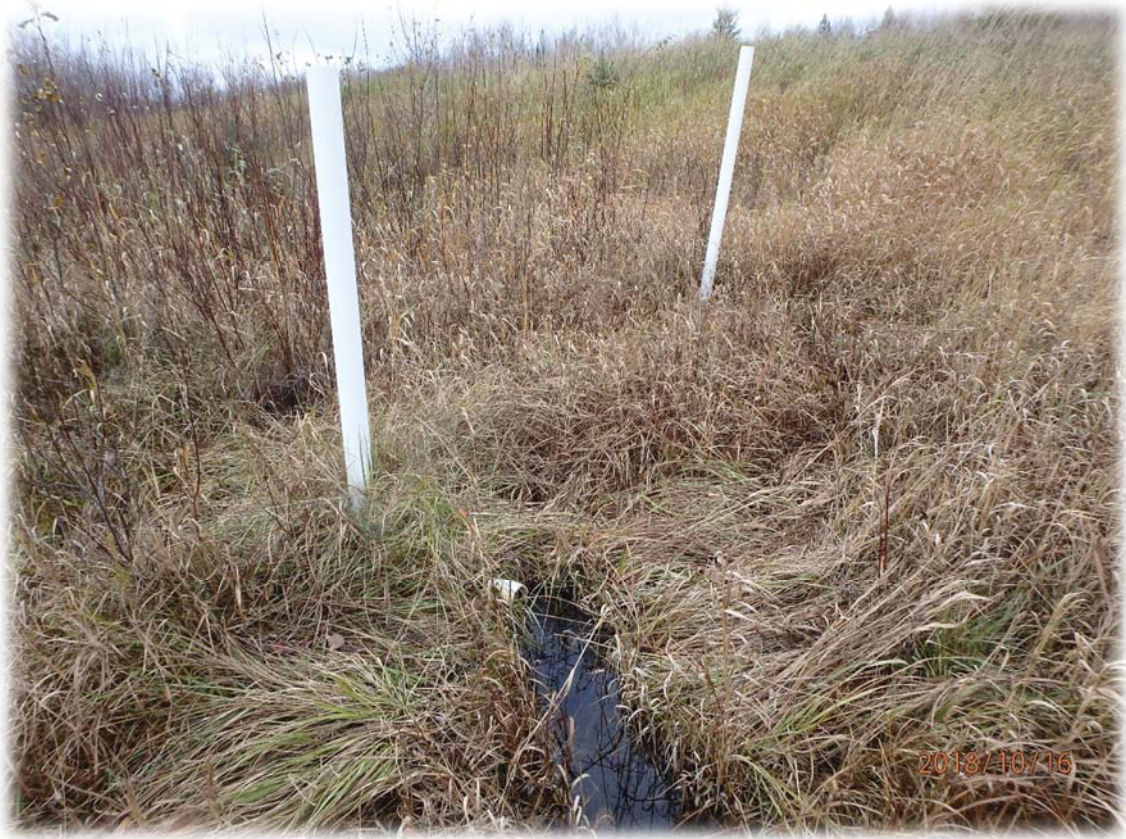
Relief wells at the dam toe

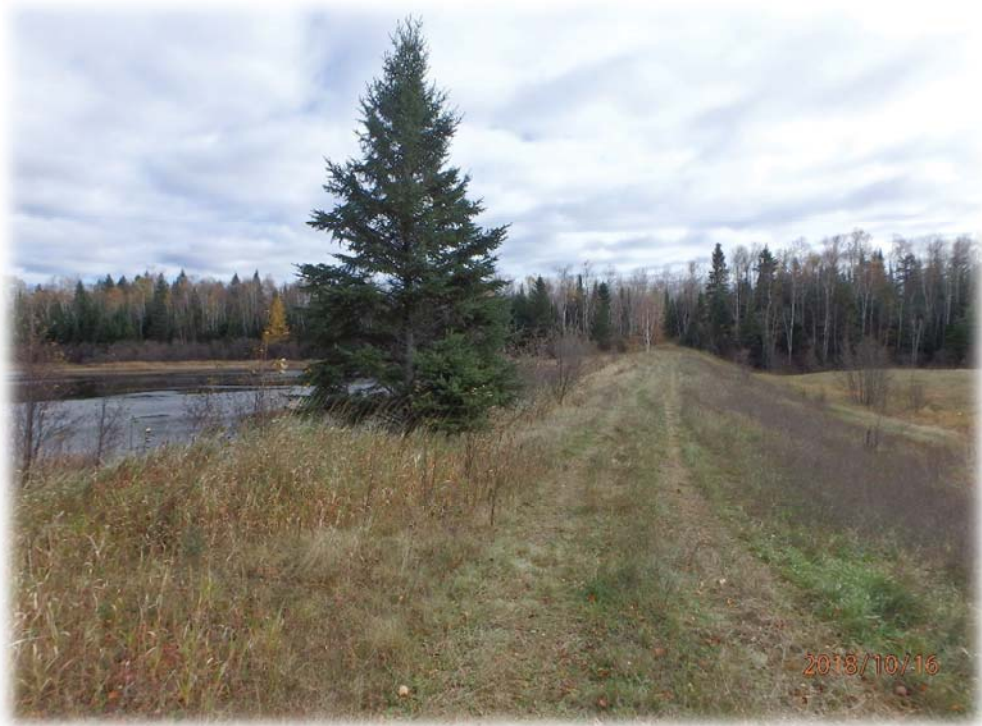
Looking east at crest of diversion dike

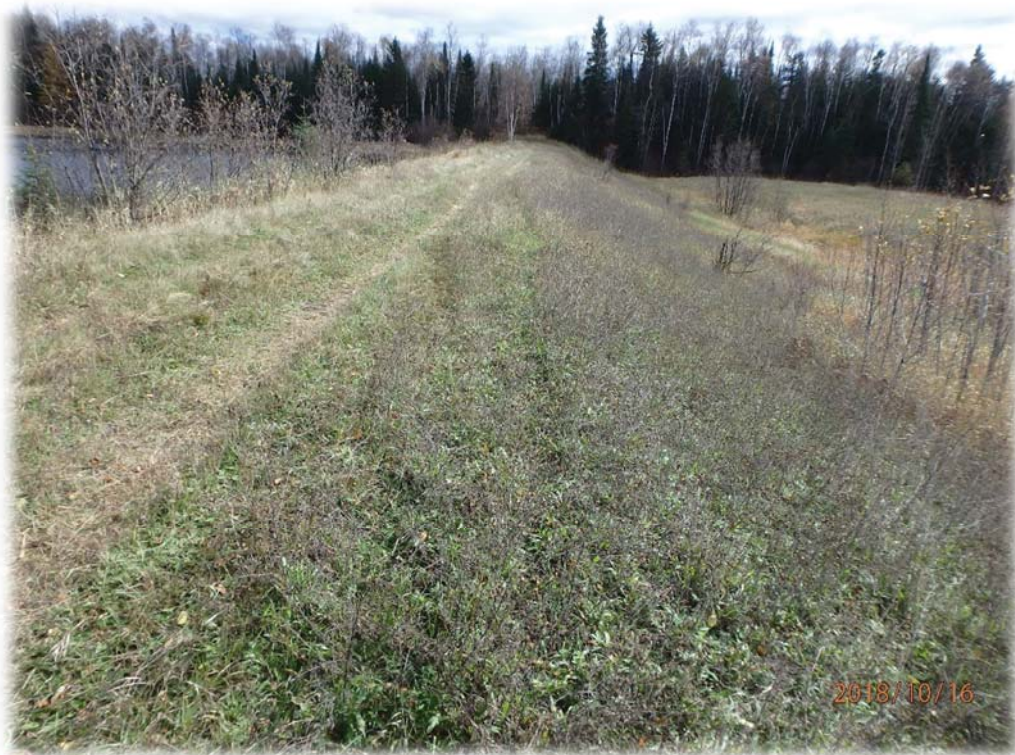
Looking east at downstream slope of diversion dike

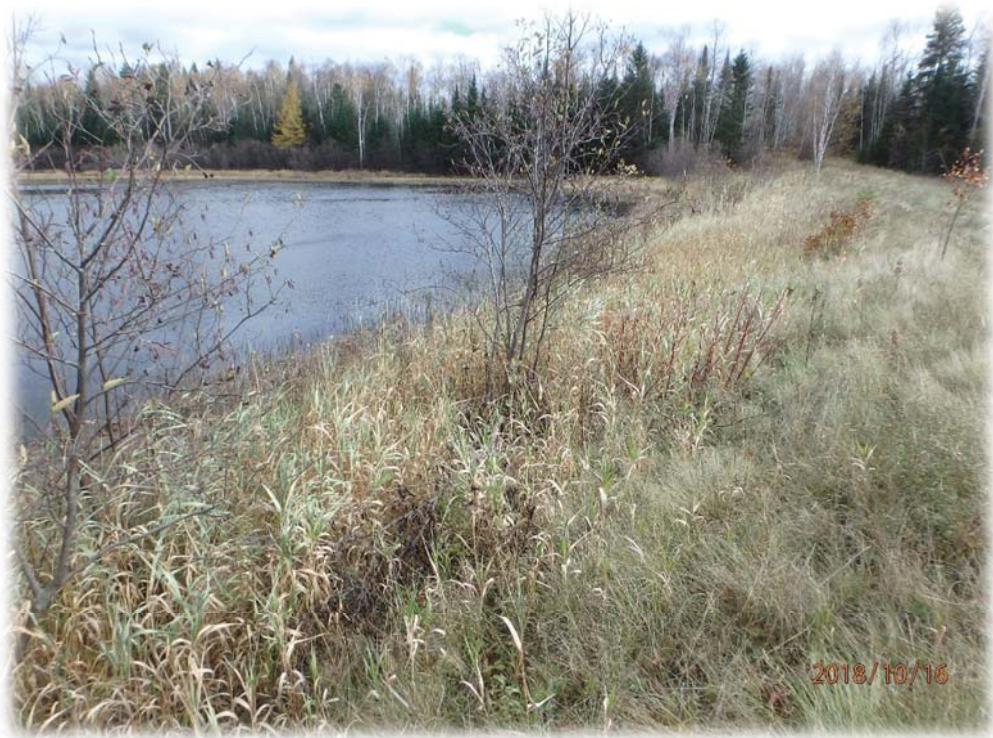
Looking east at upstream slope of diversion dike

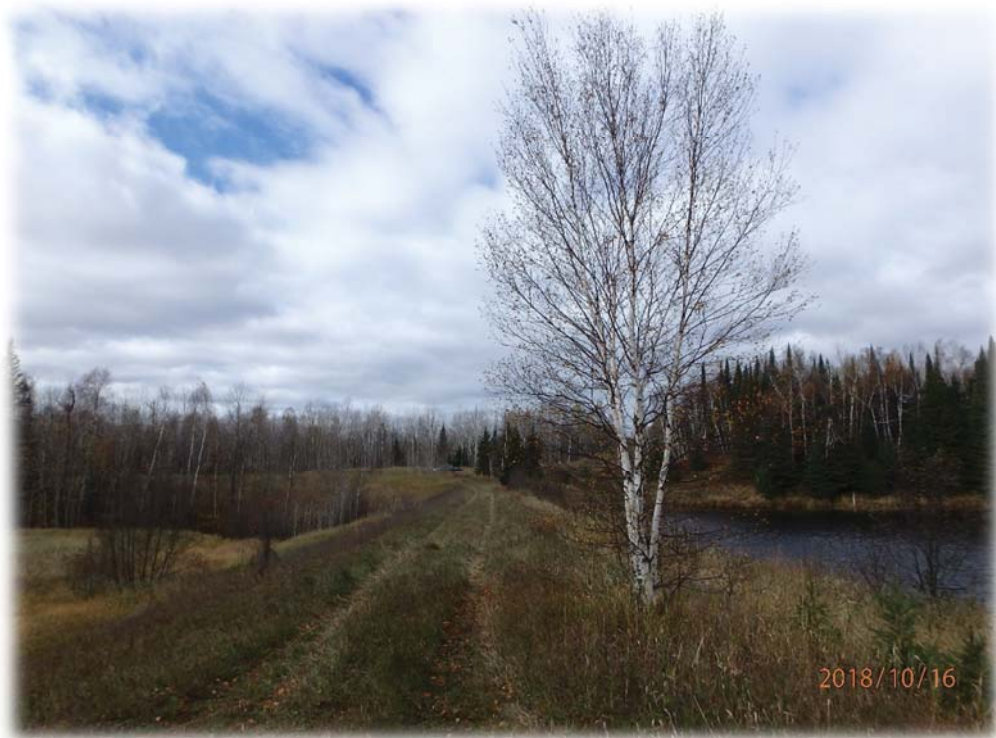
Looking west at crest and tree on upstream slope of diversion dike

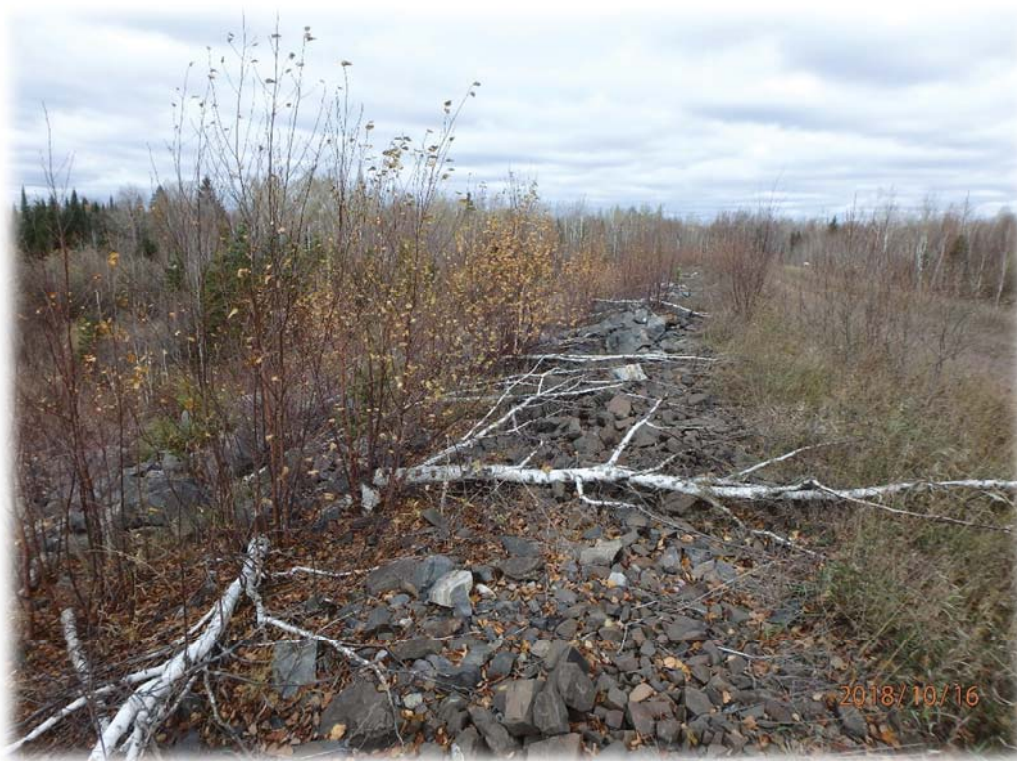
Remnants of cut woody debris on upstream slope

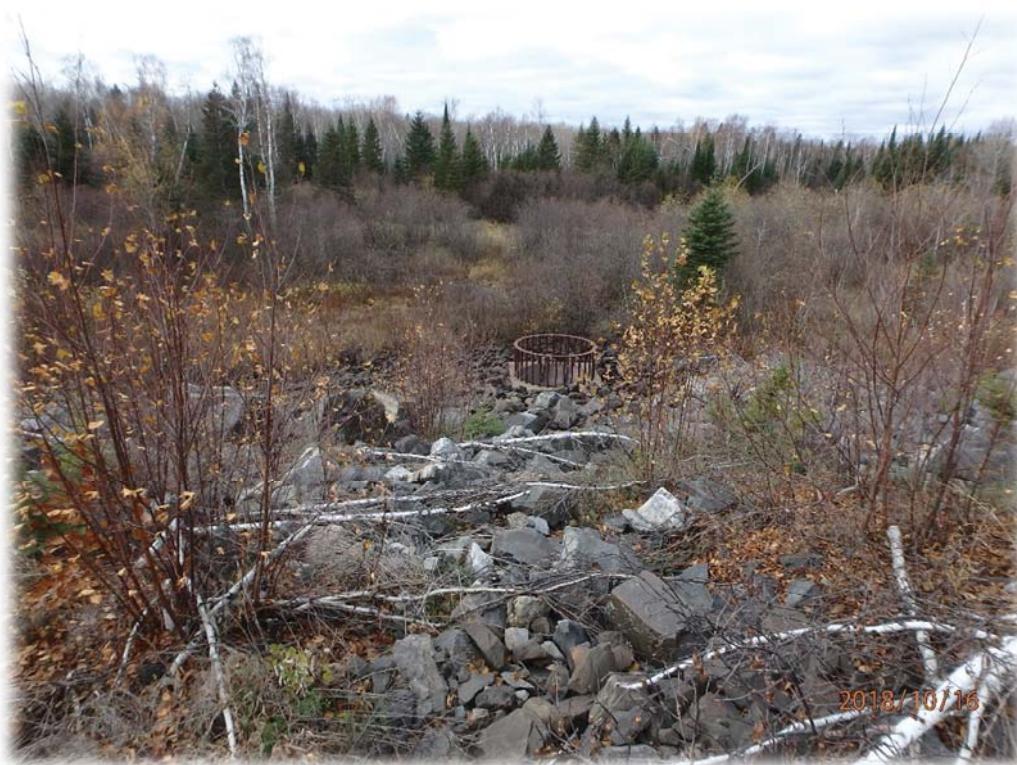
Inlet structure from previous construction

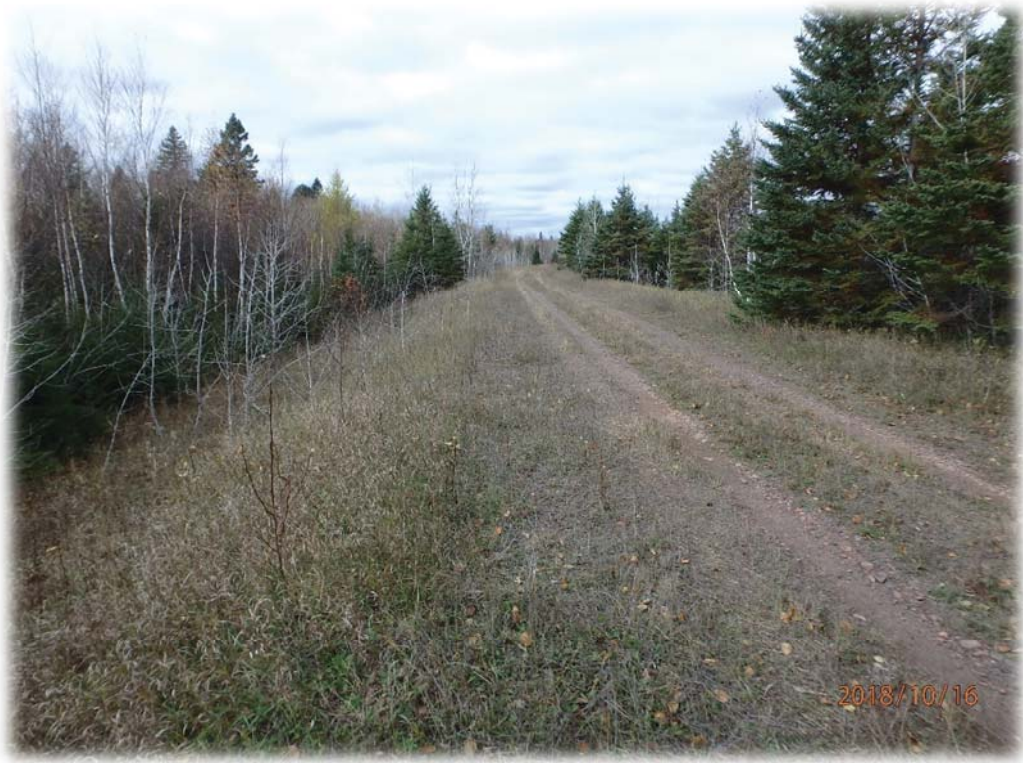
Dam crest

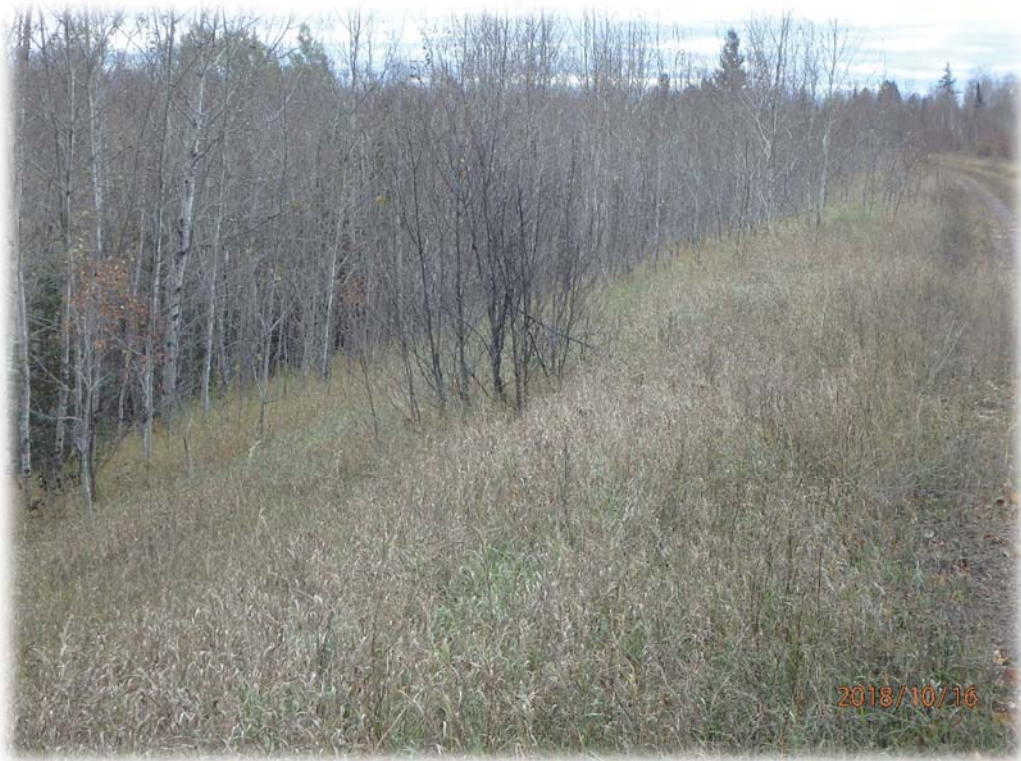
Downstream slope

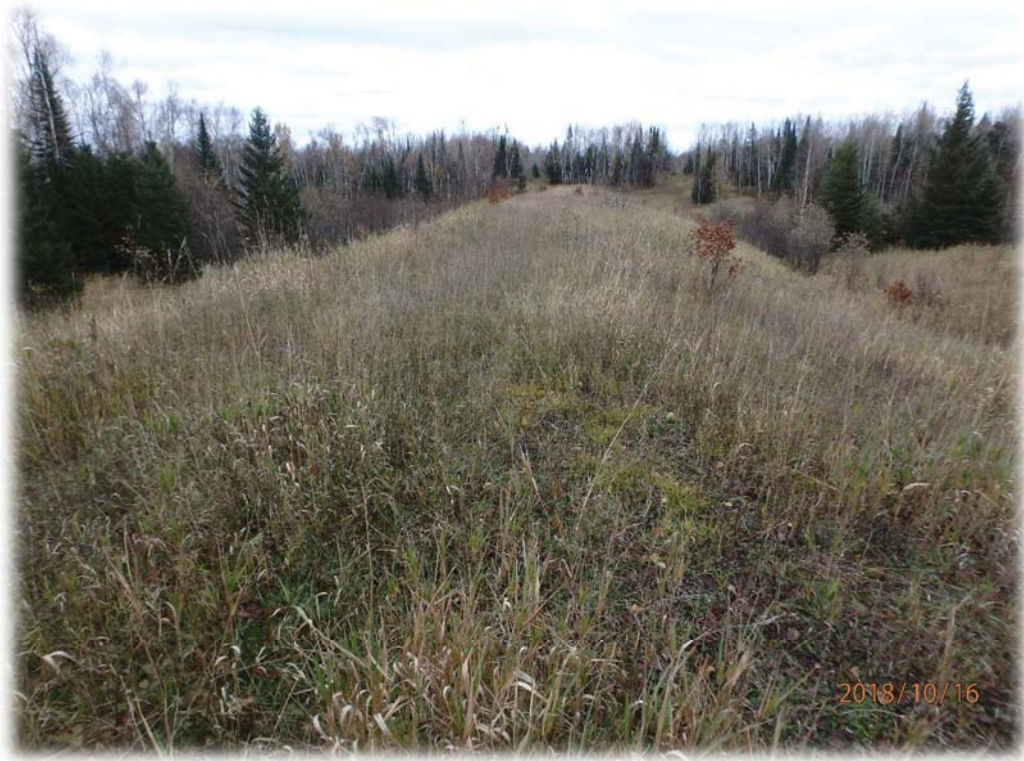
Diversion dike crest

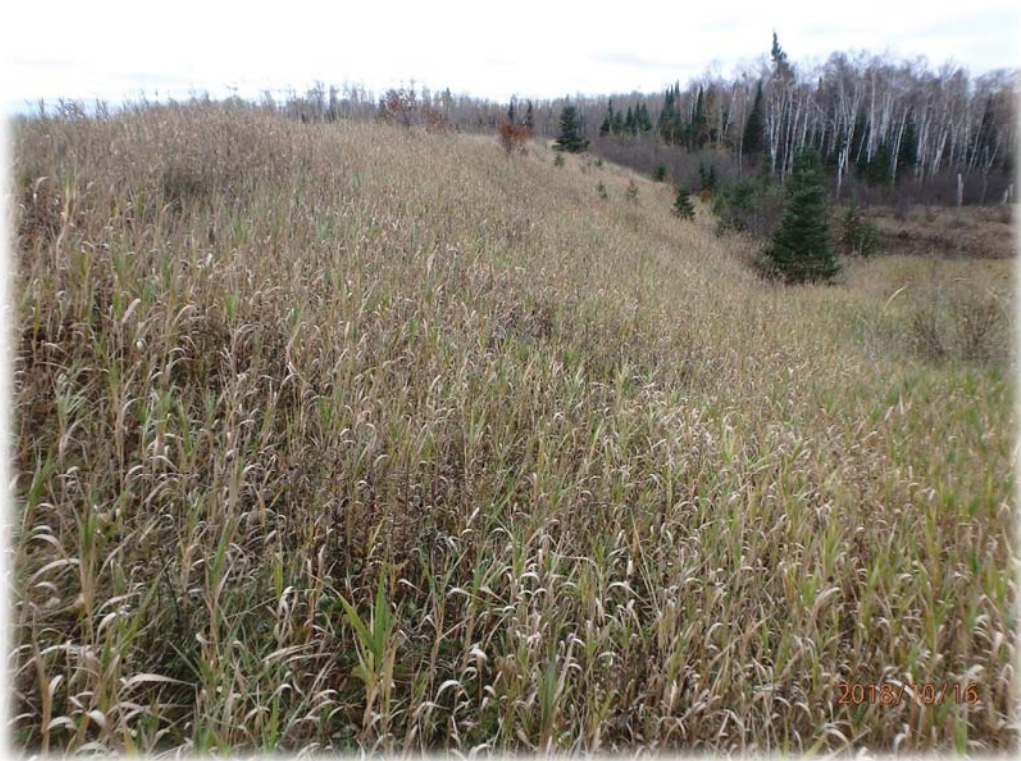
Trees on the upstream slope

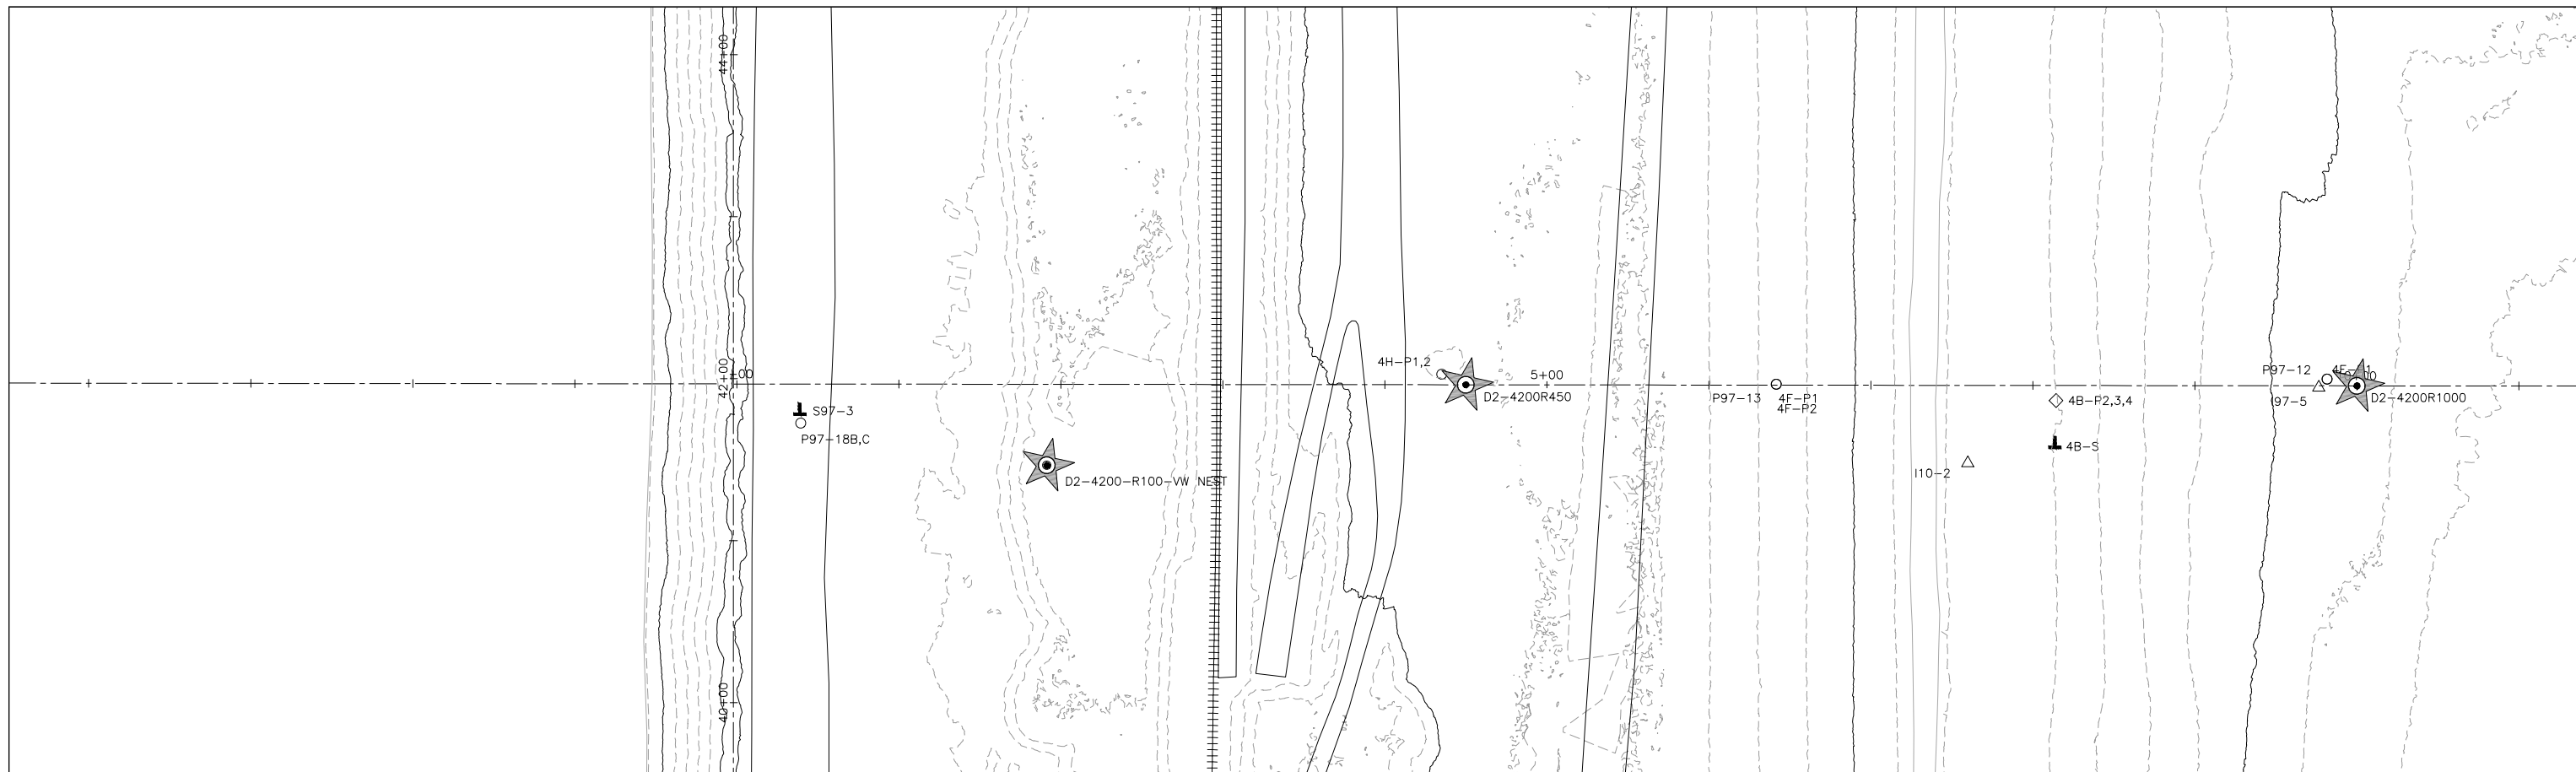
NOTE: CROSS SECTION SURFACE DEVELOPED  
FROM 2017 FLYOVER.

STRATIGRAPHIC CONTACTS BETWEEN FOUNDATION SOILS ARE BASED ON INTERPRETATION BETWEEN BORINGS. CONTACTS BETWEEN INTERNAL DAM FILL ZONES ARE BASED ON INTERPRETATION BETWEEN BORINGS AND CONSTRUCTION RECORDS INFORMATION, WHERE AVAILABLE.
