# Perimeter Dam Stability Evaluations

*Dam 1, Dam 2, and Dam 5*

Prepared for  
Northshore Mining Company

Prepared by  
Barr Engineering Co.

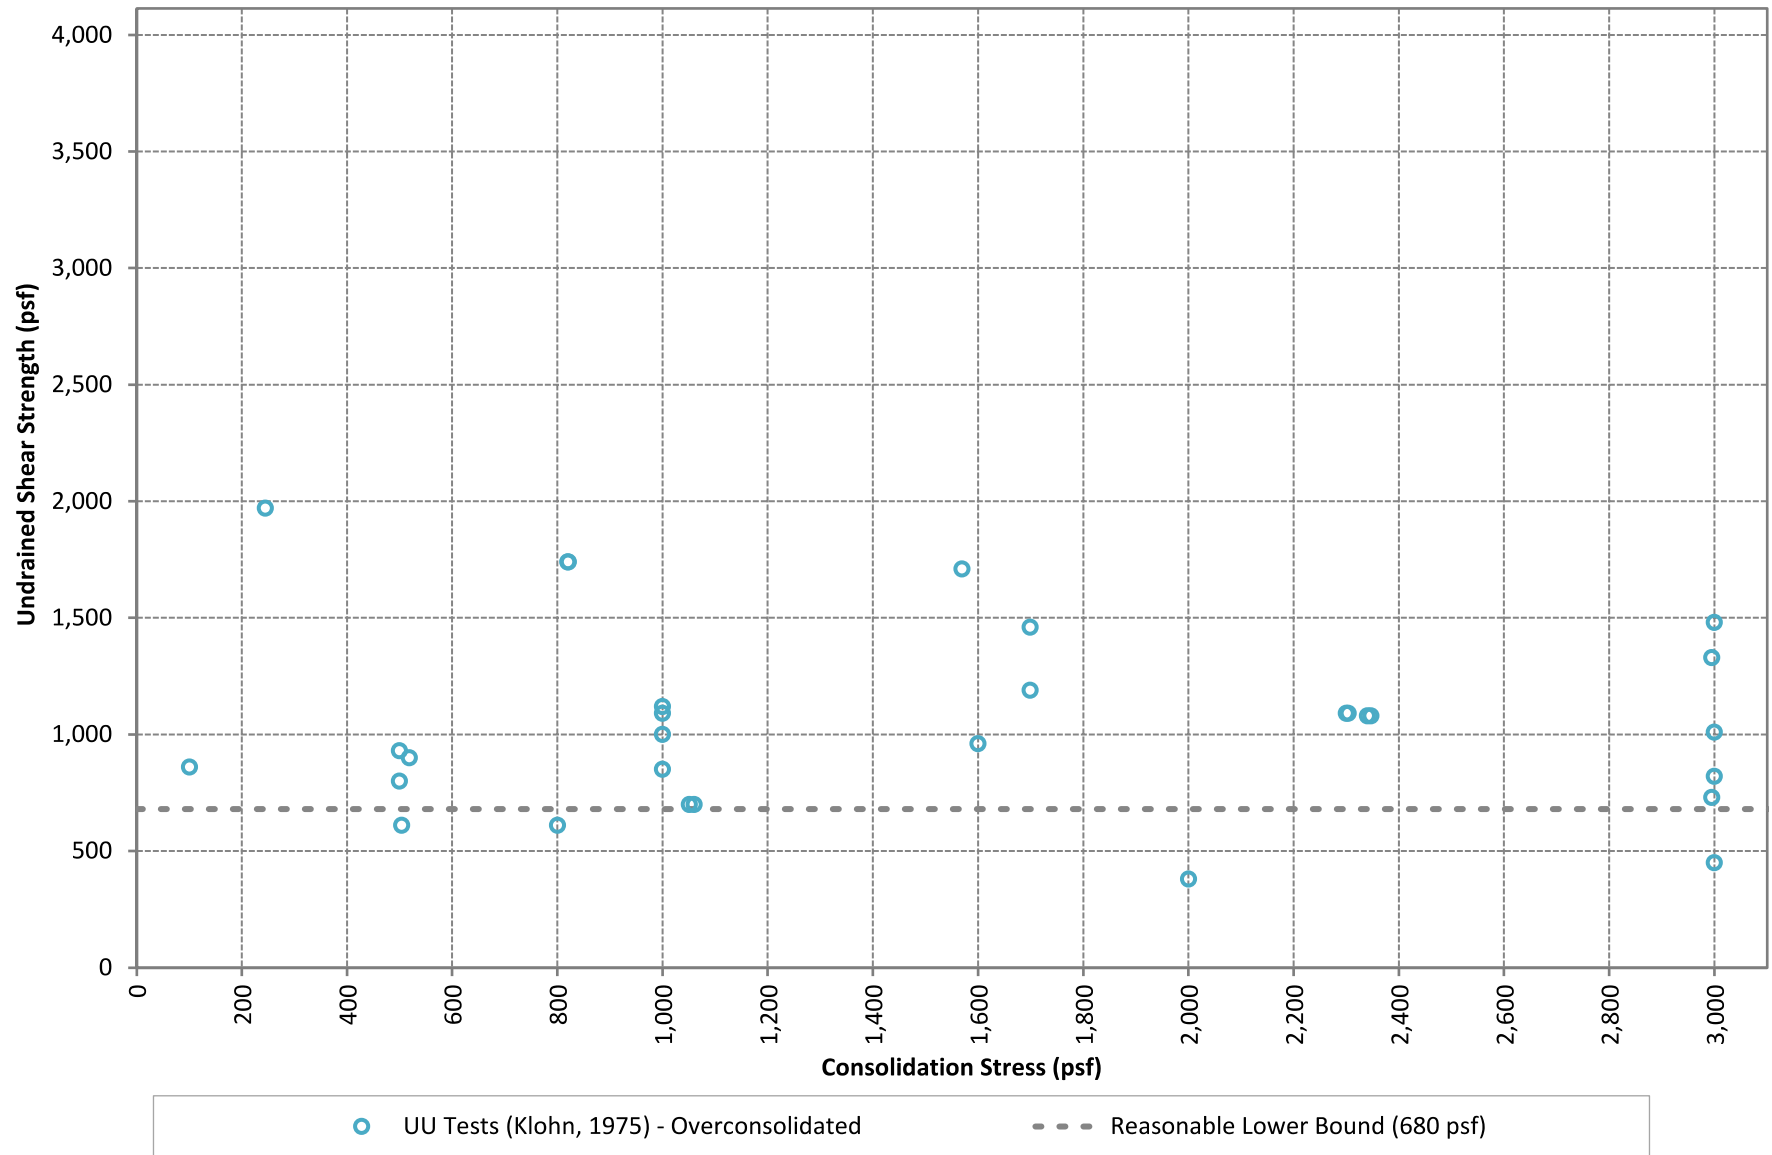
**FIGURE 14**  
**Lacustrine Clay Undrained Shear Strength - Overconsolidated, Dam 2**  
Northshore Mining Company Milepost 7 Tailings Basin

<sup>(5)</sup> Refer to Figure 14
