MILE POST 7 WEST RIDGE RAILROAD RELOCATION, DAM EXTENSIONS, AND STREAM MITIGATION PROJECT EAW
RECORD OF DECISION - FINDING OF FACT 28.d
2022 EAP

EMERGENCY ACTION PLAN

Milepost 7 Tailings Basin

Dams 1, 2, and 5 – Proposed 2023 Conditions

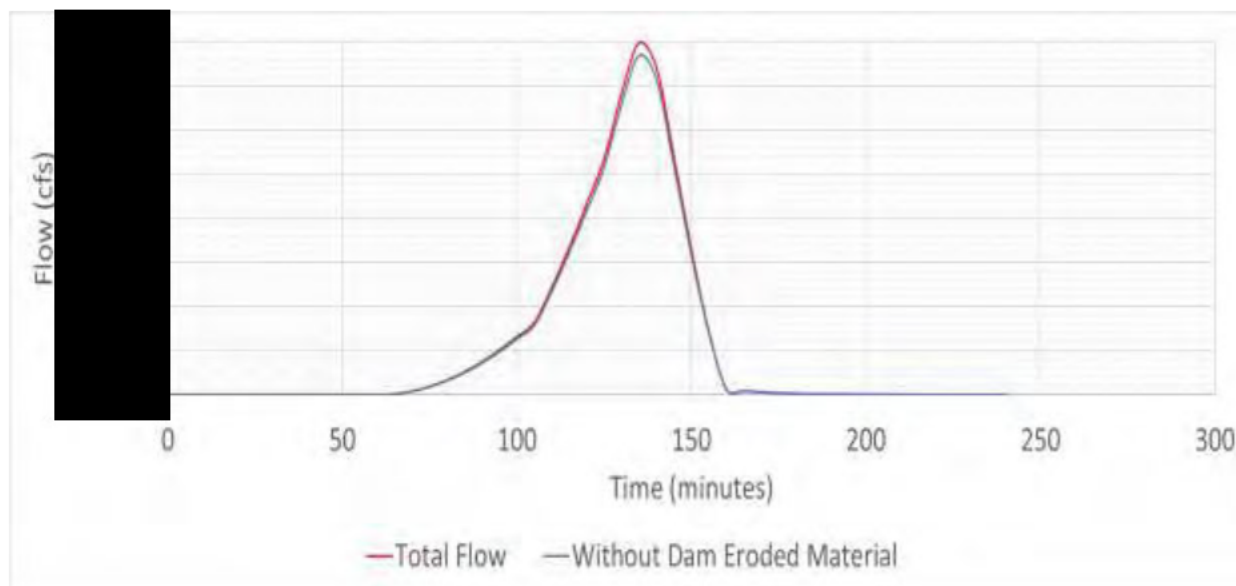
Figure E6-5 Dam 1 Breach Outflow Hydrograph Used in FLOW-3D Simulations

As explained above, the outflow hydrograph from the HEC-RAS model was used for the FLOW-3D model. However, since the outflow hydrograph included the eroded dam embankment material, which was already incorporated by adjusting the terrain, the breach outflow hydrograph was modified to reflect this. Figure E6-5 shows the outflow hydrograph generated by the HEC-RAS model using the breach parameters of Dam 1 (see Section E4). Figure E6-5 also shows the outflow hydrograph used in the model from which the eroded dam embankment material volume has been subtracted. Also, on the upstream end, a solids concentration of 20% was used based on the runout calculations, as explained in Section E5.3.

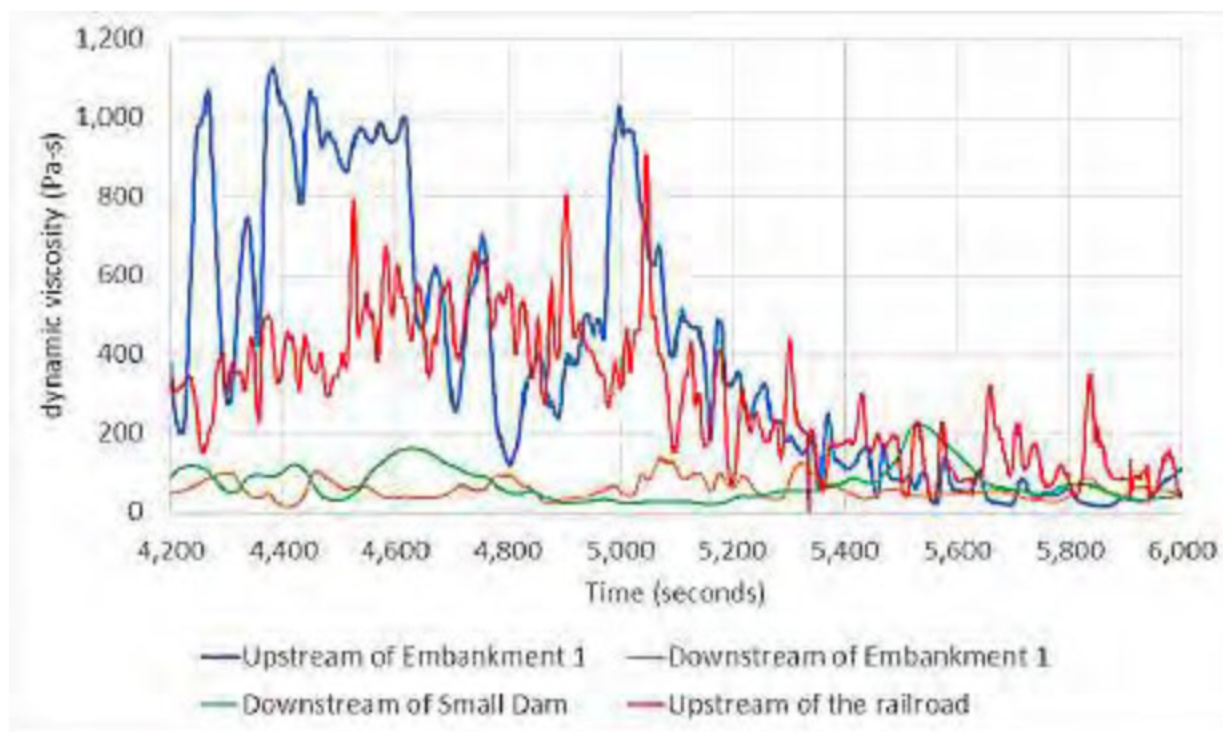
Figure E7-2 Simulated Viscosity Values for Multiple Locations in the Model

Note that in Figure E7-2, the viscosity is significantly reduced downstream of Embankment 1 and the Small Dam, where significant jamming would occur upstream of these structures. Since significant jamming would occur upstream of NSM Railroad Bridge 1, the flow downstream of the bridge would be much lower in viscosity; therefore, a Newtonian fluid model (i.e., HEC-RAS 2D) can be used to simulate routing downstream of NSM Railroad Bridge 1.

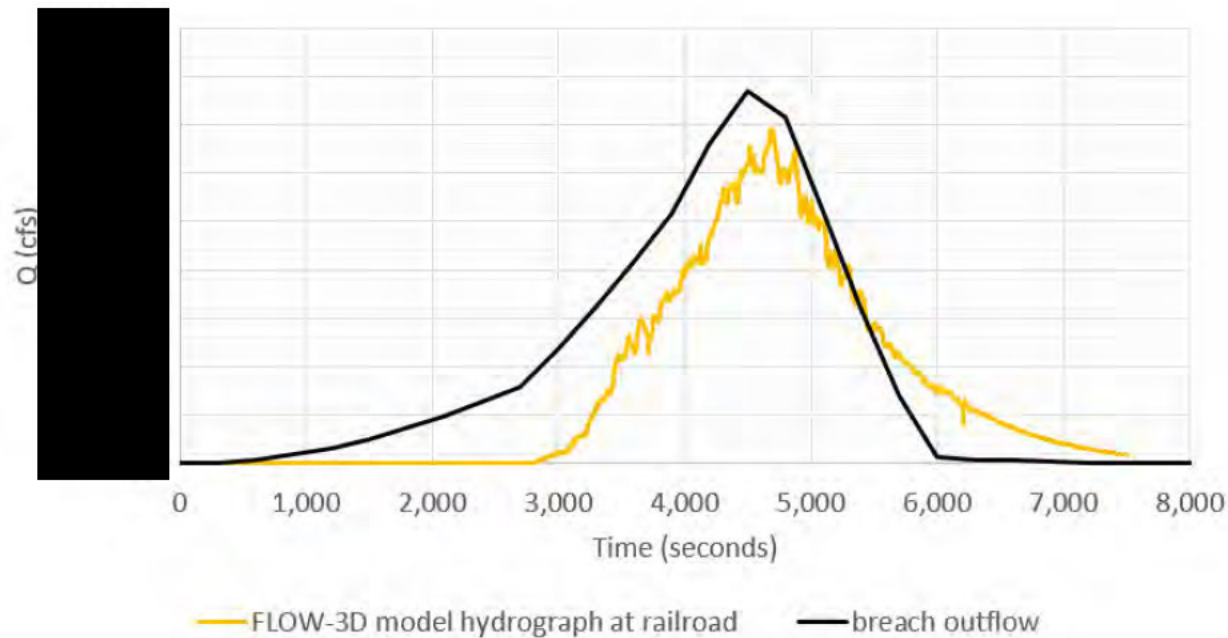
Figure E7-3 Dam 1 Breach Outflow Hydrograph and the flow hydrograph at NSM Railroad Bridge 1 during the PMP-Induced Failure Scenario

Figure E7-3 shows the hydrograph simulated from FLOW-3D at NSM Railroad Bridge 1 compared to the breach outflow hydrograph. The peak flows of the two models and the volumes are different; the FLOW-3D simulated hydrograph volume is about 24 percent less than that of the breach outflow hydrograph. To estimate the amount of solids deposited upstream of the NSM Railroad, additional calculations were carried out in FlowSight (the FLOW-3D post-processing software package). The deposited volume of solids was estimated based on the volume fraction of cells upstream of the NSM Railroad, the fluid velocity of each cell, and the solid particle settling velocity, where the solid particle settling velocity was estimated to be 2.4×10^{-5} fps using the method developed by Dietrich (Reference (14)). The volume of deposited solids, including the embankment breach material, was determined to be about 730 acre-feet (i.e., 4% of the breach outflow volume). This indicates that approximately 18 percent of solids were deposited upstream of NSM Railroad Bridge 1 due to jamming and bulking of the fluid. In fact, this is the volume of tailings not leaving the NSM property.
