APPENDIX D. GRINDSTONE RIVER DAM REMOVAL DRAFT ENVIRONMENTAL IMPACT STATEMENT

DREDGE MATERIAL ANALYSIS

GRINDSTONE RIVER DAM REMOVAL PROJECT

HINCKLEY, MINNESOTA

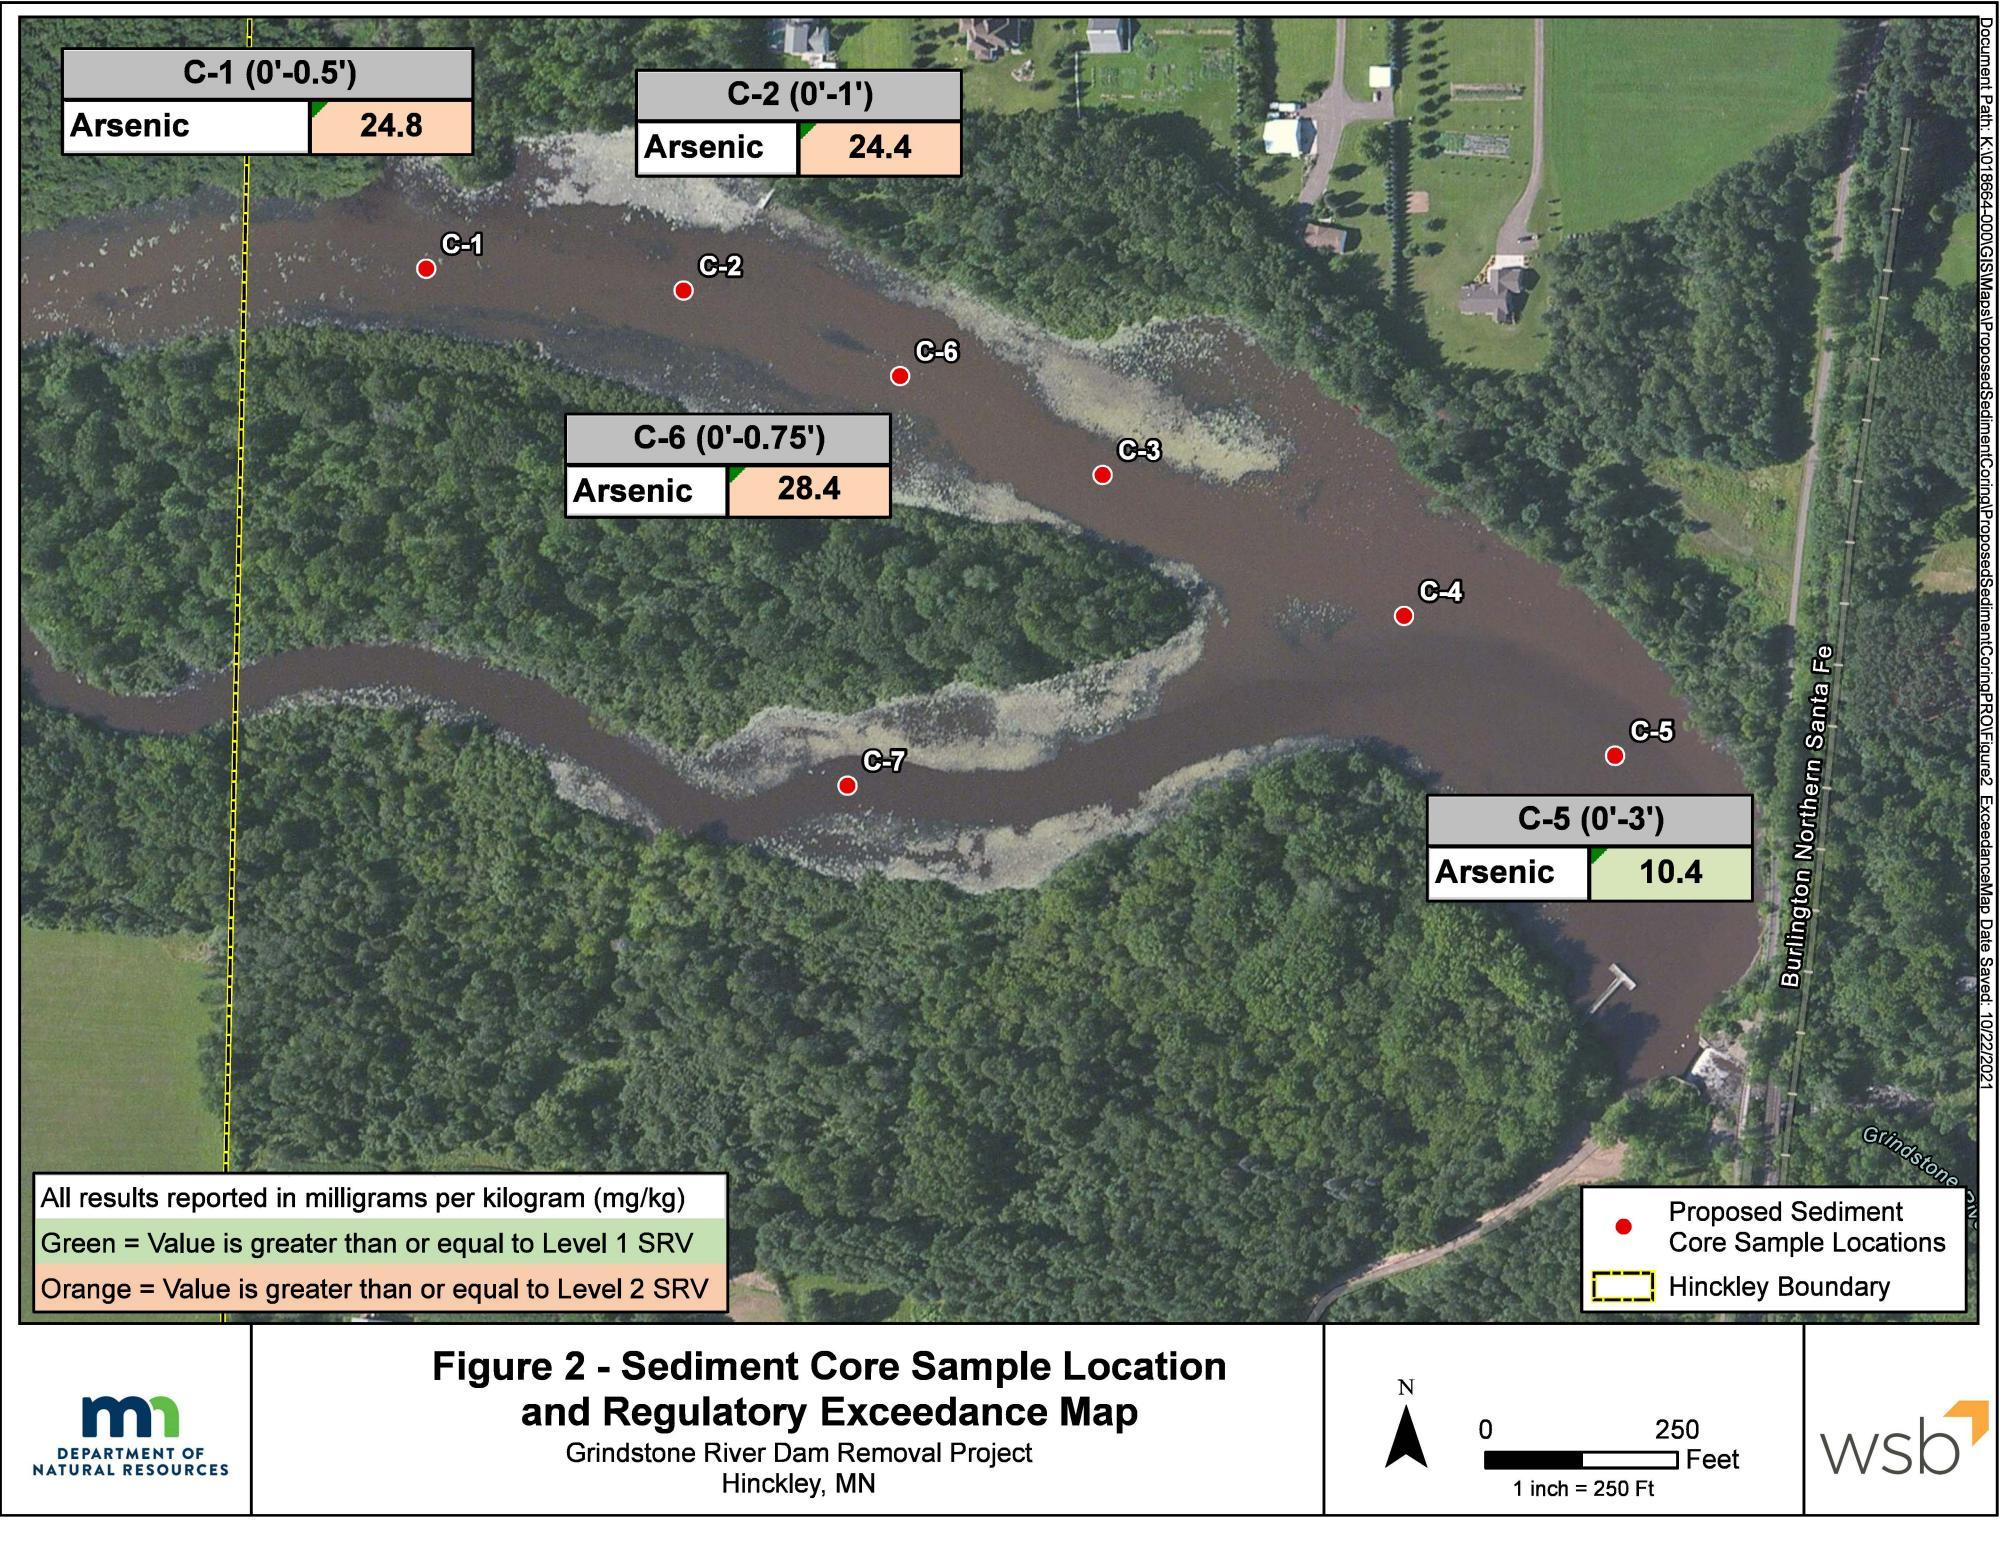
- Arsenic was detected in all sample submitted for analysis. Arsenic also exceeded the Level 1 SRV in one sample C-5 (0'-3') at a concentration of 10.4 mg/kg and the Level 2 SRV in samples C-1 (0'-0.5'), C-2 (0'-1'), and C-6 (0-0.75') at concentrations of 24.8mg/kg, 24.4 mg/kg, and 28.4 mg/kg respectively.

DEPARTMENT OF NATURAL RESOURCES Figure 2 includes an aerial photograph of the Grindstone River Reservoir located in Hinckley, MN. Further, the seven sediment core sample locations are depicted on the photograph, as well as the four core sample locations were arsenic concentrations exceed the MPCA's Level 1 and/or Level 2 soil reference values.

- If the sediment material at/near core sample locations C-1, C-2, C-5 and C-6 are disturbed or dredged as part of the dam removal project, the material will need be managed in accordance with MPCA guidance.
