Anatomy of a Firewise Home

Minnesota Firewise Project Briefing

July 2002

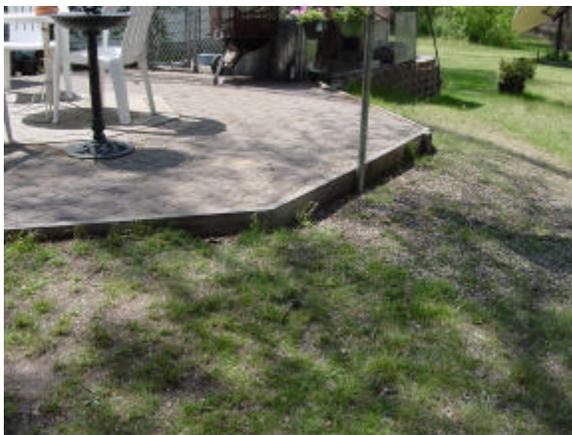
It had a brick patio rather than wood. Wood decks that can catch both dry leaves and sparks. Many homes burn down because the wood deck catches fire which, in turn, spreads fire to the home.

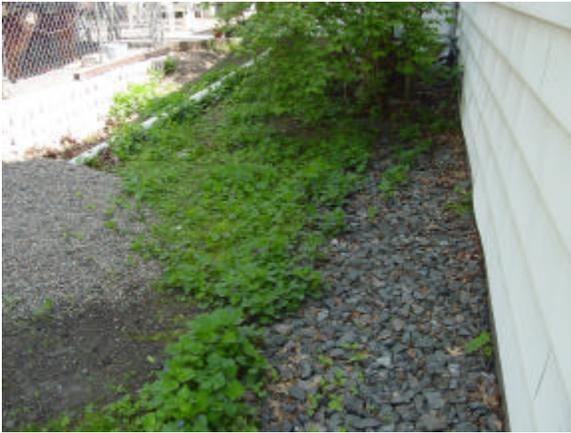
The zone nearest the house was mulched with a non-burning material. In addition, this zone was kept free from accumulations of leaves. Shrubs near the house are broadleaved, deciduous types. No ignitions possible here. Wood mulch should not be used in the zone immediately adjacent to the house in areas with a high risk of wildfire.

Out back, there was no accumulation of grass or leaves around the propane tank. Even though this tank was only a few feet from the house, it posed no risk because there no fuel around it and it was inside the homes defensible space.

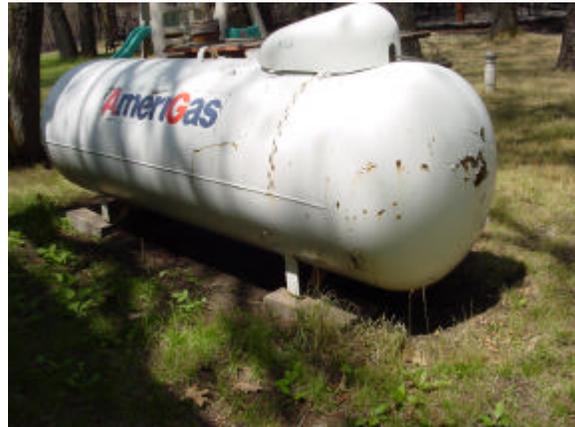
This house was surrounded by an excellent, well maintained Defensible Space. Firewise Minnesota recommends at least 30 feet of well irrigated, regularly mowed grass. Even better, this house had 100 feet of Defensible Space. The roof was clear of leaves and the shrubs near the house were deciduous.

Homes can still be surrounded by trees. This one was well shaded by oak and other hardwoods. It still is. In addition, the open space surrounding this home provided firefighters a good working space.
