In this concept, the Interpretive Center is mostly removed except for the stone retaining walls that can be safely preserved. The Department will resurface the parking lot and add trailhead amenities like a vault toilet, seating, and bike racks. These amenities are placed close to the parking lot and out of the viewshed from the picnic area and Eagle Rock Vista.

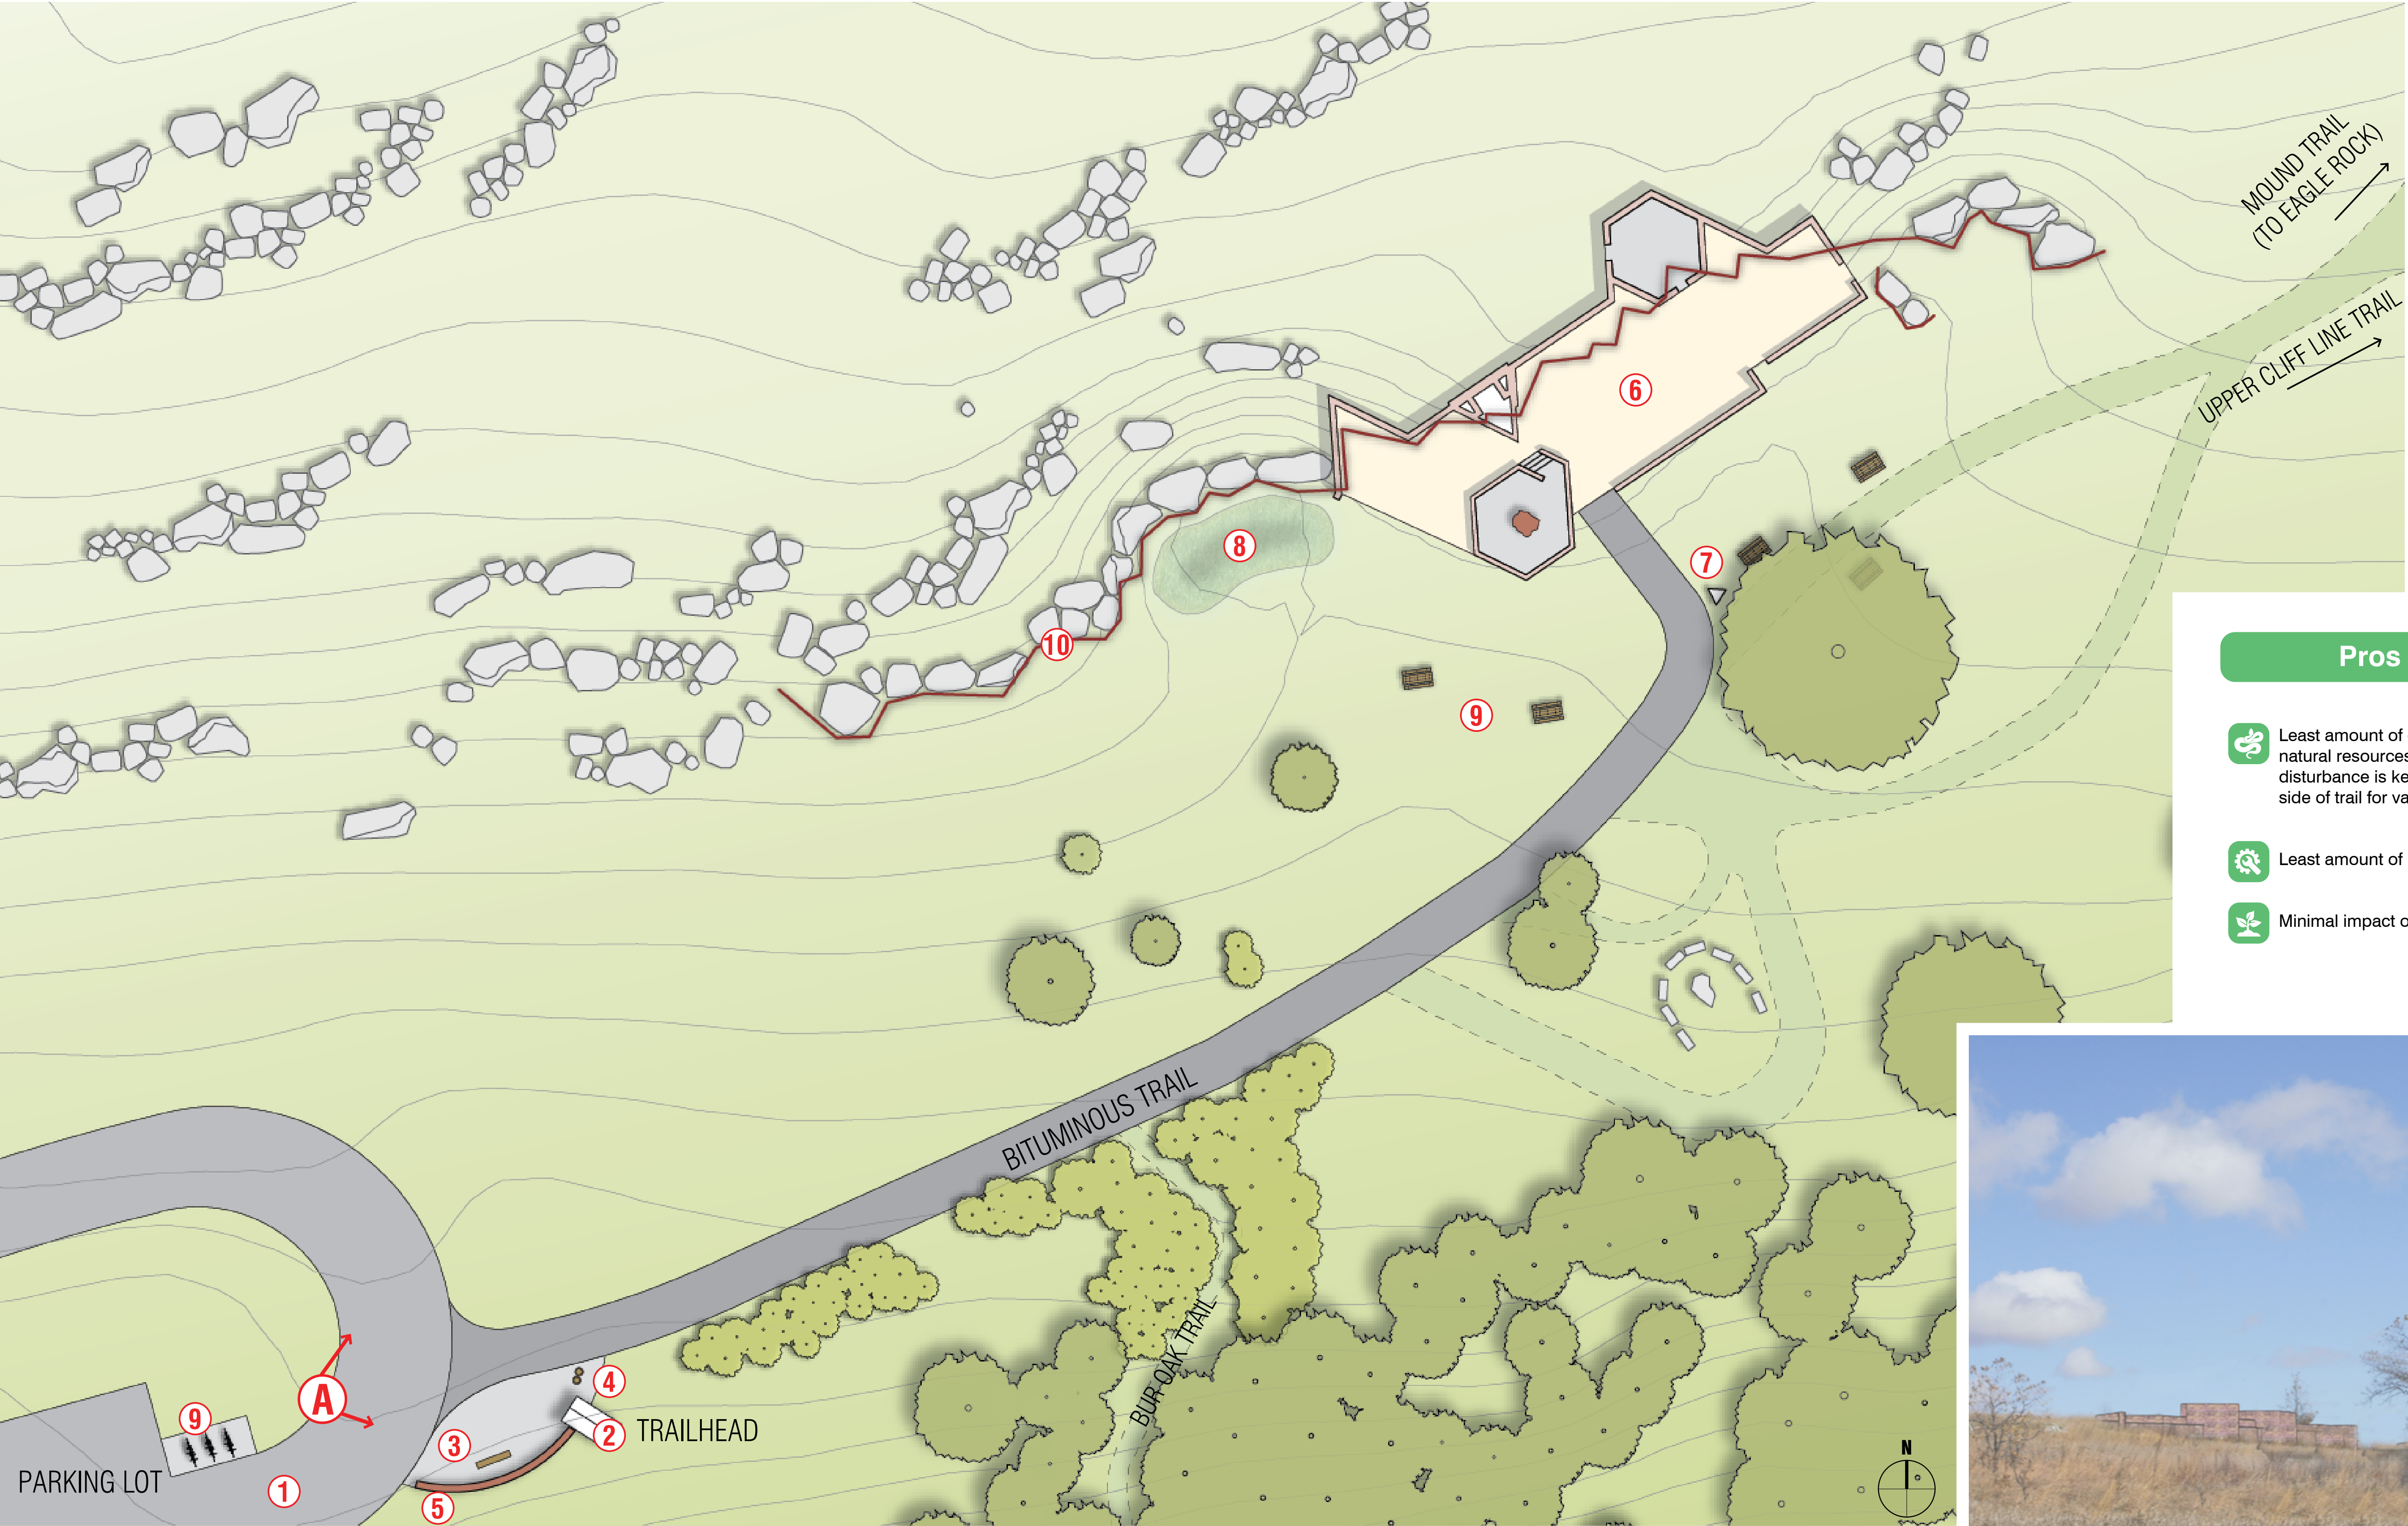
- 1 PARKING LOT IMPROVEMENTS
- 2 VAULT TOILET
- 3 PAY BOX/ WAYFINDING
- 4 TRASH/RECYCLING
- 5 STONE WALL
- 6 INTERPRETIVE CENTER FOOTPRINT
- 7 INTERPRETIVE SIGN
- 8 EXISTING SMALL POND
- 9 BIKE RACKS
- 10 SIOUX QUARTZITE BLUFF

- Least amount of disturbance to natural resources and habitat; disturbance is kept to south side of trail for vault toilet
- Least amount of maintenance
- Minimal impact on landscape

- Majority of Interpretive Center structure removed due to structural deficiencies
