C PERSPECTIVE C

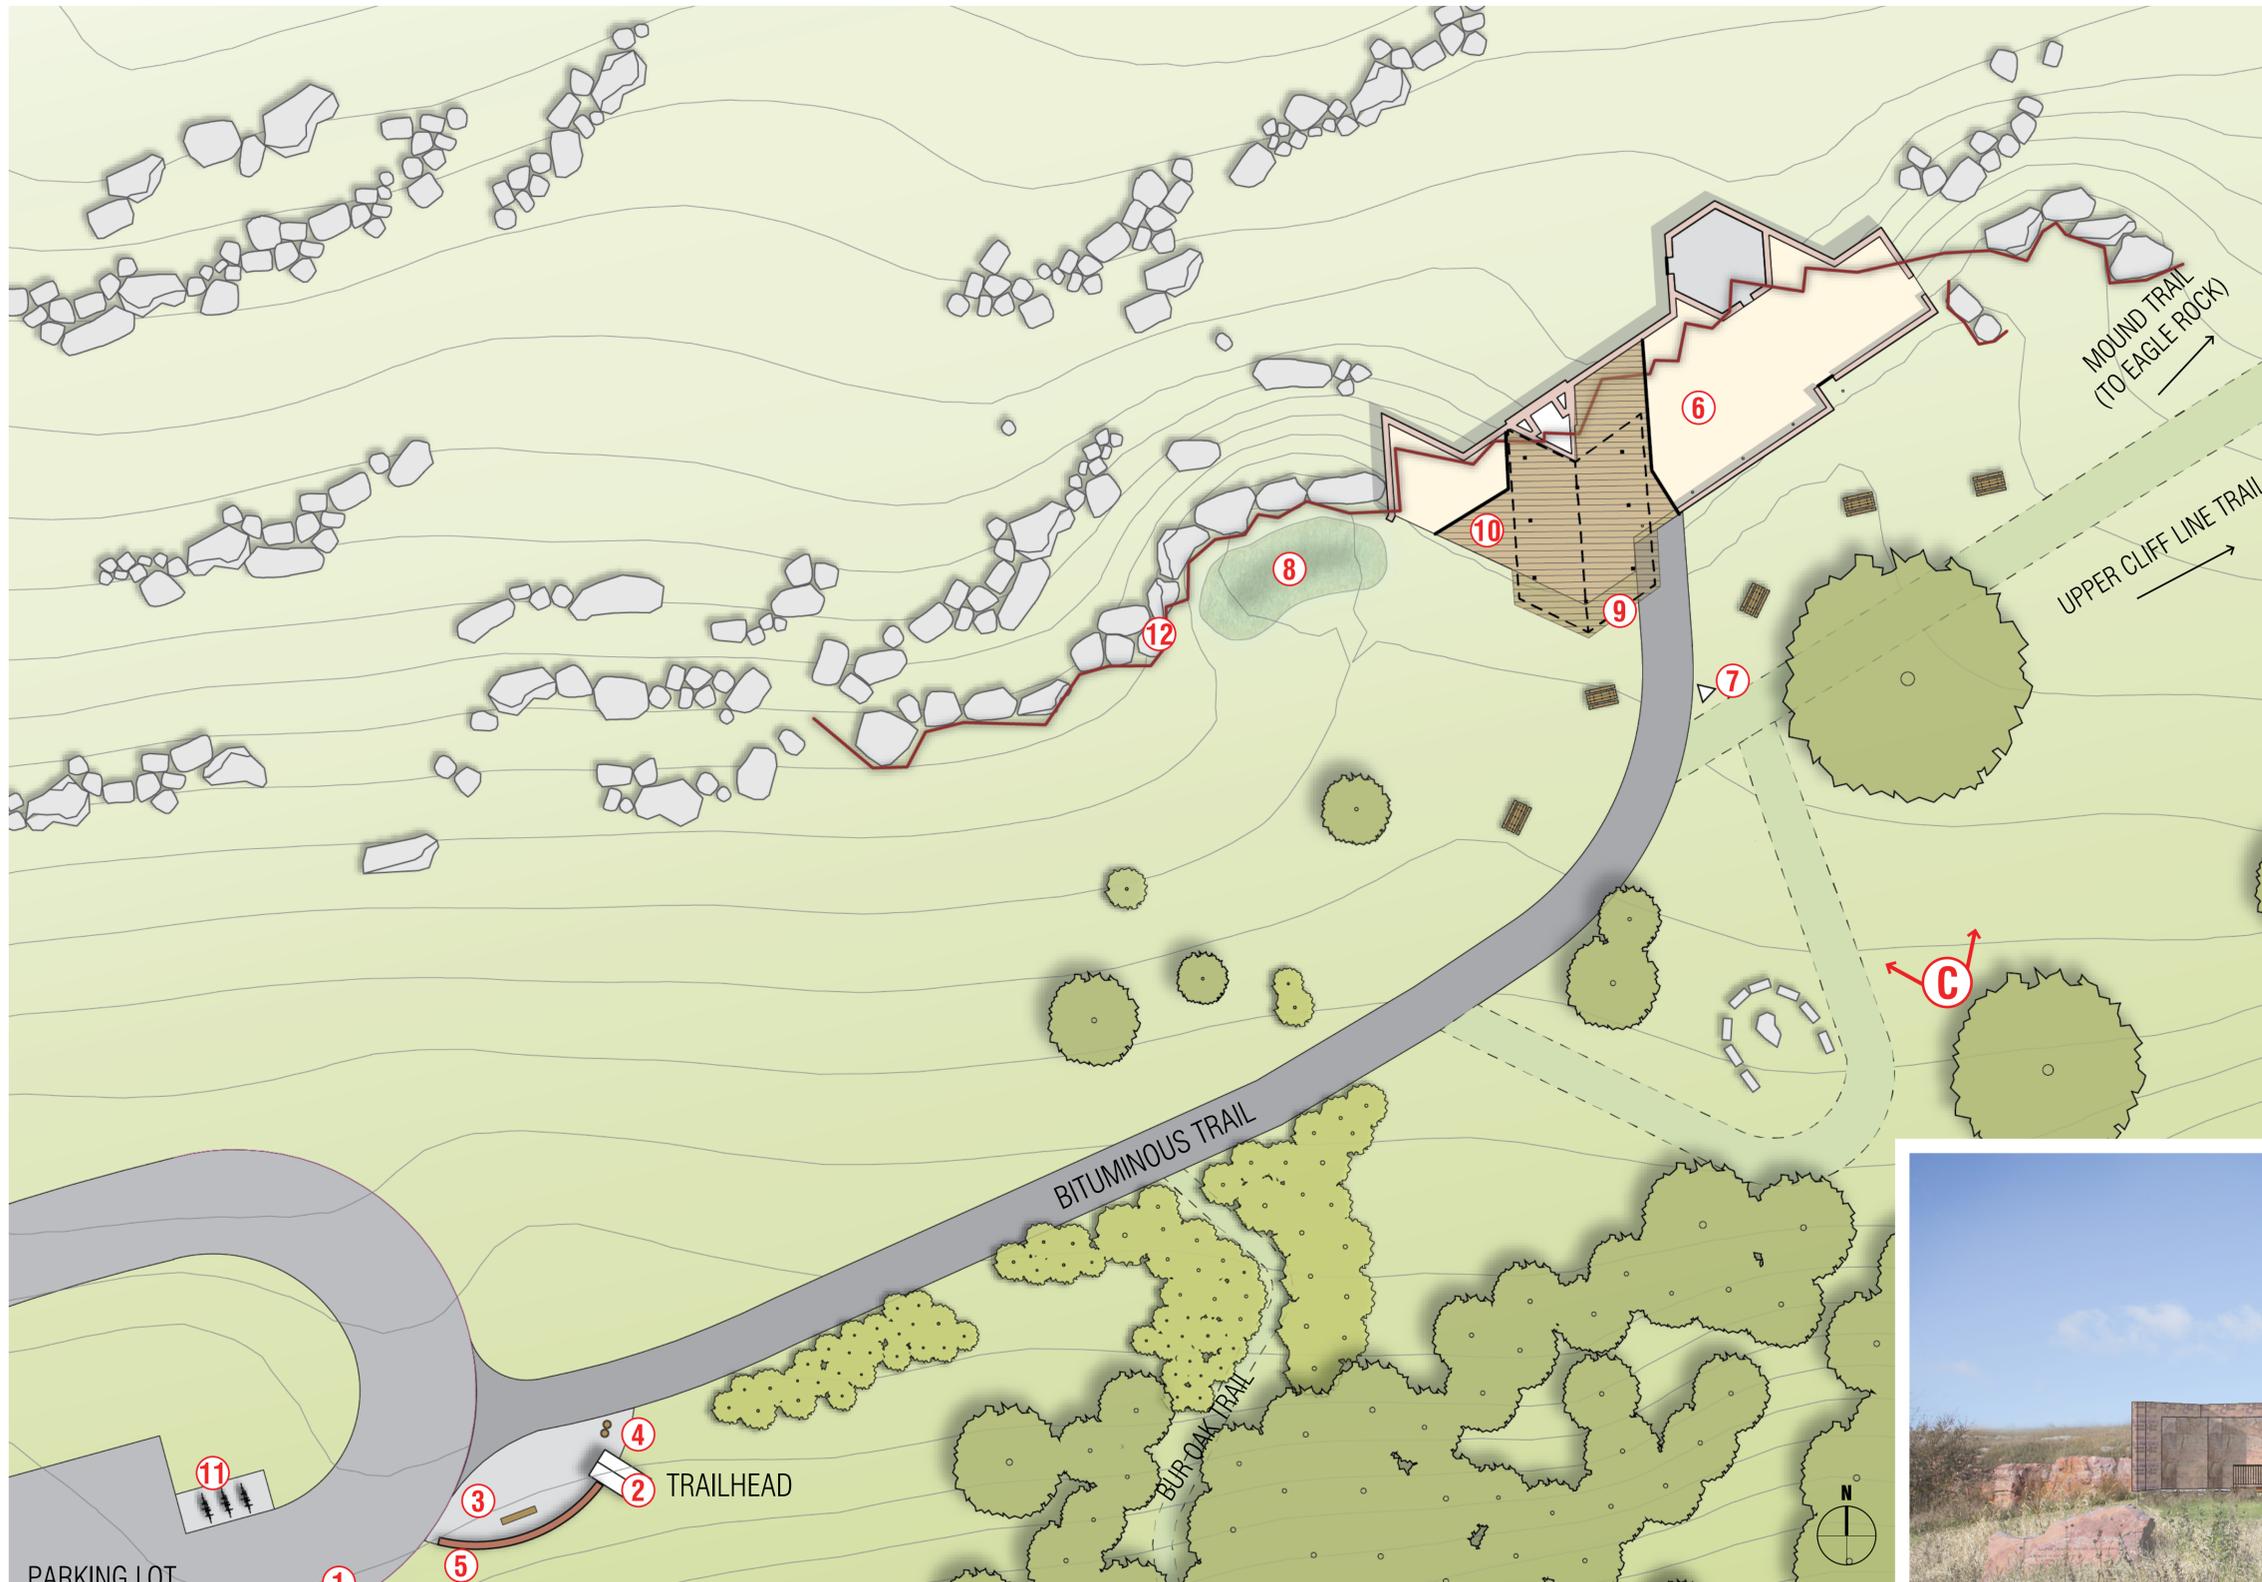
- ① PARKING LOT IMPROVEMENTS
- ② VAULT TOILET
- ③ PAY BOX/ WAYFINDING
- ④ TRASH/RECYCLING
- ⑤ STONE WALL
- ⑥ INTERPRETIVE CENTER FOOTPRINT
- ⑦ INTERPRETIVE SIGN
- ⑧ EXISTING SMALL POND
- ⑨ SHELTER/EVENT (~36-60 PEOPLE)
- ⑩ FLOATING FLOOR
- ⑪ BIKE RACKS
- ⑫ SIOUX QUARTZITE BLUFF

- Pros**
- Adaptive reuse of Manfred house footprint and compatible design of new shelter
 - Accessible picnic shelter
 - Minimal impact on landscape

- Cons**
- Shelter over critical snake habitat; impact potentially minimized by floating floor
 - Majority of Interpretive Center structure removed/alterd to accommodate shelter and address structural deficiencies

In this concept, the trailhead improvements and the disposition of the Interpretive Center remain the same as shown in Concept 01. A new picnic shelter has been added to the Interpretive Center footprint in the location of a former sunken living room. The location takes advantage of the same vantage point as the living area and incorporates the triangular fireplace. A new floor for the shelter would be built over the existing building slab to cover the heaving slab and provide an accessible, uniform surface.
