STATE OF MINNESOTA DEPARTMENT OF NATURAL RESOURCES		
DIVISION OF FISH AND WILDLIFE ECOLOGICAL SERVICES SECTION		
CROOKED LAKE (2-84) ANOKA COUNTY		
T. 31, 32 N. R. 24 W. S. 4.33		
FIELDWORK J.L.G., D.J.S.	DRAWN BY S. L. Engg.	PROJ. IDENT. NO.
DATE 5-20-82	DATE 5-16-84	FW-1-R-27,28

C-2830

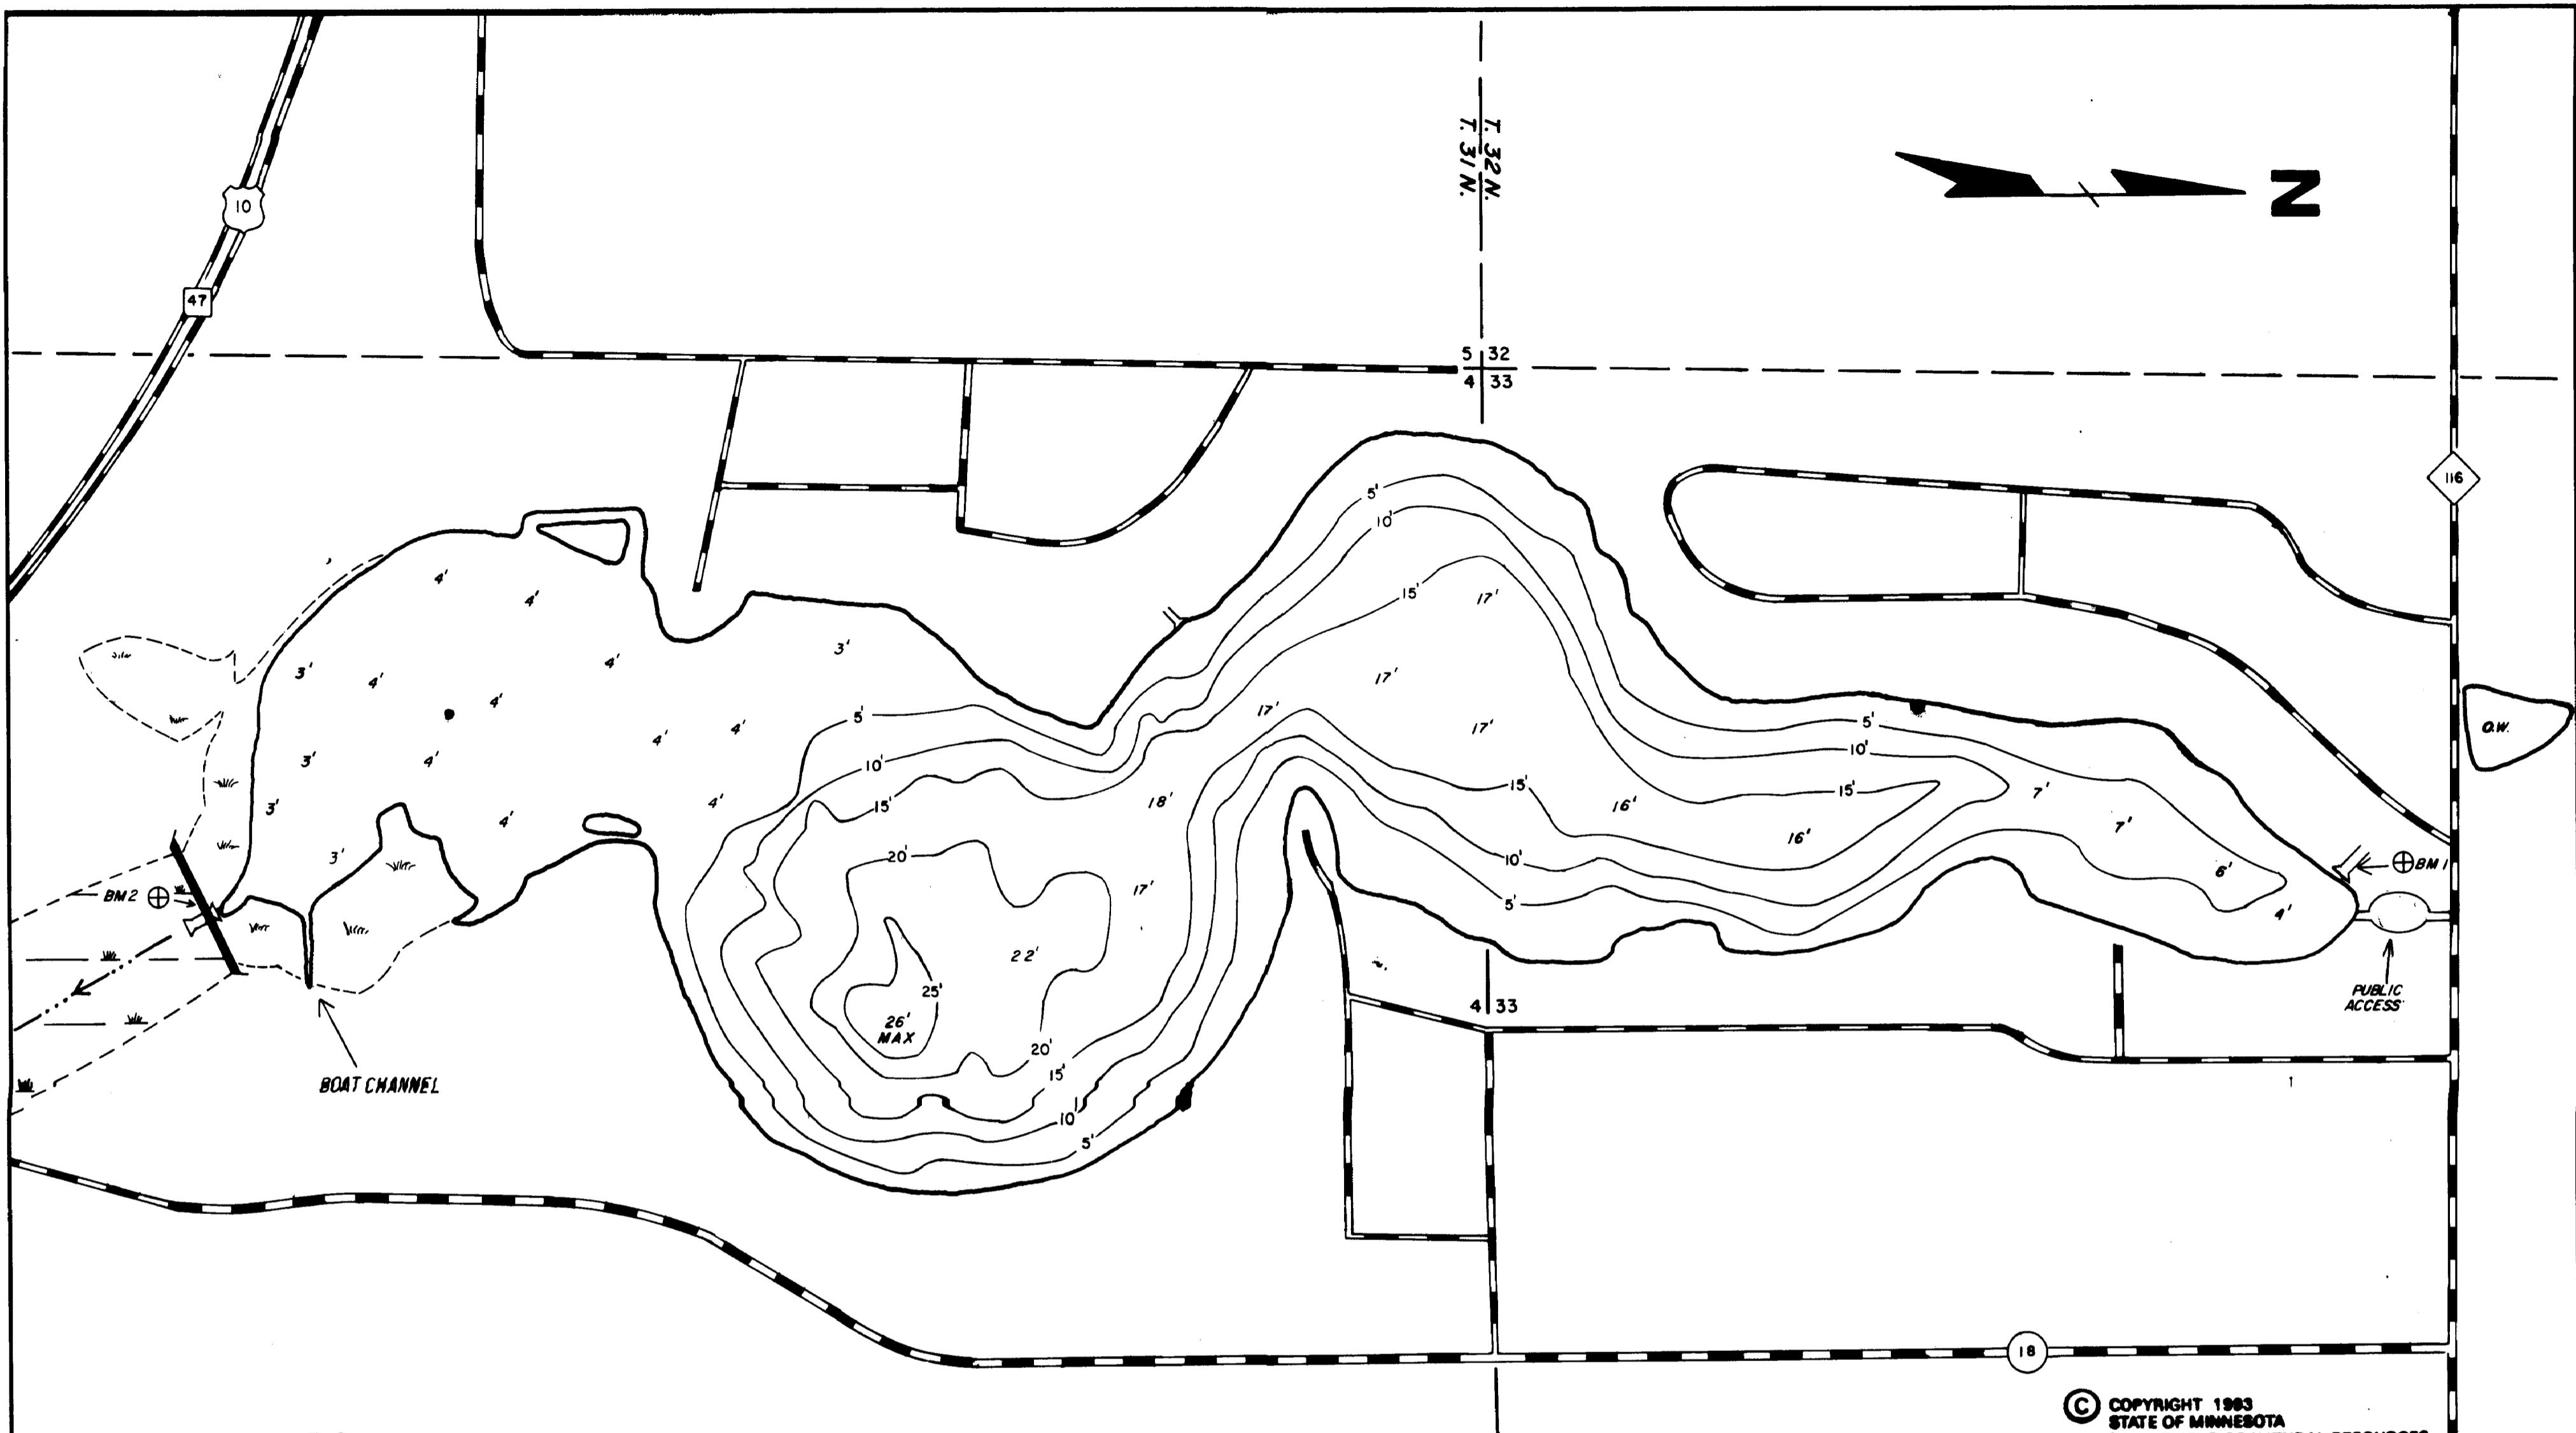
PLANIMETERED AREA 117.0 ACRES
 LITTORAL AREA 86 ACRES (74%)
 MEDIAN DEPTH 6.9 FEET
 LENGTH OF SHORELINE 1.1 MILES

LAKE OUTLINE DRAWN FROM 1977 BLUELINE
 AERIAL PHOTO SHEET NO. 121-1.

B.M.1-TOP OF METAL GRATE OVER CONCRETE
 CULVERT, 150' WEST OF BOAT RAMP AT PUBLIC
 ACCESS, ON NORTH SHORE OF LAKE.
 W.S.E. = 1.23' BELOW B.M.1.

B.M.2-TOP OF CORREGATED METAL CULVERT AT
 OUTLET ON SOUTHEAST END OF LAKE.
 W.S.E. = 1.94' BELOW B.M.2.
