POLYMET
MINING

NorthMet Project

Geotechnical Data Package

Volume 2 - Hydrometallurgical Residue Facility

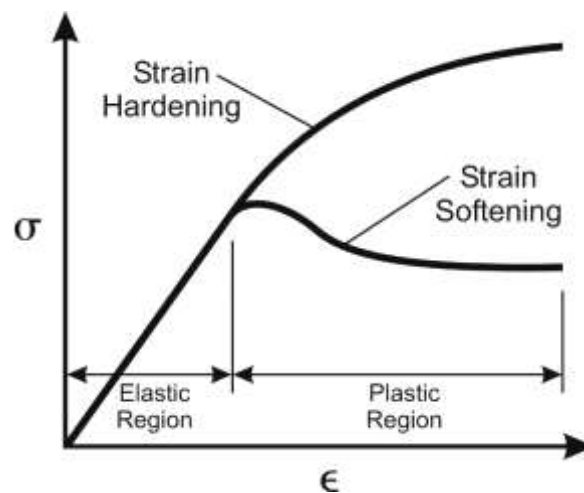
Figure 4-2 Modified Cam-Clay (MCC) Stress-Strain Diagram

There are two distinct regions of the MCC constitutive model: (1) an elastic region at lower strains and (2) a plastic region at higher strains. The term elastic relates to non-permanent deformation; a material will spring back to its initial shape. The plastic region of the stress-strain curve is the range of higher strain values that will cause permanent deformation in a material. The transition between these regions is termed the yield point. Moving to the right of the yield point, the additional strain will cause an increase in stress (strain hardening) or a decrease in

The MCC constitutive model is an elasto-plastic strain hardening/softening model. The MCC constitutive model is most appropriately applied to saturated normally to slightly over-consolidated soils, which experience significant non-reversible volume changes when compressed (Reference (18)). Residue, LTVSMC fine tailings, LTVSMC slimes, LTVSMC slimes - wick, compressed peat, and compressed peat - wick were assigned MCC parameters. Figure 4-2 illustrates the stress (σ) strain (ϵ) relationship in a MCC material model.

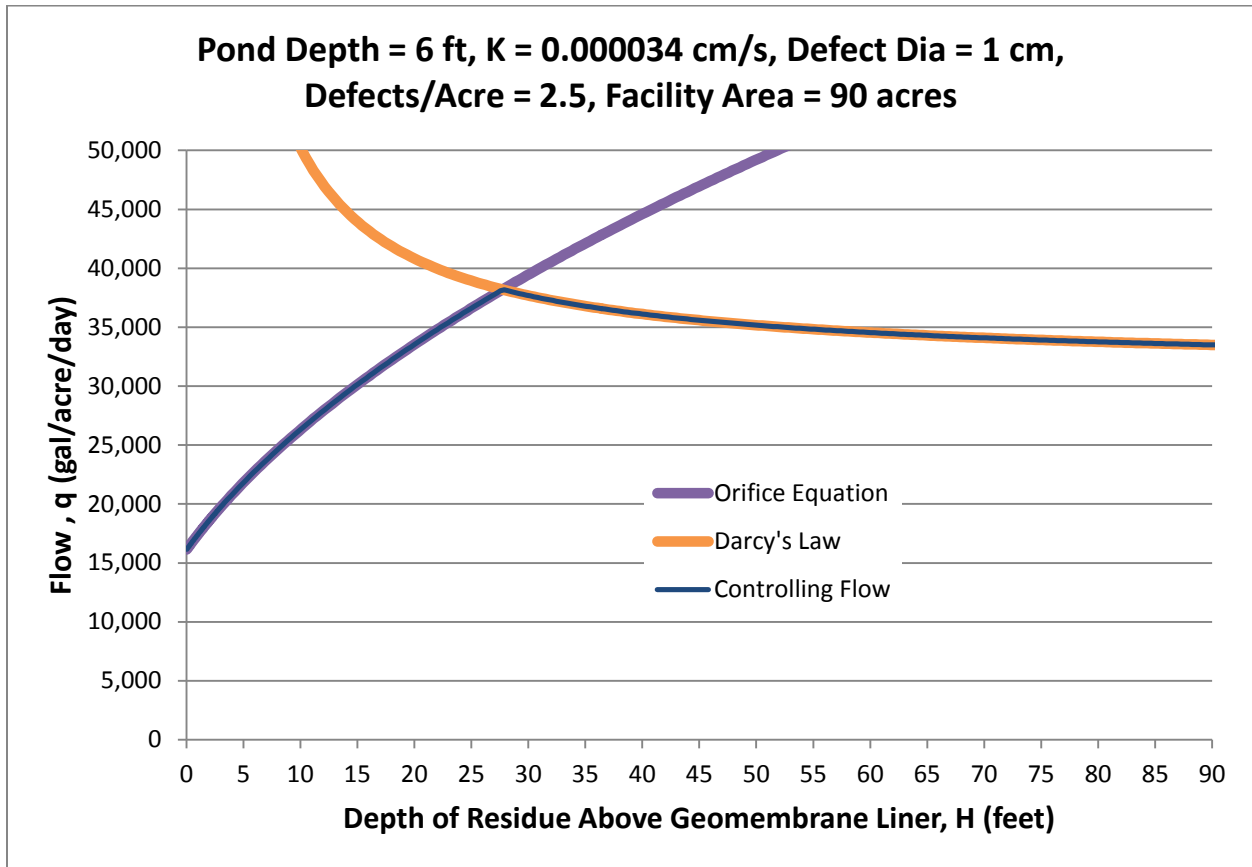
Figure 6-2 HRF Dewatering: Hydraulic Head Drawdown vs. Time

Leakage flow is constrained by the limitations on flow through liner defects (the orifice equation) and by the hydraulic conductivity of the Residue (Darcy’s law). Figure 6-2 is an example plot of leakage flow based on the orifice equation and Darcy’s Law at different Residue depths. When Residue is shallower, flow is constrained by the inability of liner defects to transmit an unlimited amount of flow, so the controlling flow line (the dark blue line) follows the orifice equation (purple line). However, as the Residue depth increases, a point is reached where flow becomes constrained by the hydraulic conductivity of the Residue, which controls the rate at which liquid can move through and drain from the Residue (the orange line). From that point, the controlling flow line follows Darcy’s Law (the orange line). The Drainage Collection System is designed to collect the leakage flow as shown by the dark blue controlling flow line.

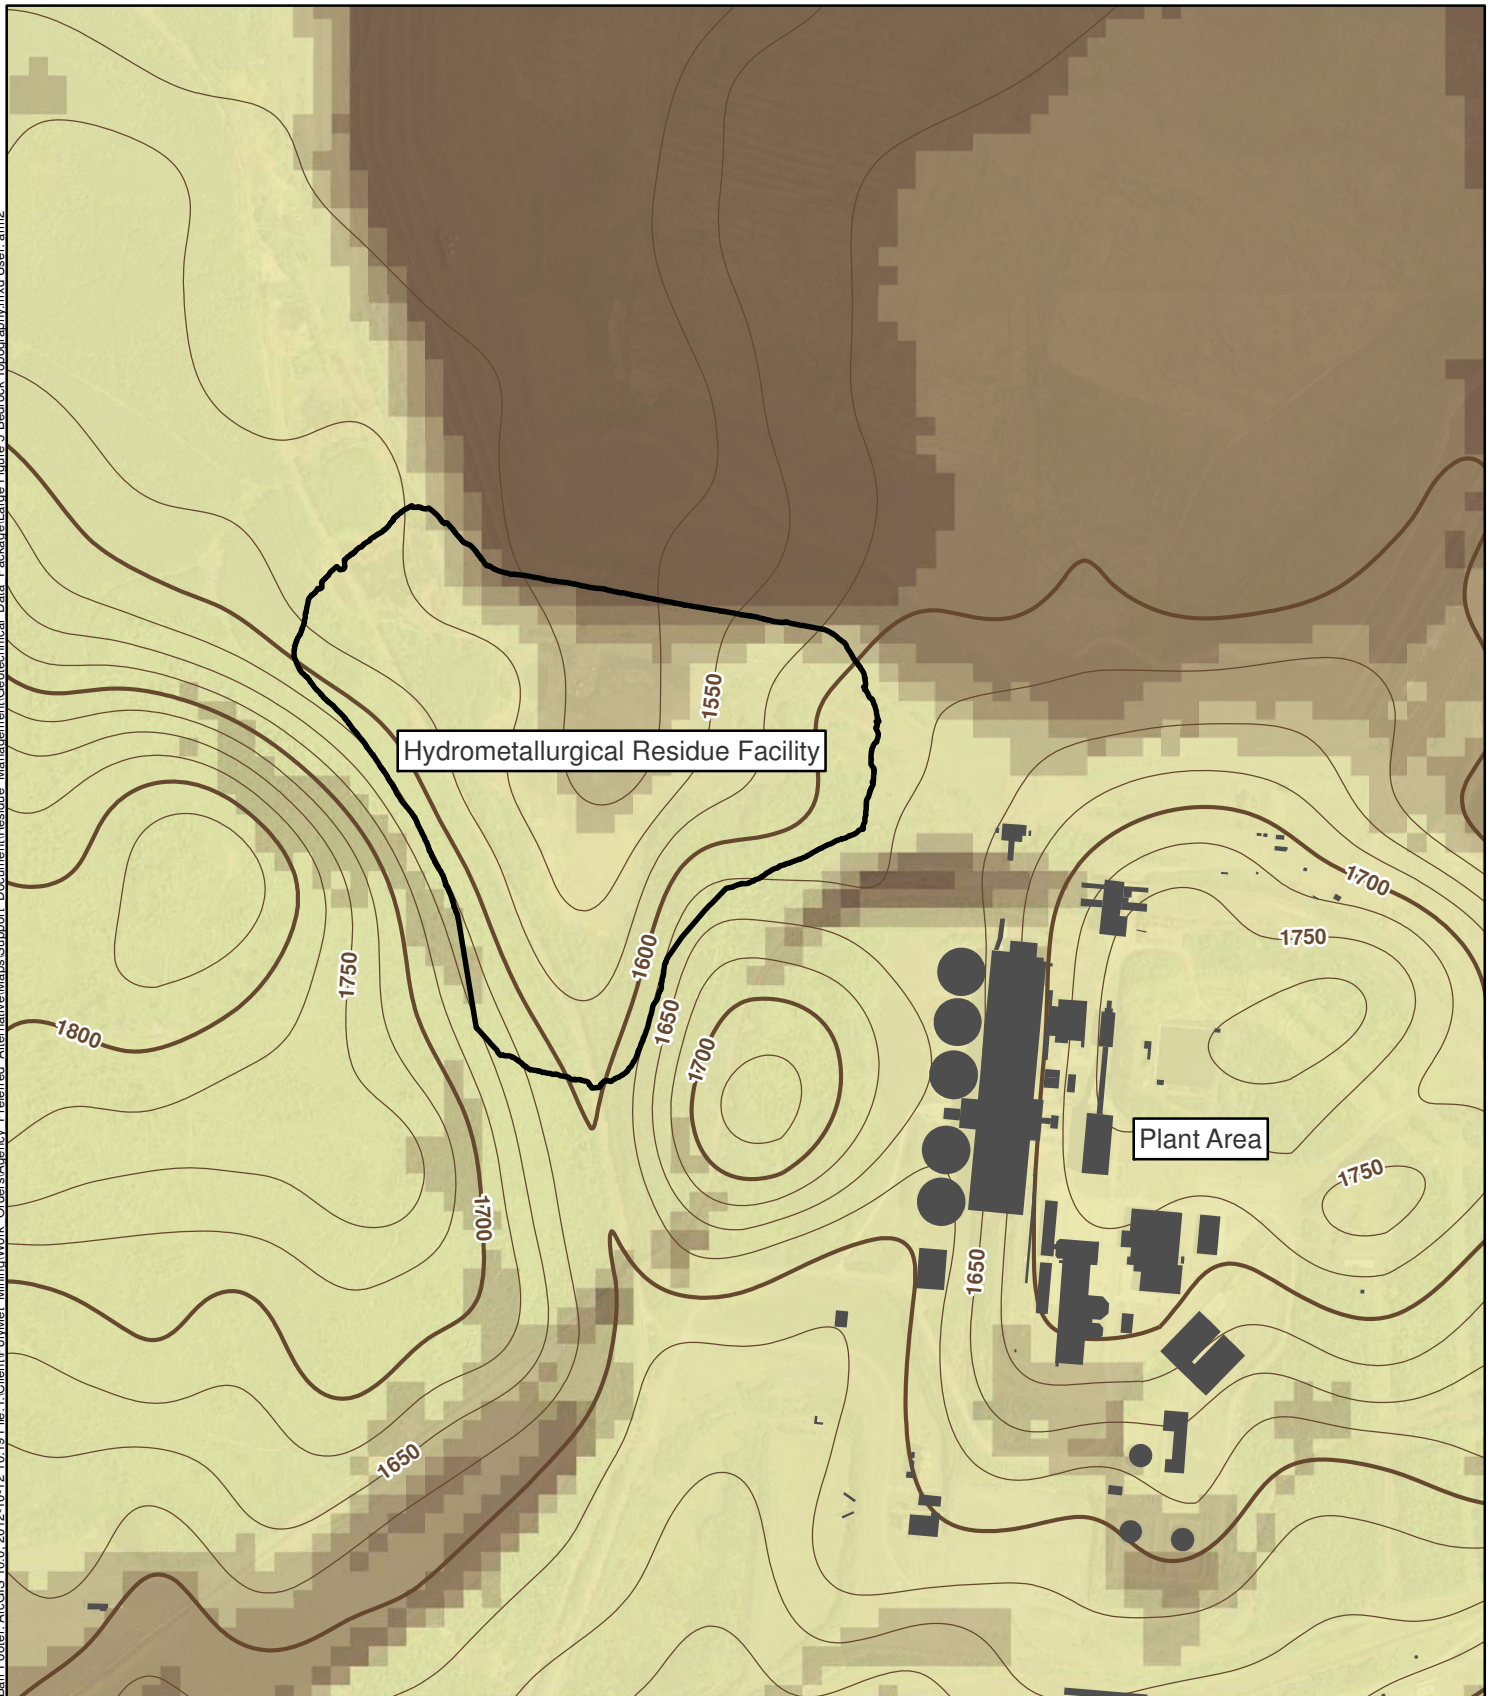
Large Figure 4
HRF AREA
BEDROCK GEOLOGY
 NorthMet Project
 PolyMet Mining Inc.
 Hoyt Lakes, MN

Depth to Bedrock Top of Bedrock (interval = 25 ft)

The location of linear valleys is sometimes interpreted to correspond with the location of faults in the bedrock. For example, the Minnesota Geological Survey (MGS) has inferred but not confirmed the presence of a north-south trending fault to underlie the proposed HRF (Reference (6)), Large Figure 4). A bedrock geological map compiled in 2003 by M.A. Jirsa and T.J. Boerboom of the MGS depicts the same area without an inferred fault (Reference (7)).

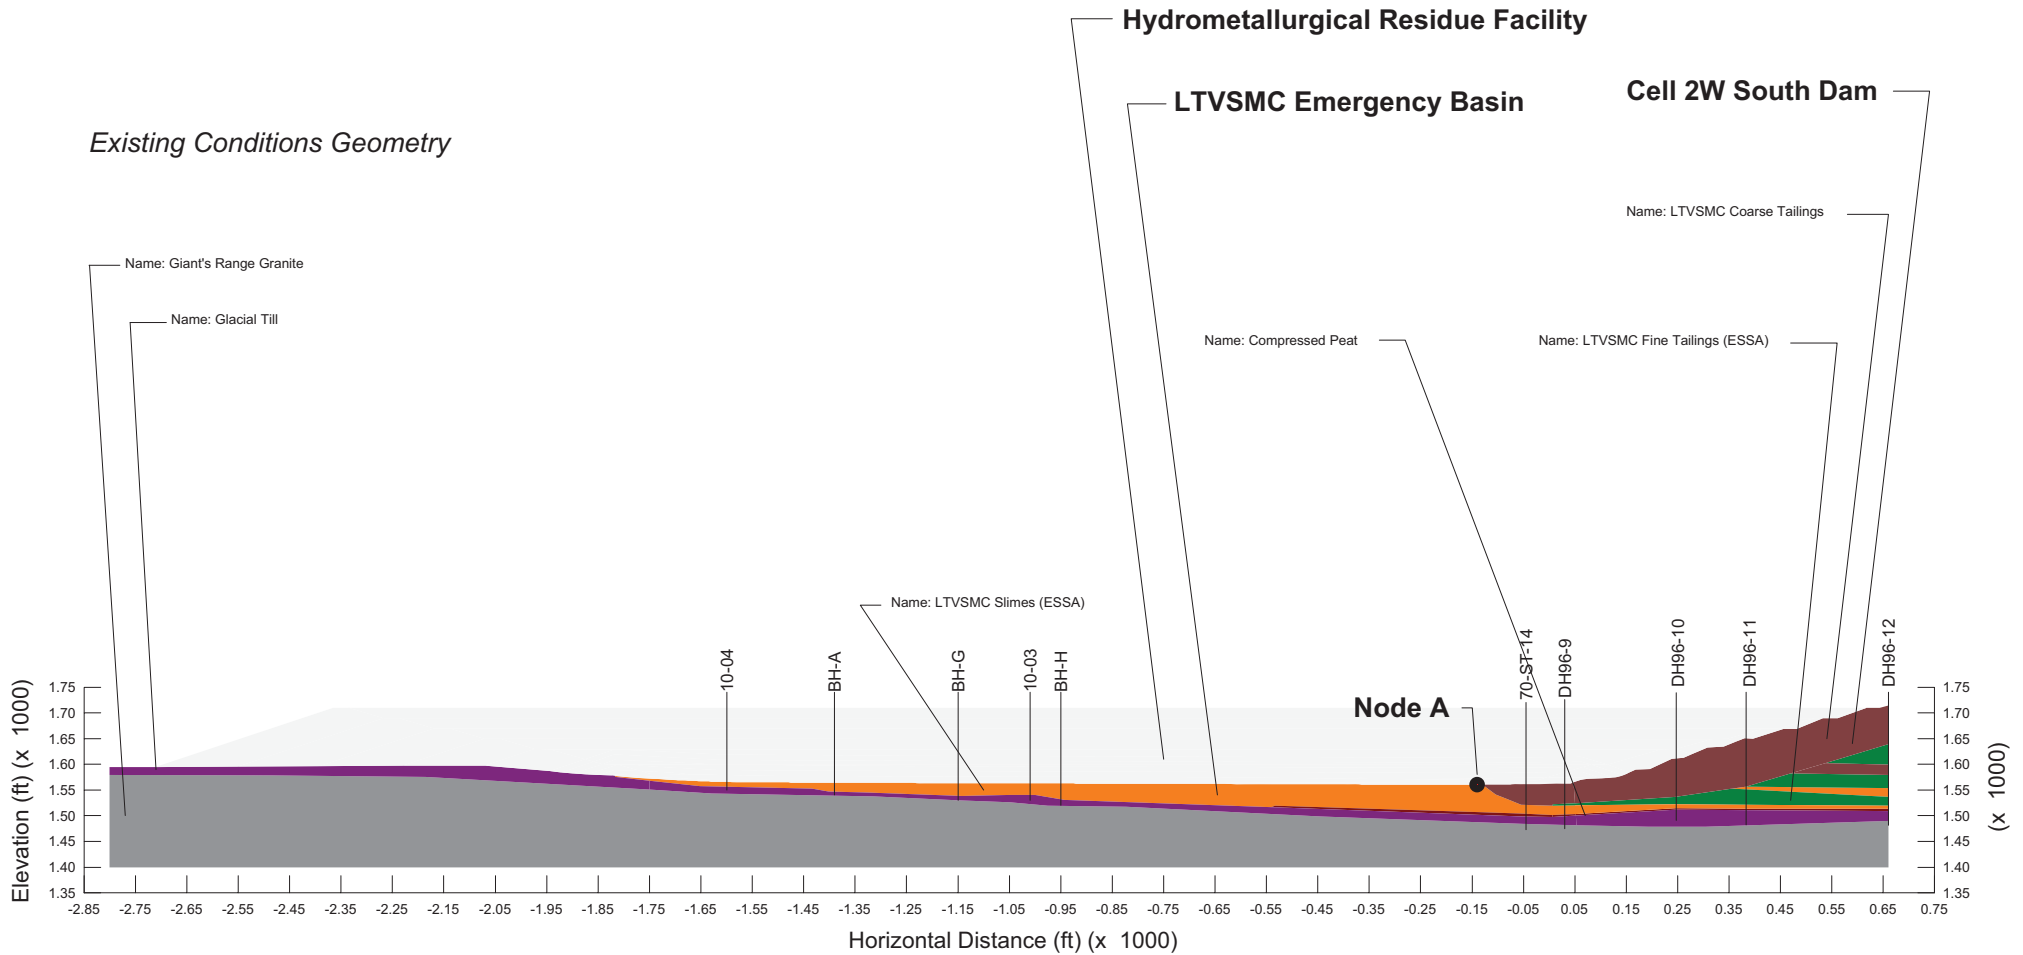
Large Figure 13
HRF End of Operation (Year 20)
Geometry A-A'

PolyMet: NorthMet Hydrometallurgical Residue Facility
Critical Cross Section A-A'
File Name: HRF 2012 Model.gsz
Date: 9/11/2012
SIGMA/W Analysis, Coupled Stress/PWP Method

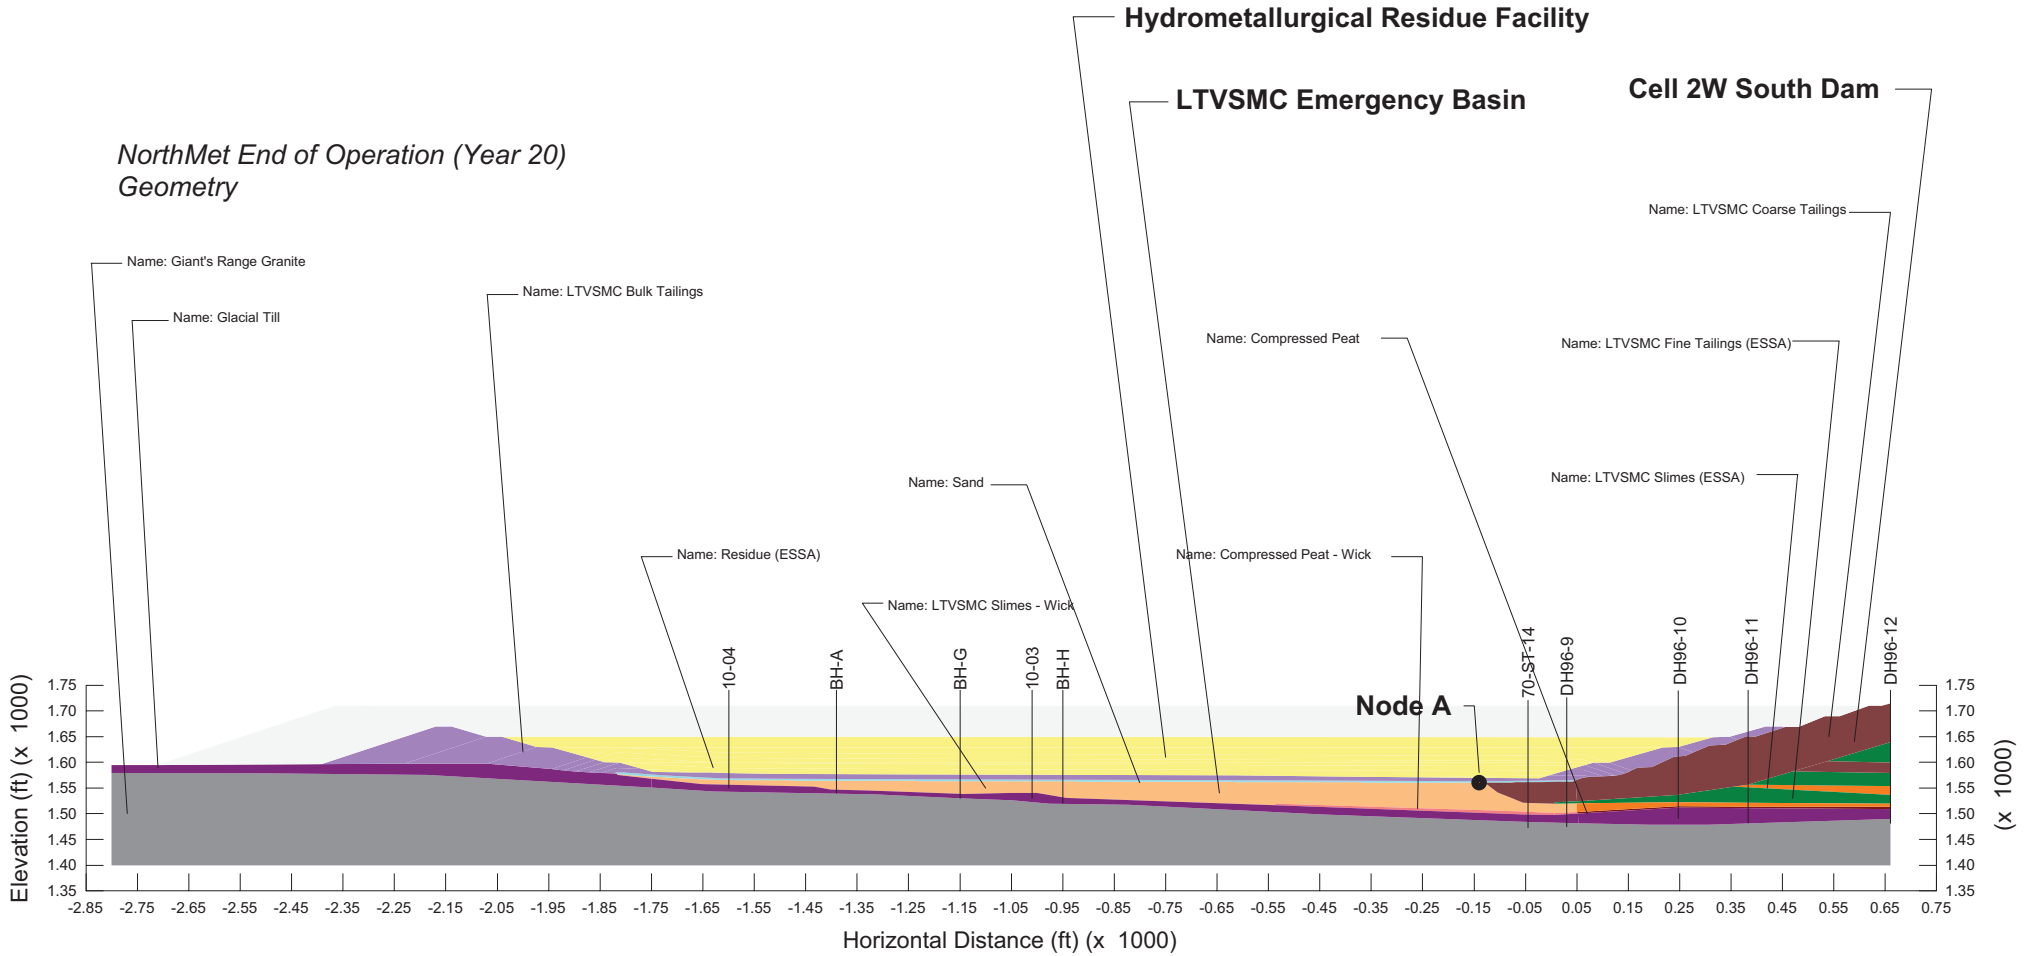
Large Figure 14
HRF End of Operation (Year 20)
Finite Element Mesh A-A'

PolyMet: NorthMet Hydrometallurgical Residue Facility
Critical Cross Section A-A'
File Name: HRF 2012 Model.gsz
Date: 9/11/2012
SIGMA/W Analysis, Coupled Stress/PWP Method

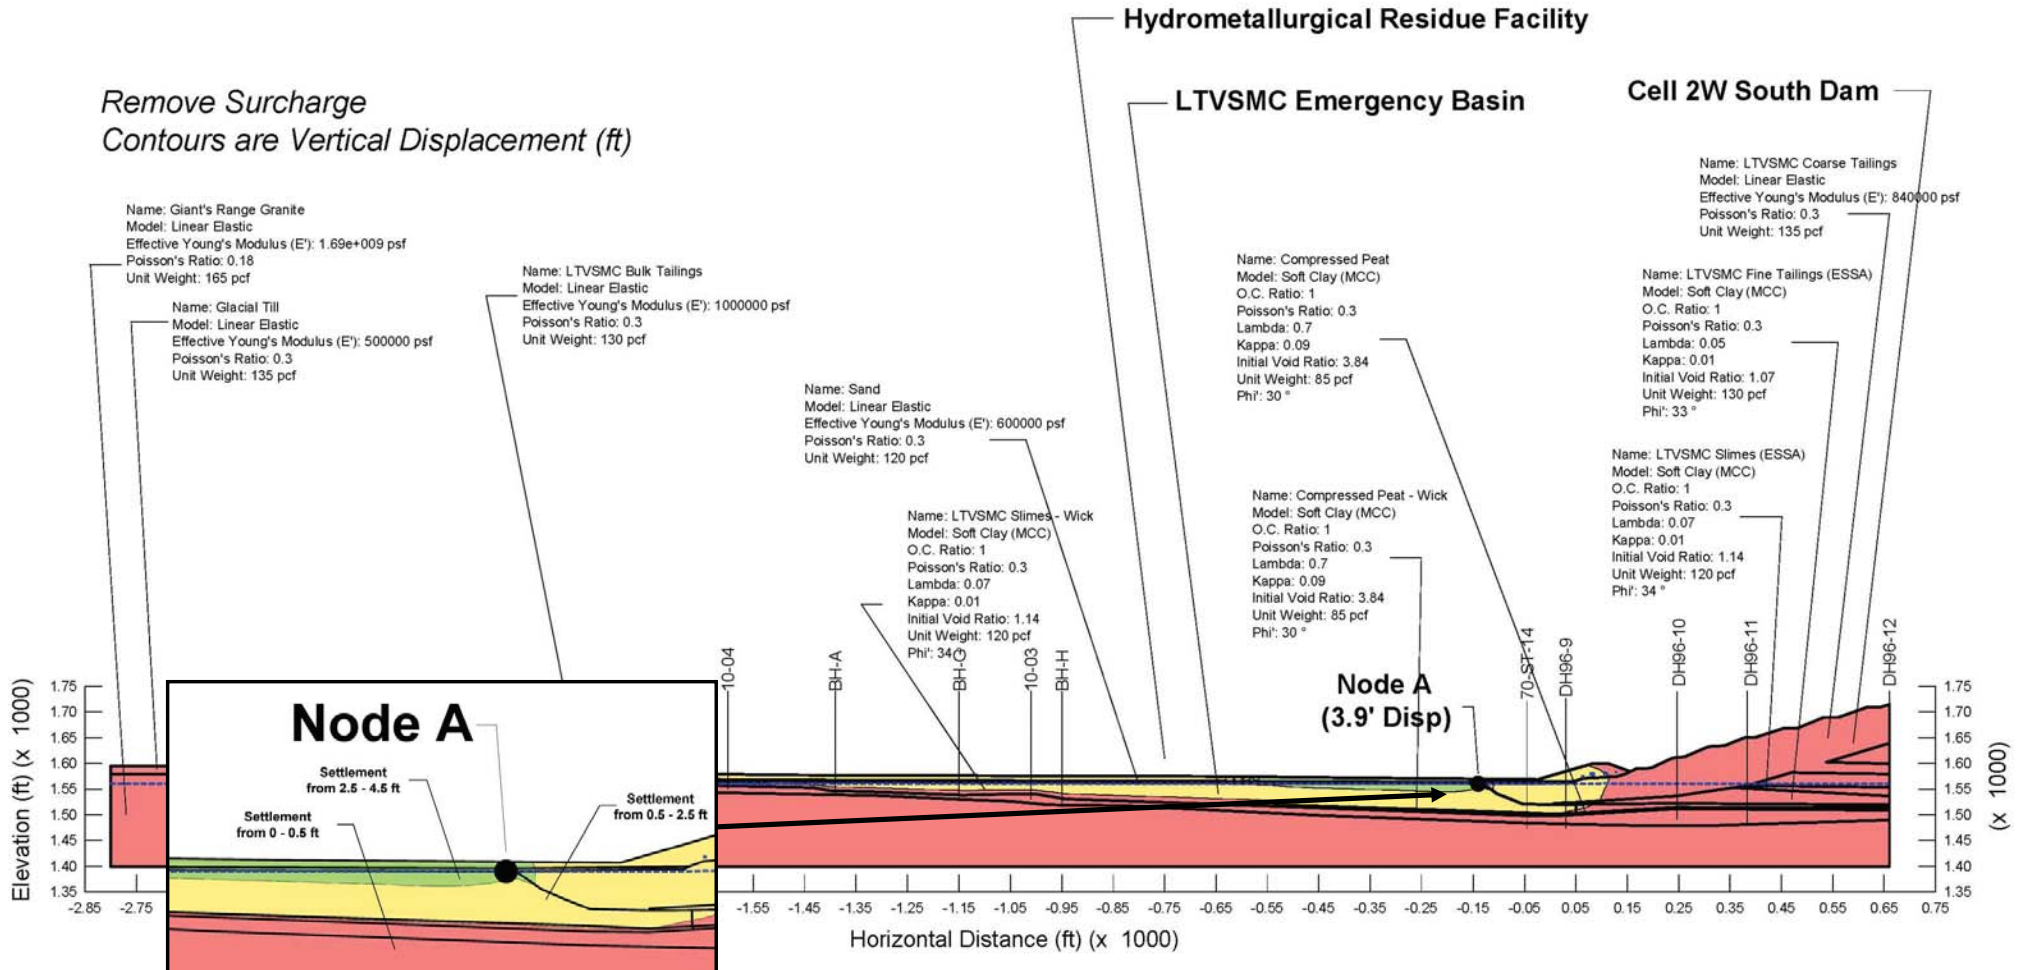
Large Figure 17
Pore-Water Pressure at Removal of Preload

PolyMet: NorthMet Hydrometallurgical Residue Facility
Critical Cross Section A-A'
File Name: HRF 2012 Model.gsz
Date: 9/10/2012
SIGMA/W Analysis, Coupled Stress/PWP Method

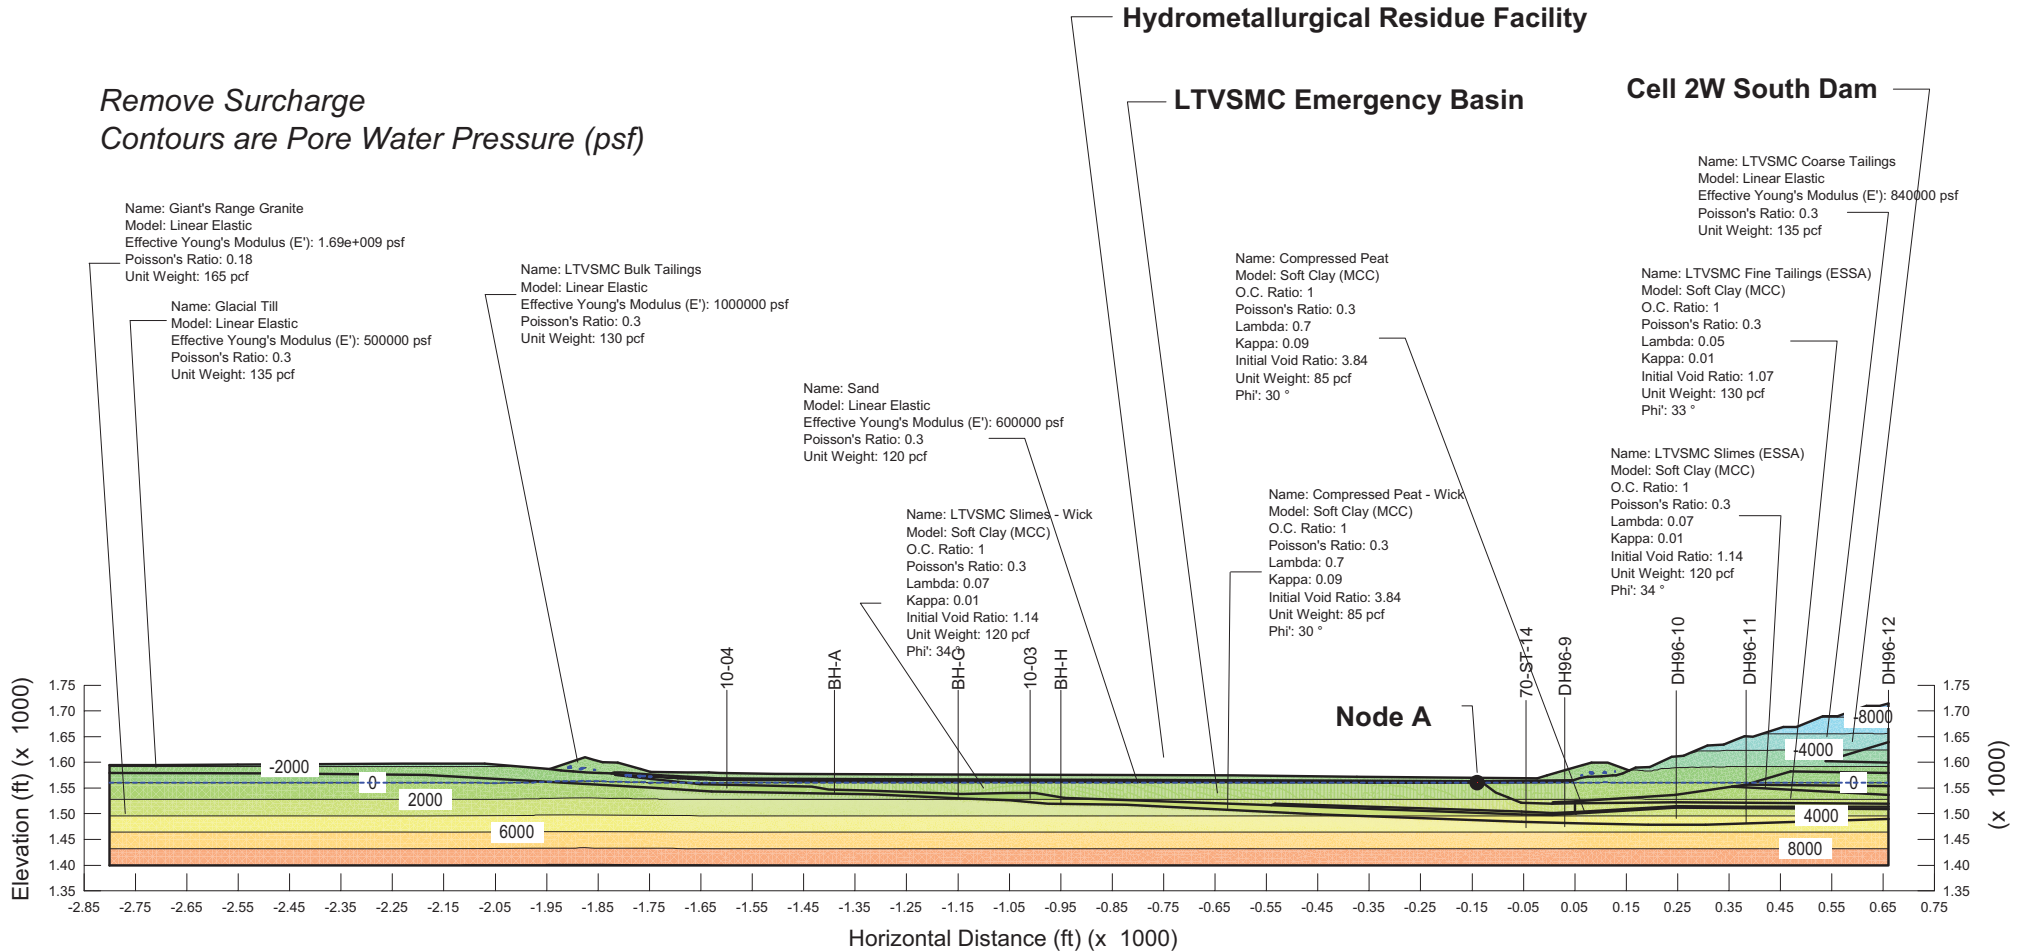
Large Figure 18
Total Head Pressure at Removal of Preload

PolyMet: NorthMet Hydrometallurgical Residue Facility
Critical Cross Section A-A'
File Name: HRF 2012 Model.gsz
Date: 9/10/2012
SIGMA/W Analysis, Coupled Stress/PWP Method

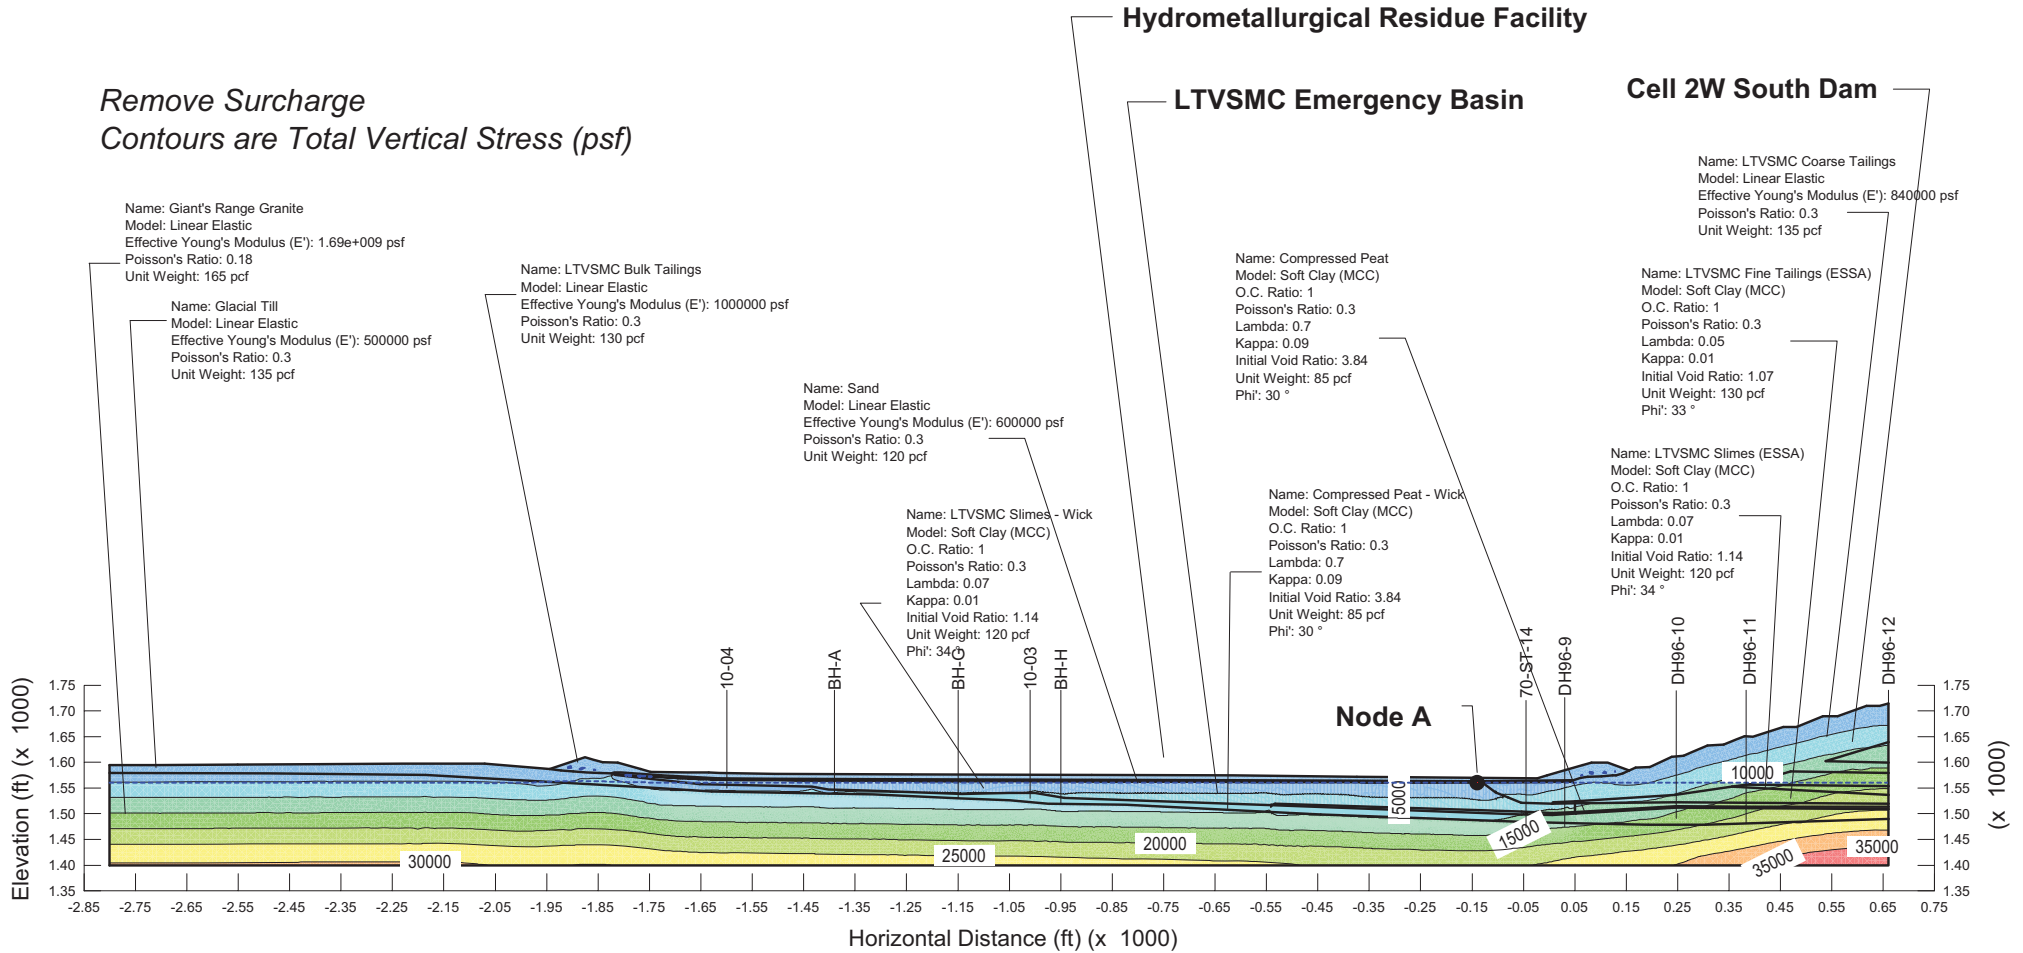
Large Figure 20
Effective Vertical Stress at Removal of
Preload

PolyMet: NorthMet Hydrometallurgical Residue Facility
Critical Cross Section A-A'
File Name: HRF 2012 Model.gsz
Date: 9/10/2012
SIGMA/W Analysis, Coupled Stress/PWP Method

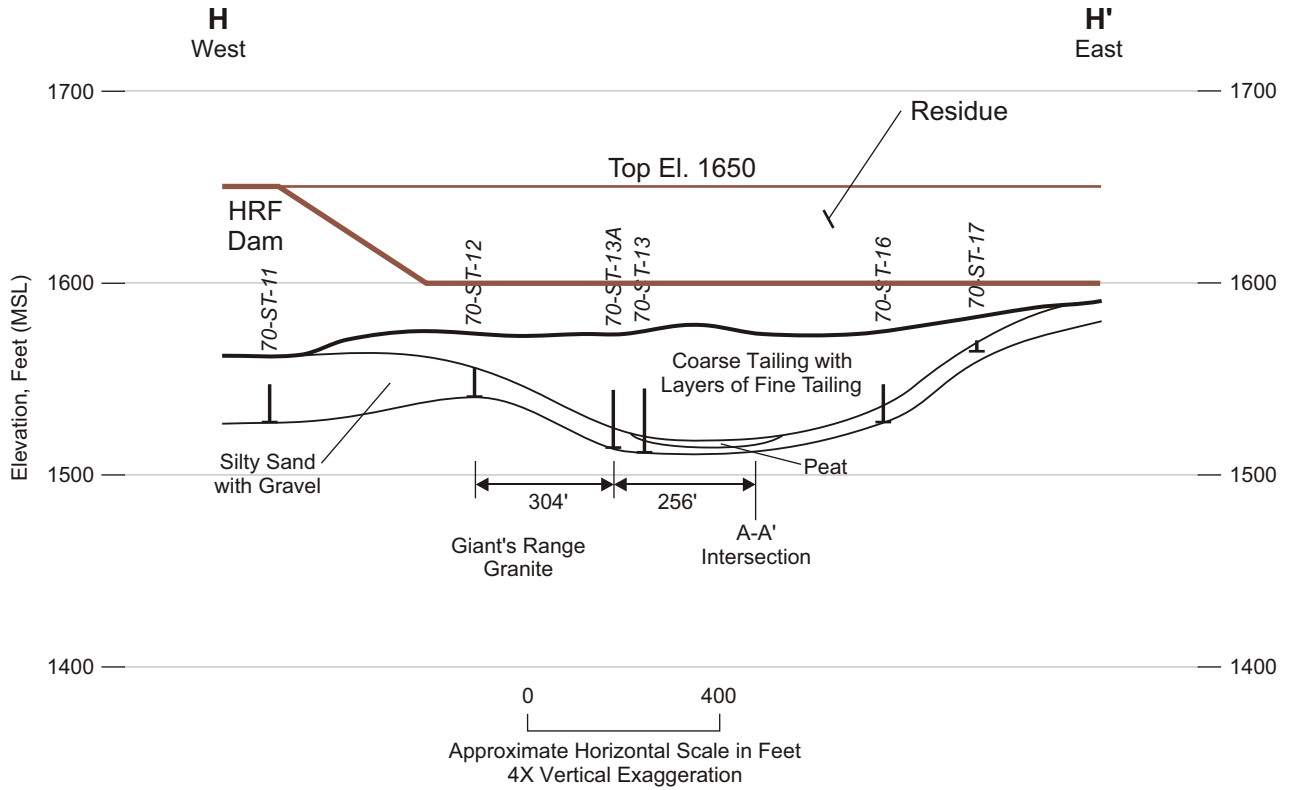
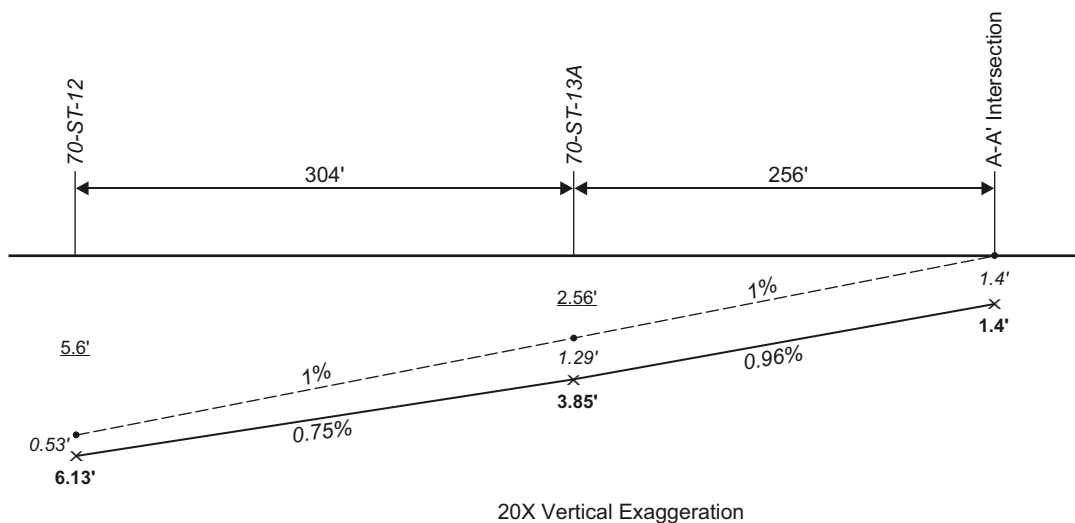
- 5.6' Change in Depth due to 1% Slope
- 0.53' Change in Depth due to Expected Settlement
- 6.13' Total Change in Depth
