Storm Data and Unusual Weather Phenomena - May 2018

Storm Data and Unusual Weather Phenomena - September 2018

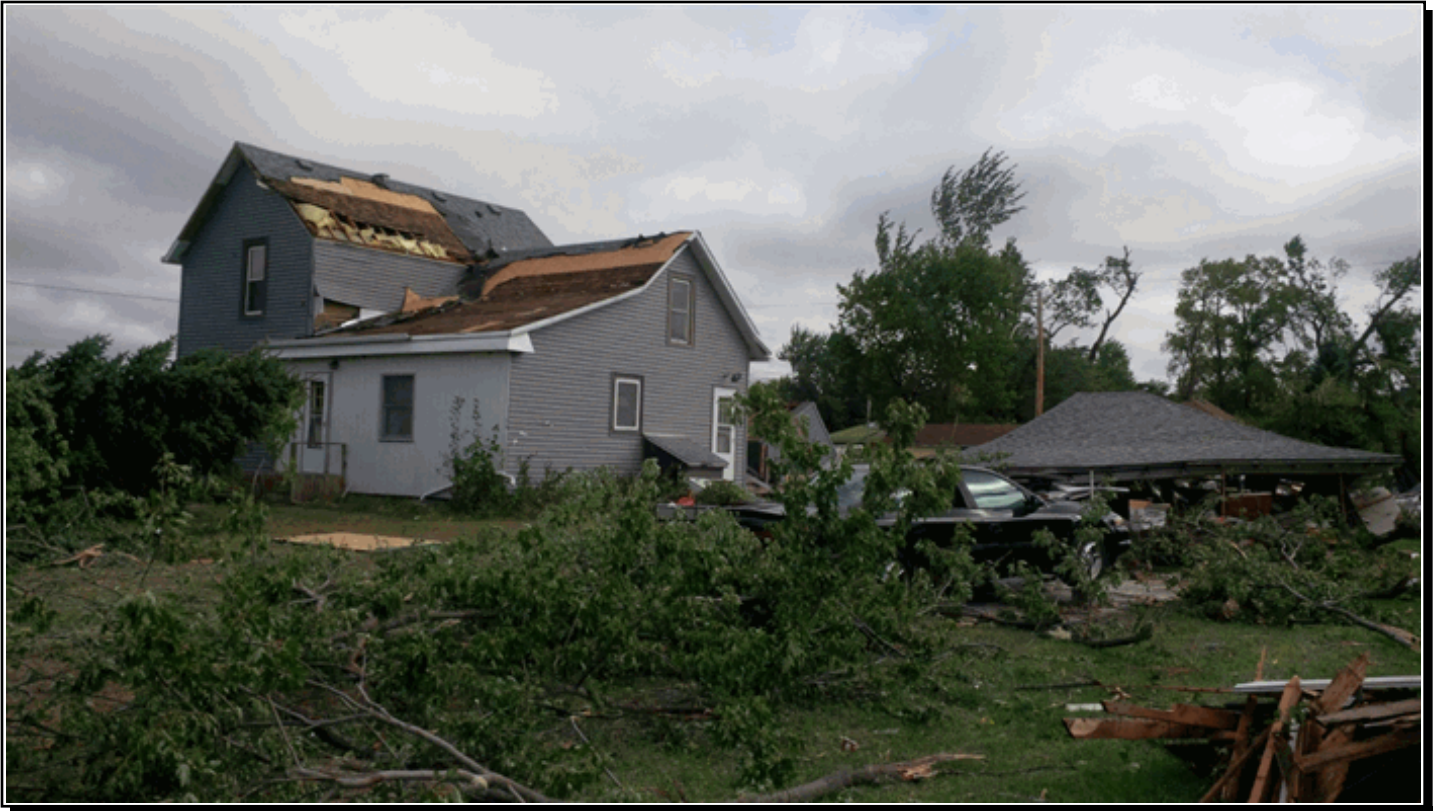
A NWS Storm survey confirmed an EF1 tornado developed just west of the City of Granada, and tracked eastward for 5.3 miles as it moved into Faribault County. The average width was 220 yards and damaged several homes in Granada, before moving across farmland to the east. Numerous large trees were uprooted or blown down. The damage in Granada was consistent with EF1 damage as large sections of roof structures were removed, and one house was shifted from its foundation. Highest winds were estimated at 105 mph.

House in Granada damaged by tornado
